### **The spatiotemporal evolution of compound impacts from lava flow and tephra fallout on buildings: lessons from the 2021 Tajogaite eruption (La Palma, Spain)**

This supplementary information provides a compilation of field observations of i) house typology, ii) hazards metrics and sequence and iii) impact mechanisms for the buildings described in the main manuscript. Building nomenclature follows the definition provided in Figure 2a of the manuscript. For each house, we provide the damage state inferred from the scheme of Meredith et al. (2022) summarised in Table 2 of the manuscript. Each house also comprises a collection of pictures taken during the Oct 2021 (during the eruption, pre lava-flow inundation) and Nov 2022 (after the eruption).

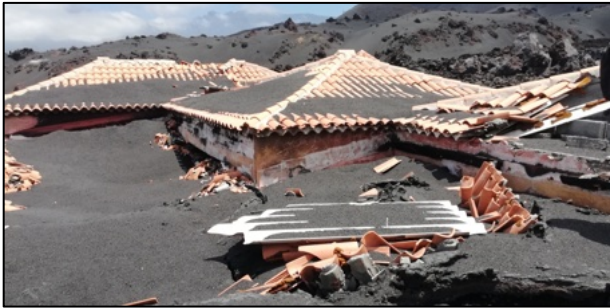
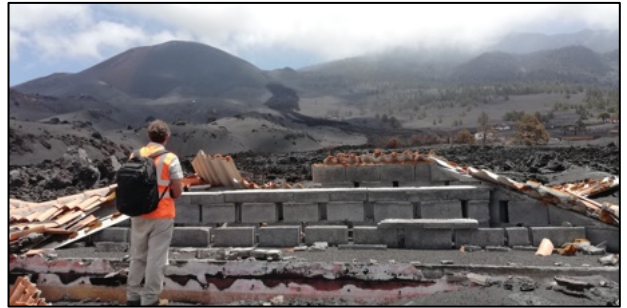
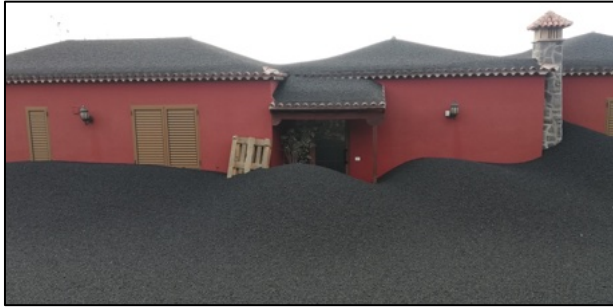
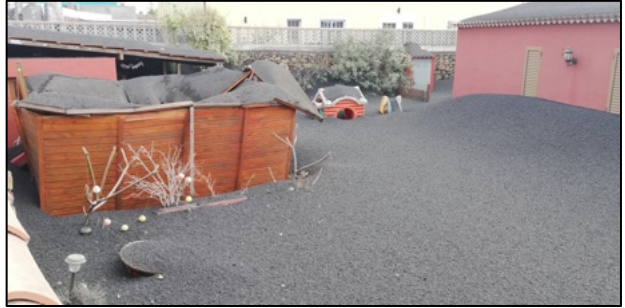
**Name: DSLP-2**

**I) Main house:** - 1: 259 cm long, pahoeohoe lava up to the top of the window

\* 50 cm deflated pahoeohoe measured from the top of the ceiling to the top of the collapsed accessory roof (b)

\* A'a inside the house and pahoeohoe outside

\* Roof of the main house of corrugated composite material and tiles supported by cement blocks collapsed by pahoeohoe

\* Accessory roof (b) moved downstream by pahoeohoe lava flow

**Damage:** Flow impacting from the E to the front of the main house (up to 75 cm on the roof). First floor 50-70% flooded by lava, only the ceiling can be seen. A'a lava from the E, NE and pahoeohoe from S-SE of the house. Lava comes out through openings of the W side of the house. No major structural damage but there are fractures in the corners of the walls and the chimney. Fire damage in the interior and heat removes exterior paint from the house leaving the wall white. Burnt wooden beams and composite material and tiles of the accessory roofs collapsed (a,b,c). Garage (II), storage room (III) and Pool (IV) completely covered by lava.

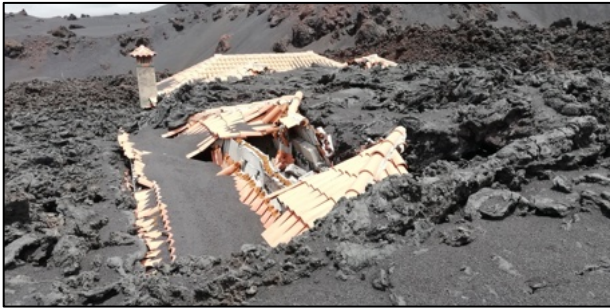
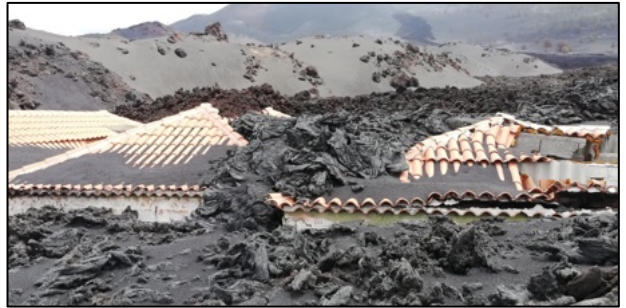
**Name: DSLP-3**

\* The pressure of the lava could have helped to destabilize the roof and together with the accumulation of tephra it collapsed.

\* The double load where the pitches of the two northern roofs meet could have caused it to collapse since its shape allows for greater accumulation.

**Damage:** A'a flow impacting from the N and NE and Pahoehoe from the E, S and W to the main house. First floor completely flooded by A'a lava and pahoehoe on top of it. Structural damage of the chimney and fractures in the walls. Fire damage in the interior and heat removes exterior paint from the house leaving the wall white. Accessory roof "a" completely covered by pahoehoe lava and "b" collapsed. Secondary structures (II, III) and pool (IV) completely covered by lava.

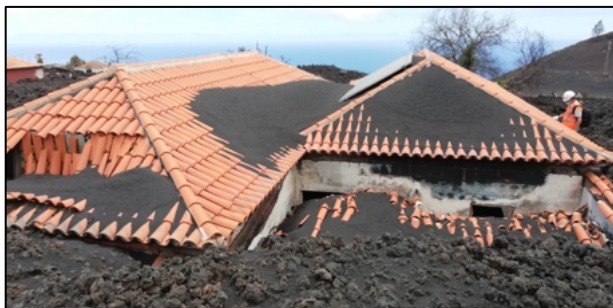
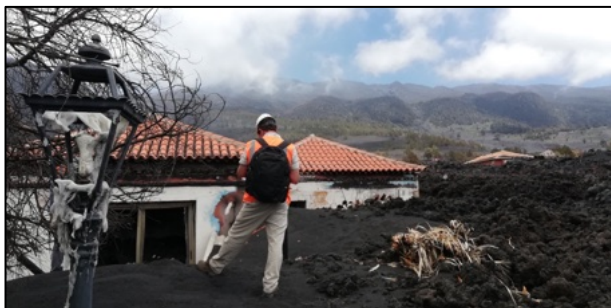
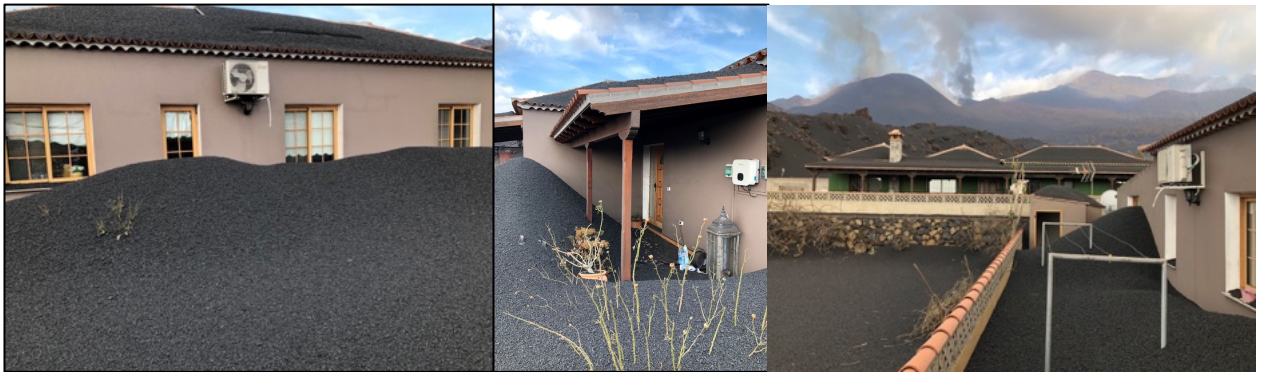
**Name: DSLP-4**

**I) Main house/ First floor:** - 1: 90 cm with 19 cm from its top to the top of the A'a lava,  
- 2: 136 cm long with 90 cm from the top of the window to the top of the A'a lava  
- 3: ~125 cm long and - 4: 66 cm long (3 & 4 free of lava)

\*The A'a flow could have been still in motion when the pahoe-hoe flow passed over it. There could be evidence of this on what was once the street to the south of the house.

**Damage:** Flow impacting from the E to the main house. First floor completely flooded by lava entering openings E, and SE. Lava comes out through openings of the W, of the house. No major structural damage but fractures in the NW corner of the house, fire damage in the interior heat removes exterior paint from the house leaving some parts of the wall white. Metal frame of sliding door (opening 2) deformed by heat. Burnt wood beams and collapsed fiberglass and tile roof of the accessory roofs (b and c). Accessory roof "d" collapsed by A'a lava pressure. Secondary structure (II) and accessory roof "a" completely covered by A'a lava (at least 60 cm on top of the roof).

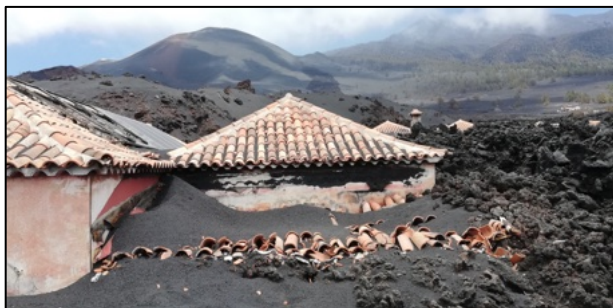
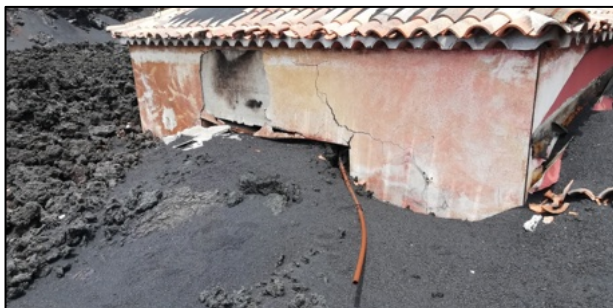
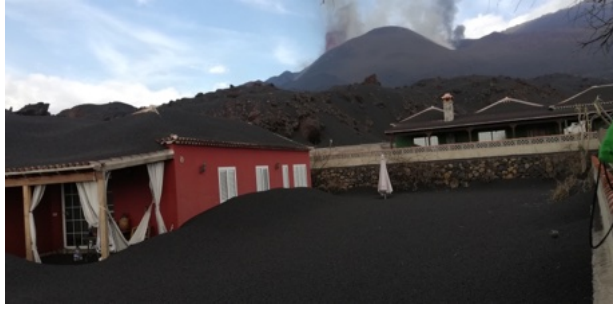
**Name: DSLP-5**

\*The double load where the pitches (pitch angle of 19-27°) of the two northern roofs meet could have caused it to collapse since its shape allows for greater accumulation. Just under this area there are no cement blocks to hold the fiberglass sheets and tiled roof.

\*broken solar panels probably caused by the internal heat of the house (3 out of 8 and 4 out of 8 in both southern pitches of the main house).

**Damage:** Flow impacting from the E to the main house. First floor completely flooded by lava, pahoehoe probably entering S-SE openings. Lava Pahoehoe comes out through W opening (I). Structural damage, fractures and openings in the W walls and fractures in the N side of the house, fire damage in the interior, heat removes exterior paint from the house leaving some parts of the wall white. Burnt wood beams and collapsed fiberglass and tiled roof of the accessory roof (a). Secondary structure (II) completely covered by A'a lava.

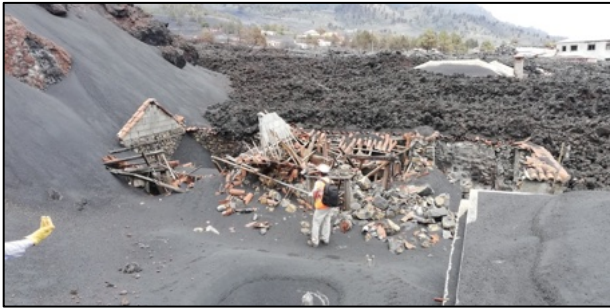
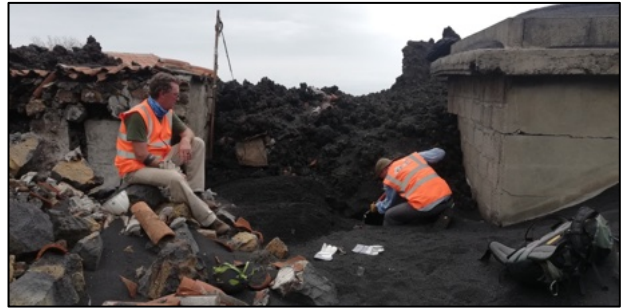
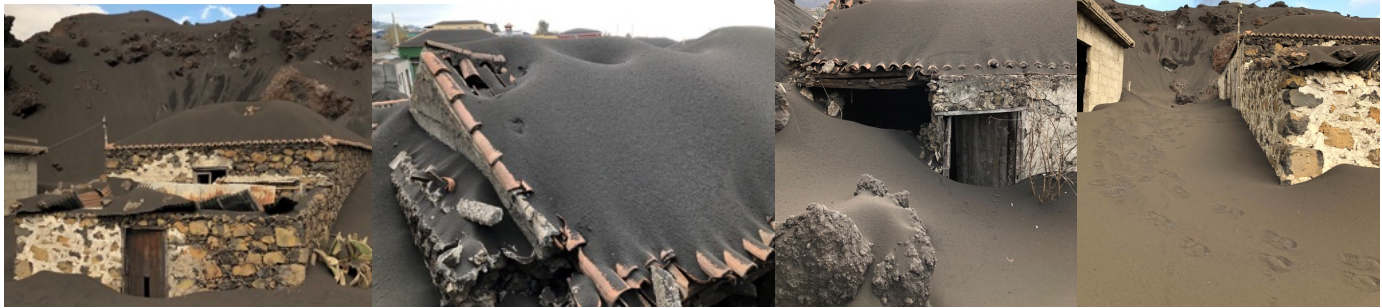
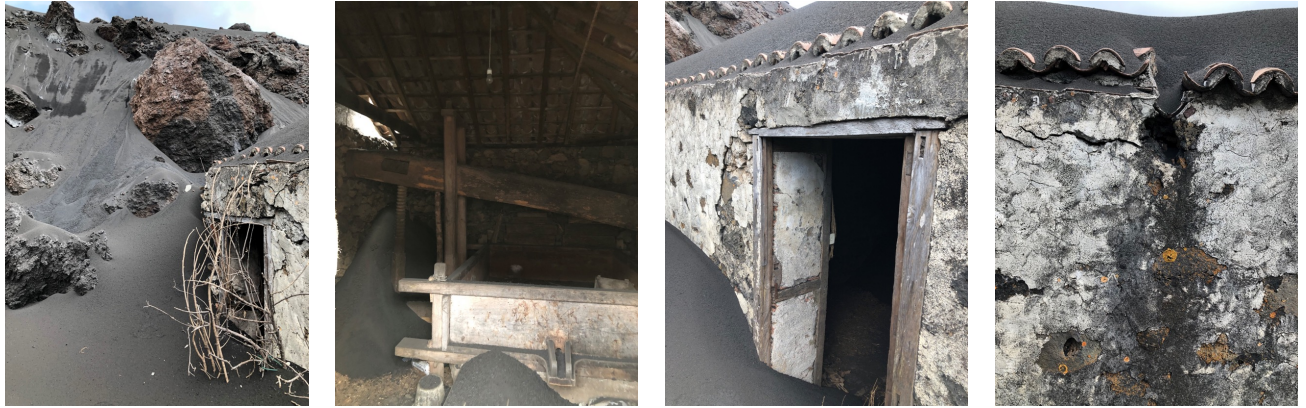
**Name: DSLP-6**

\*Broken stone walls ~60 cm wide in contrast to 12 cm concrete block walls

**Damage:** Flow impacting from the S to the secondary structure 1. The A'a lava pushes the wall of broken stones and tilts it to the N. Lava does not enter the structure 1 but surrounds it from the S-SW until it reaches the secondary structure 2 and enters it through opening 3. Structural damage, in the northern wall of structure "I", and SE corner of structure "II". Melted cables and opening 1 (wooden door) burned. The pressure of the lava finished collapsing the roof that had previously begun to fall due to the accumulation of tephra and then helped the north wall to collapse.

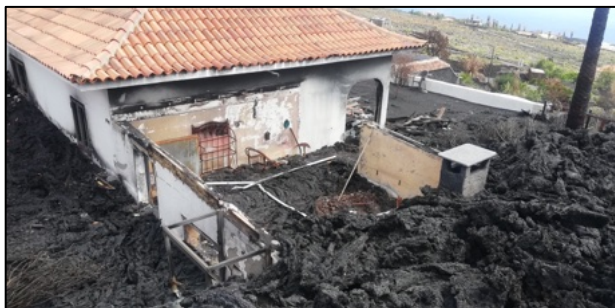
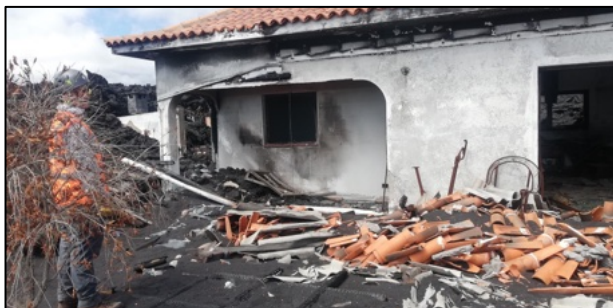
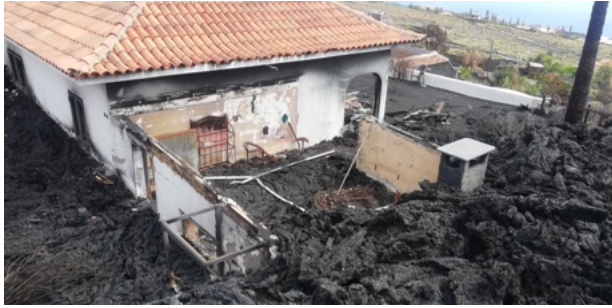
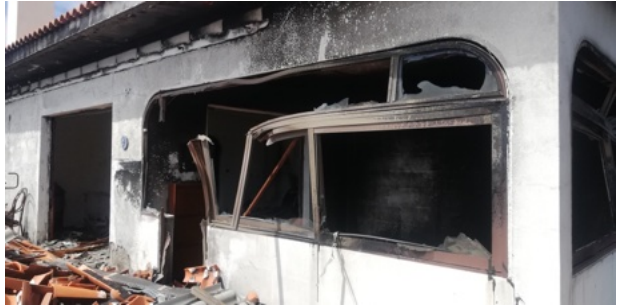
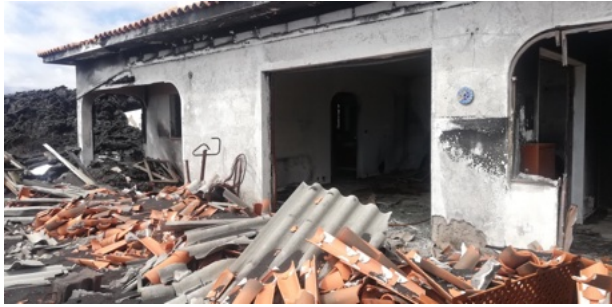
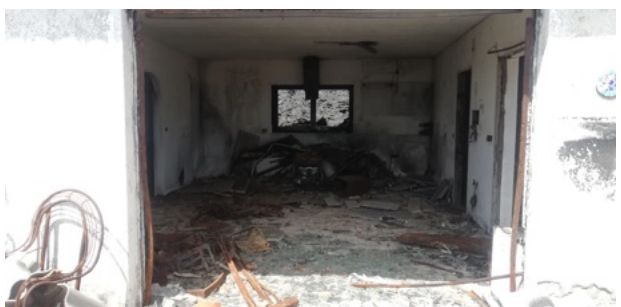
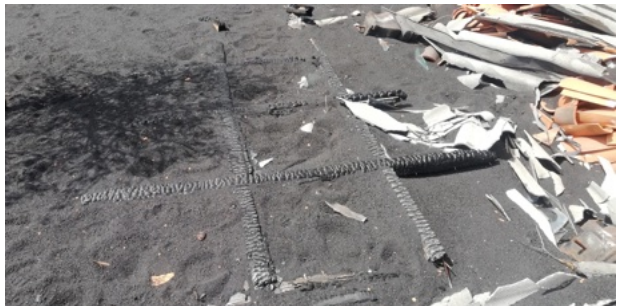
**Name: DSLP-7**

\* point of interest: stratigraphic section that has not been cleaned. Pahoeohoe lava over tephra is observed. Section "D" is not complete but there are 6.5 cm below "D" and 18 cm above "D" that apparently reach "G".

**Damage:** (T277 field campaign #1 no damaged). Pahoeohoe lava floods secondary structure 3. Separation of the lava and the wall of about 3-4 cm is observed, probably produced after lava cooling.

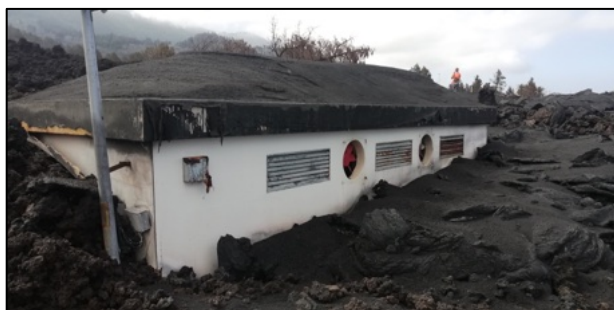
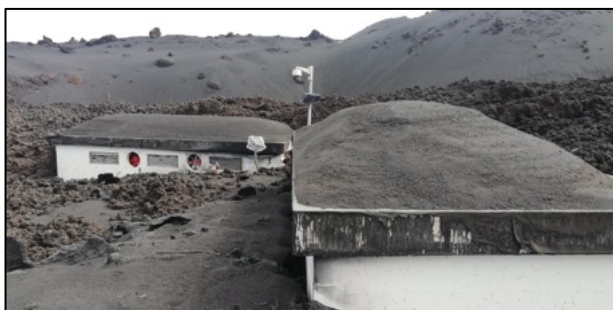
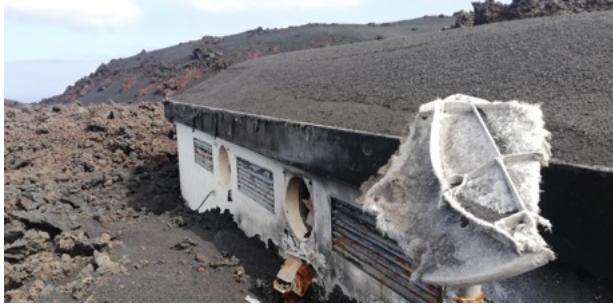
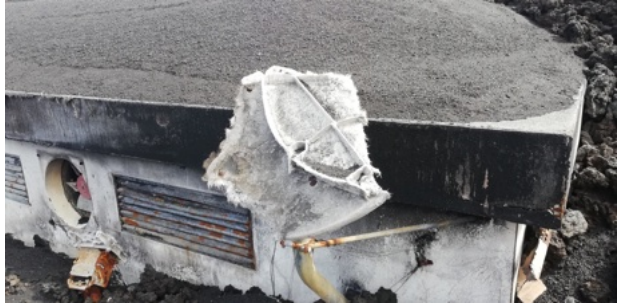
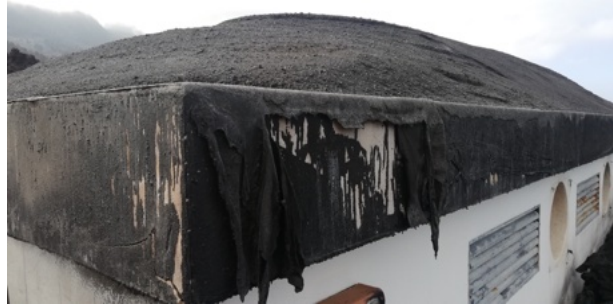
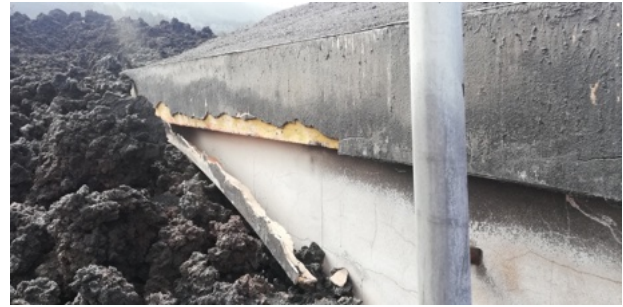
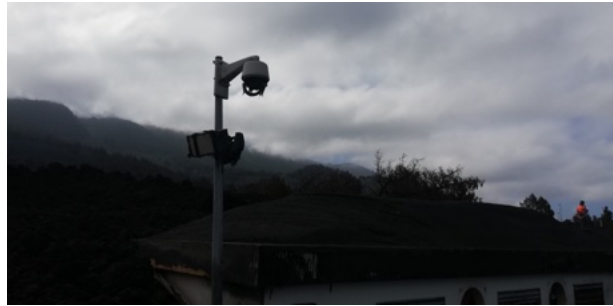
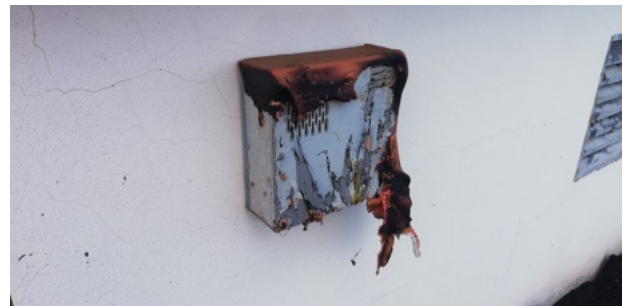
**Name: DSLP-8**

**Damage:** The A'a lava flow goes down first and then the final flow is the slaby pahoeohoe. It looks like it runs on the A'a flow, probably there is a reactivation of a tube or fissure that channels the pahoeohoe flow due to a new injection of magma. There are 2 structures that were part of the complex of solar panels. Made of concrete, with a flat roof also made of concrete, they were not destroyed by the A'a flow but completely surrounded and almost buried. The roofs still preserve tephra with an accumulation of 50-60 cm. Metal and plastic structures are melted.

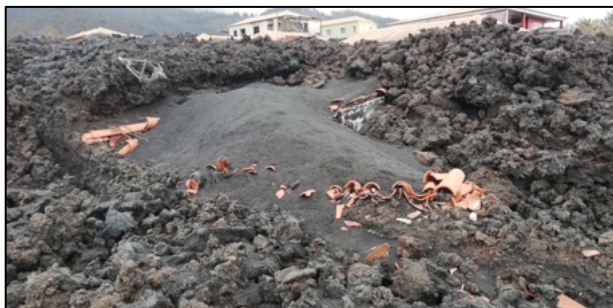
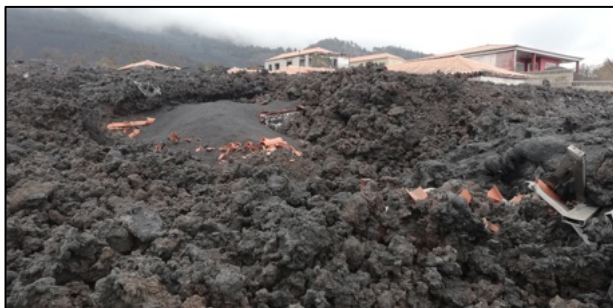
**Name: DSLP-9**

**Damage:** It may be part of the DSLP-5 property. It is completely destroyed and covered by lava and tephra. It looks like a secondary structure with metal beams, concrete walls and tiled roof. A'a lava observed in the NE and S sides. Pahoe-hoe observed to the W side.

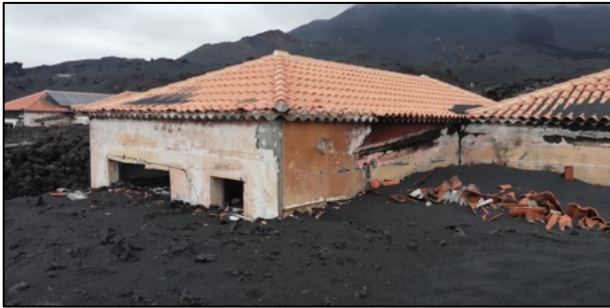
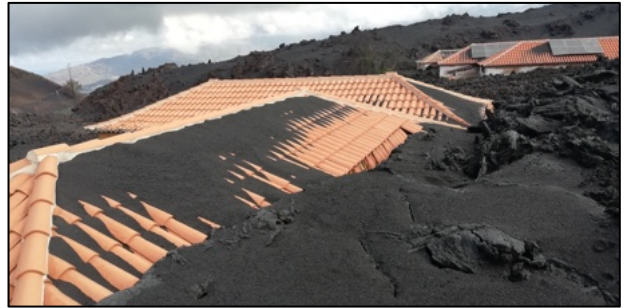
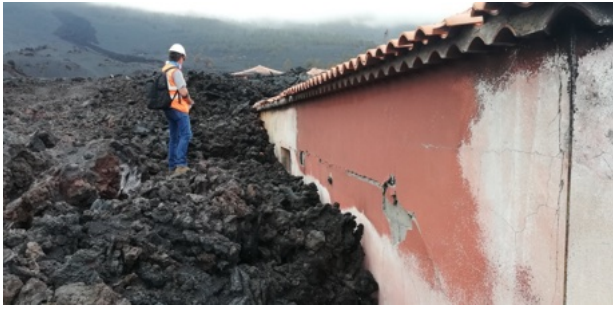
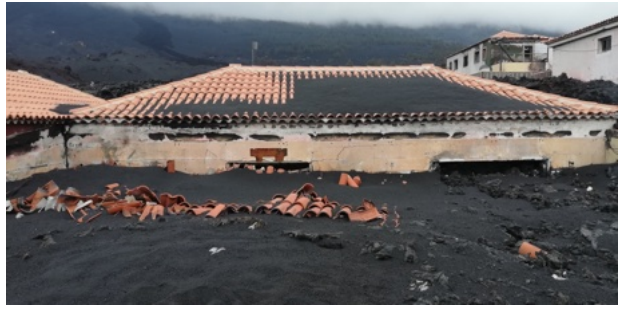
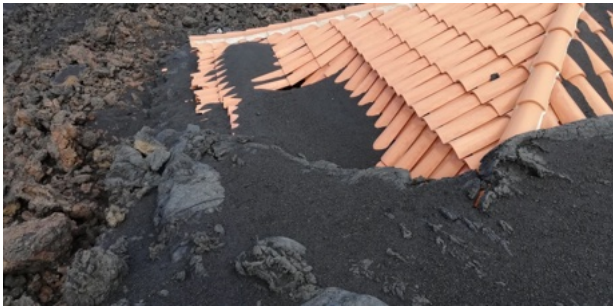
**Name: DSLP-10**

**Damage:** There is structural damage all over the walls. Accessory roofs (a, b) collapsed. Lava A'a can be seen on the N and E (covering up to 1/3 of the house) and pahoehoe on the E (2/3) and S side. There are 140 cm from the axis of the double pitch of the roof until where the pahoehoe lava covered the roof. Lava A'a was channeled down by the south side of the house.

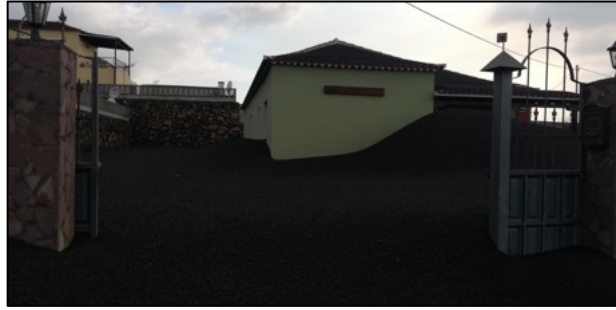
**Name: DSLP-11**

**Damage:** Totally surrounded by pahoe-hoe lava. Tephra accumulated in the middle of the 2 roof pitches generates collapse. There are cracks in the walls (facade). There is structural damage but not major, it is possible, but we are not 100% sure (it cannot be seen due to the lava flood).

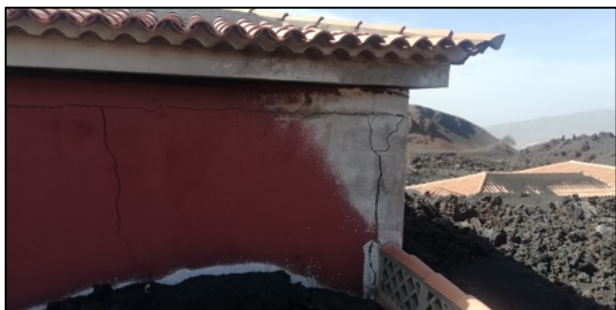
**Name: DSLP-12**

**Damage:** House surrounded by pahoehoe lava coming from the E and touching the NE corner. The heat removes red paint leaving the wall white and what is left of the paint appears bubbly. From the bottom of the roof to the top of the pahoehoe lava there are 130 cm. Structural damage (cracks in the walls) is observed. There are deflation cracks on the edges of the pahoehoe lava. We entered the house and took photos, there are fractures in every room of the house. On the N wall of the house an iron rod sticks out of it. This could be very bad for the house as in this coastal environment, it can be corroded very quickly.

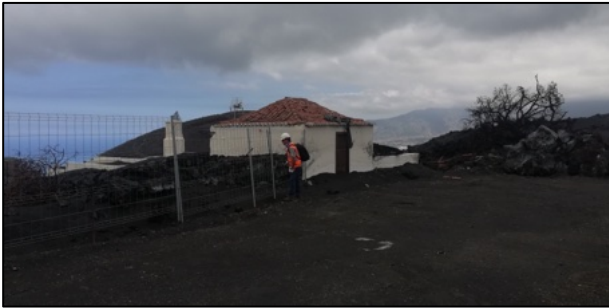
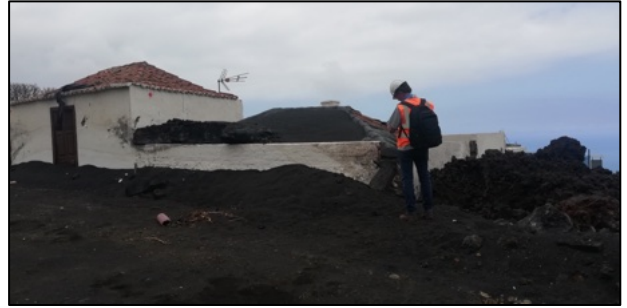
**Name: DSLP-13**

**Damage:** Pahoe-hoe lava enters opening 4 but just a little and then surrounds the house to the N. Tephra accumulated to the north of the house protects openings 2 and 3 and blocks the advance of lava A'a into the house. There are fractures in the block and broken stone walls, but it is not possible to see if the roof broke under the pahoe-hoe lava.

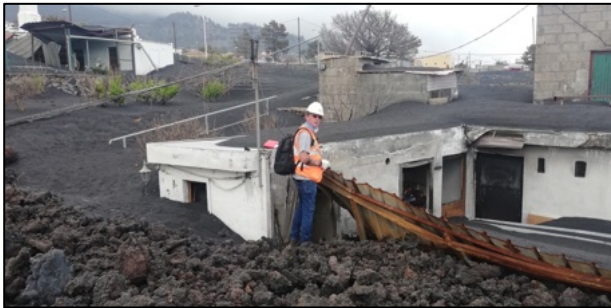
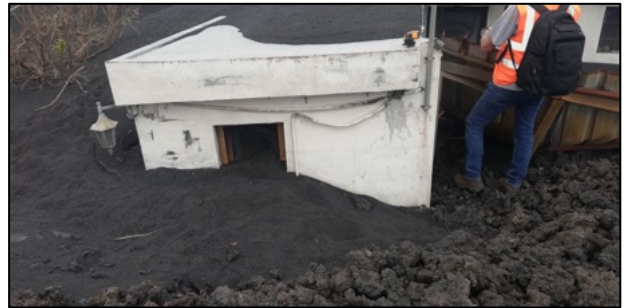
**Name: DSLP-14**

**Damage:** Lava A'a enters through opening 2 (N) towards what looks like a bathroom and through the side door (opening 1). Corrugated metal accessory roof collapsed by tephra prior to lava arrival.

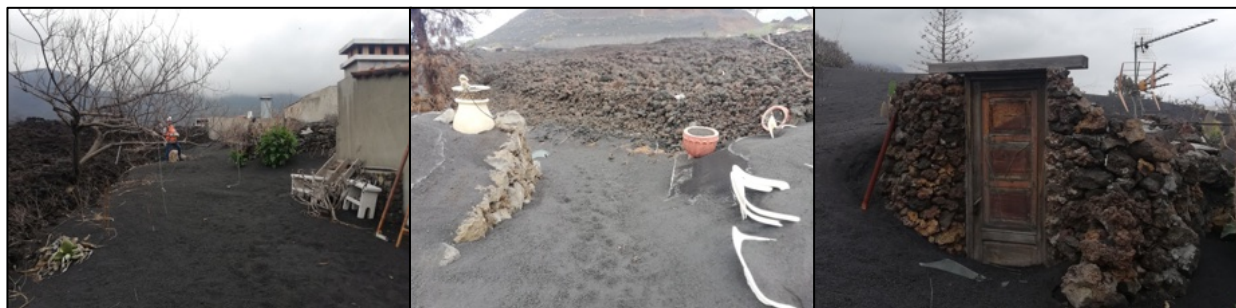
**Name: DSLP-15**

**Damage:** 460 cm of distance between the A'a lava and the structures of the house. The glass of the door facing the lava (opening 1, to the N) was probably broken by the heat but the lava did not touch the house and there are no other visible damages.

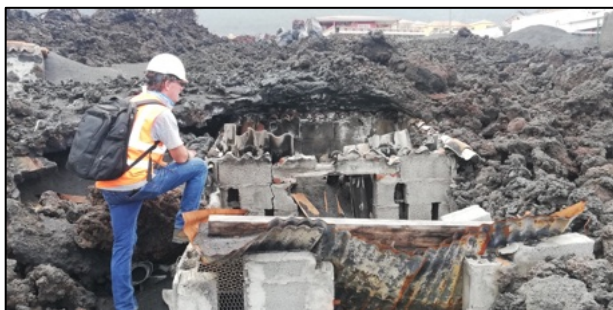
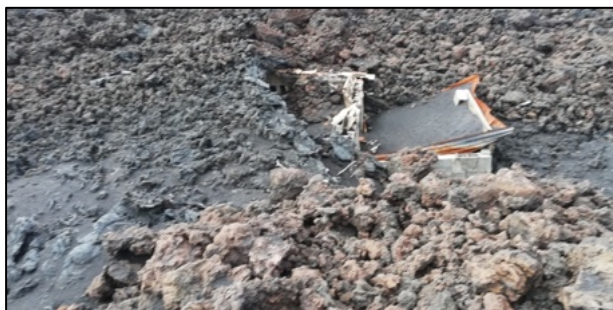
**Name: DSLP-16**

**Damage:** There are signs of 3 buried structures, one with broken stone and tiles, another with blocks and fiberglass and tiles roof, and another with blocks and a corrugated metal roof. The northern structure has A'a lava on top of pahoe-hoe. The other 2 structures are destroyed by pahoe-hoe lava and then lava A'a collapses the roofs.

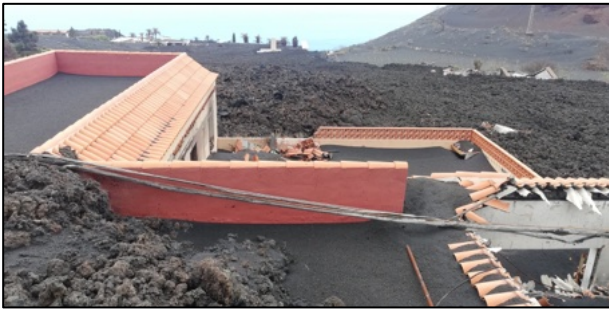
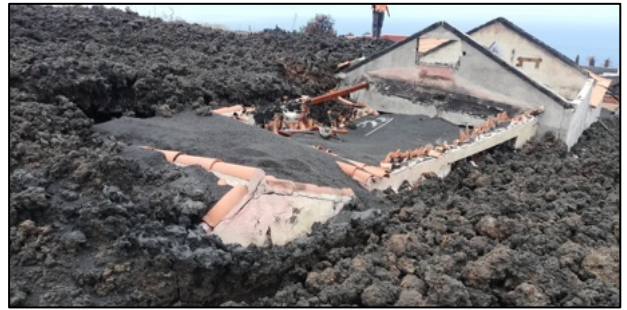
**Name: DSLP-17**

\*There is pahoehoe lava on the E and W side of the house (going down) and "transitional" on the S side. To the N there is only A'a.

\*In structure (I) it can be seen that the lava entered through opening 6, then continued down the corridor, and also entered through the skylight in the ceiling (14).

**Damage:** All roofs collapsed except for Primary 1 (I). Lava A'a does not enter through openings 1 and 2, it only passes over the flat roof of (I). The bars protected the structure (II) from the lava entering through opening 16. Total failure of the S wall of (III) due to the external A'a flow. In (III) deflation is observed. A'a probably entered the house through opening E (15), filled the room up to the ceiling, and then breached wall W, draining the lava. There is evidence of lava on the walls (at least 2 m). A'a flow also entered the house through the opening 12. Composite material and tiles roofs supported by wooden beams (burned) are collapsed. Metal framing melted (windows). Wooden beams that supported the accessory roofs are burned.

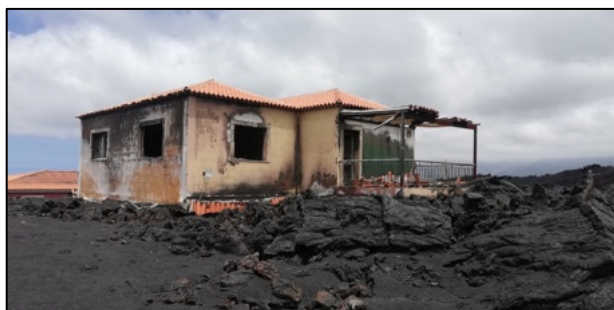
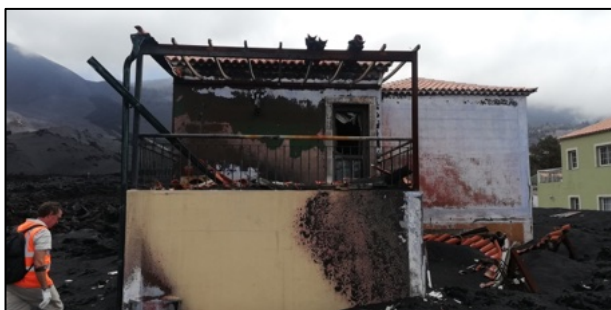
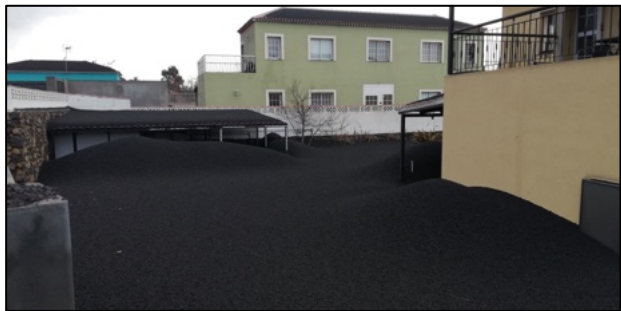
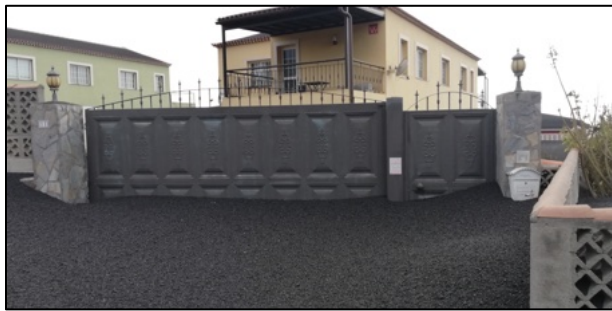
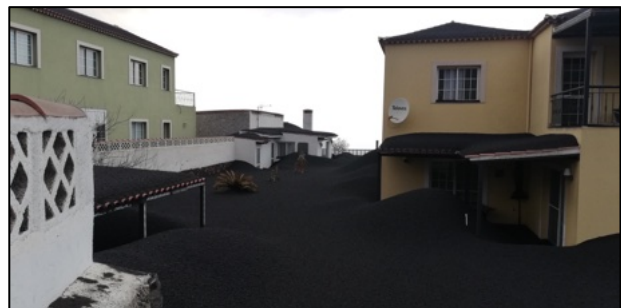
**Name: DSLP-18**

**Damage:** Flow impacting from the E to the front of the main house. First floor completely flooded by lava entering openings E, NE and SE. Lava comes out through openings of the W, NW and SW of the house. No major structural damage but fire damage in the interior of the house. Thermal sagging in the steel rafters of the accessory roofs (Tube support 8x8 cm and 4x6 cm) and roof of composite material and tiles collapsed. Thermal sagging in the big steel rafter, burnt wood beams and collapsed fiberglass and tile roof of the Barbecue structure. Pool (IV) completely covered by lava.

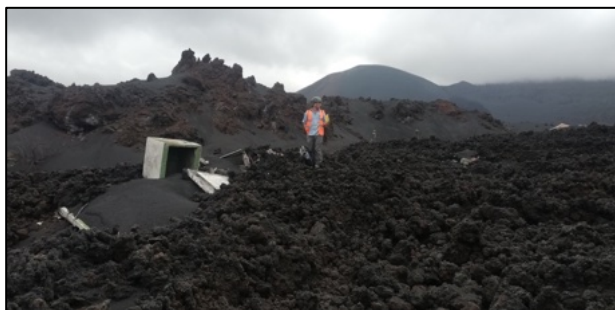
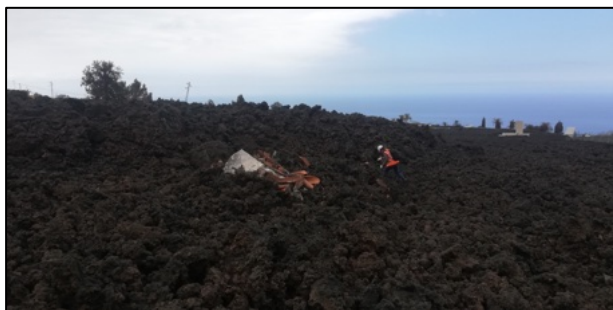
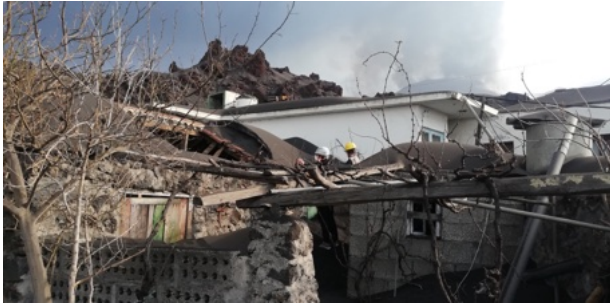
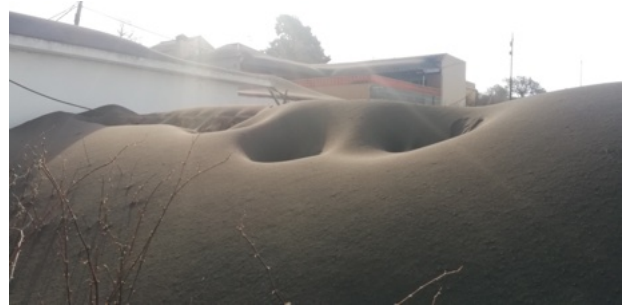
**Name: DSLP-19**

**Damage:** Completely buried or washed away by A'a lava flow. Pahoehoe lava also appears in contact with one of the walls that is possible to see through the rubble with a new texture that we had not seen before. 10 m downstream there is another piece of the wall and tiles running SW and NW.

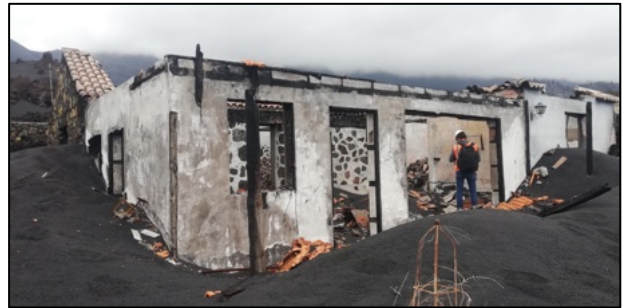
**Name: DSLP-20**

**Damage:** Fractures are observed in the walls, the top plate on the wall. The beams that support the ceiling and the tiles were made of wood and they are burned now. A'a lava entered the house through opening 8 and 10 filling the room but stopped in the frame of opening 9.

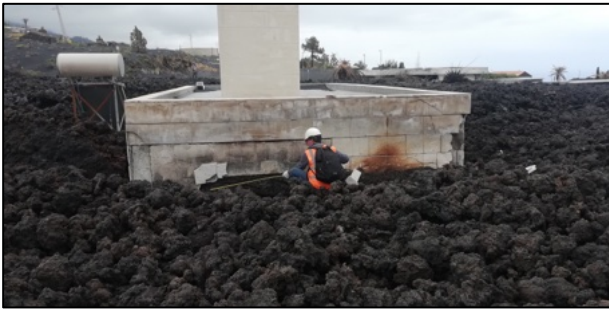
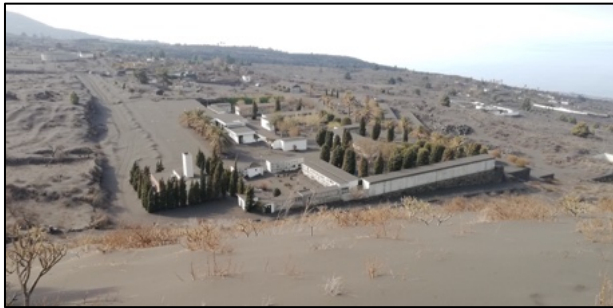
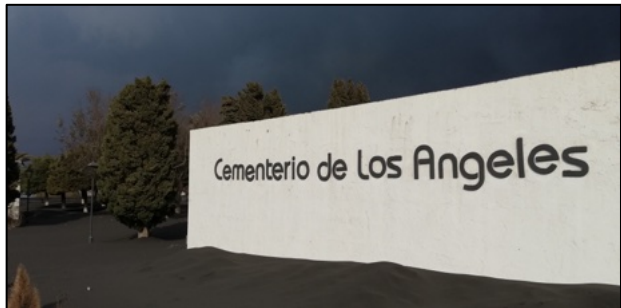
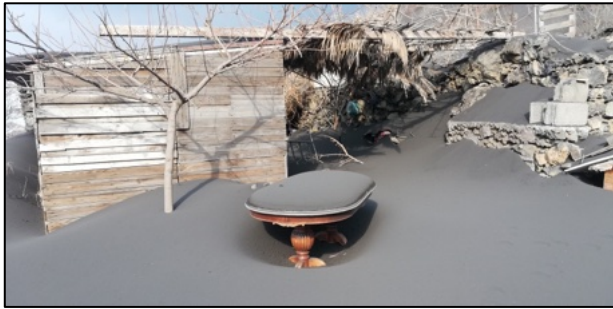
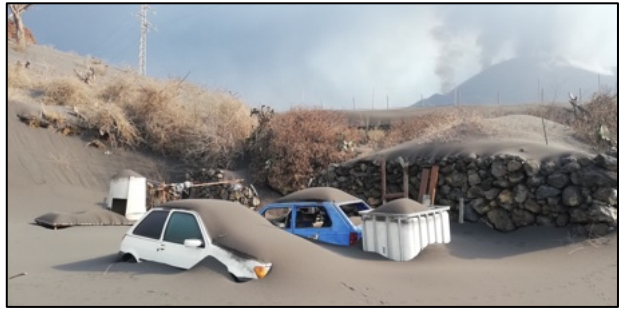
\* Between DSLP-21 and DSLP-22 we found a hole left by a palm tree (3.20 m deep) and a fissure where pahoehoe lava came out. The crack crosses the DSLP-22 structure at the NW corner and impacts the entire building.

**Damage:** Lava A'a surrounds the entire building. The roof is bulging. The lava flow removed the tile facade that covered the building. The walls are made of reinforced concrete, some 1 cm diameter steel bars are observed in the broken corners of the building.

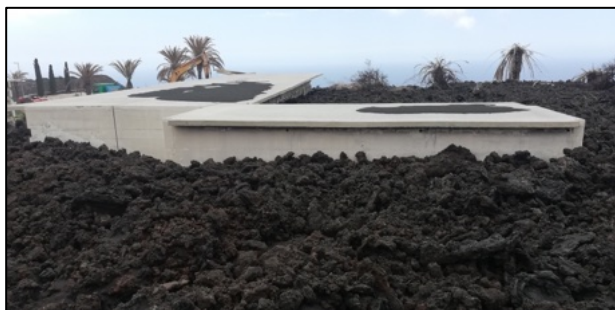
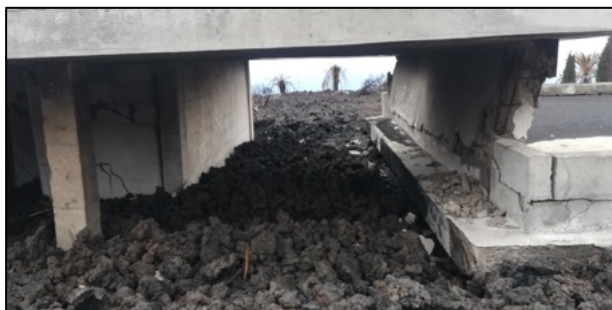
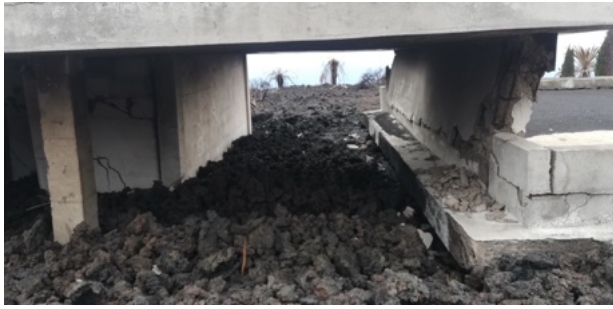
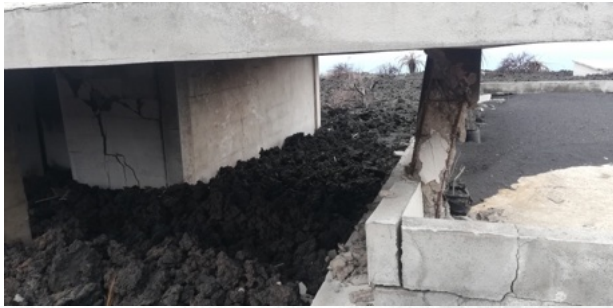
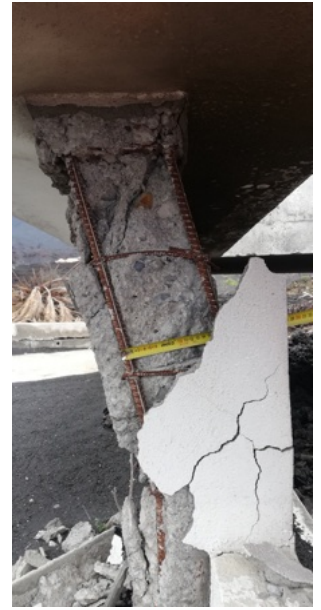
\* Between DSLP-21 and DSLP-22 we found a hole left by a palm tree (3.20 m deep) and a fissure where pahoe-hoe lava came out. The crack crosses the DSLP-22 structure at the NW corner and impacts the entire building.

**Damage:** Structure made of blocks and reinforced concrete pillars. Fractures are observed throughout the building and the walls are inclined (9-10°). One of the pillars moved 16 cm to the left. Southern wall is displaced 2.5 cm from the pillar. The building looks burned inside.
