# Anthropogenic fill and geological–hydrological controls on progressive failure in the 2023 Stenungsund quick-clay landslide (SW Sweden)

Christian Öhrling<sup>1,2\*</sup> and Ola Fredin<sup>1</sup>

## Abstract

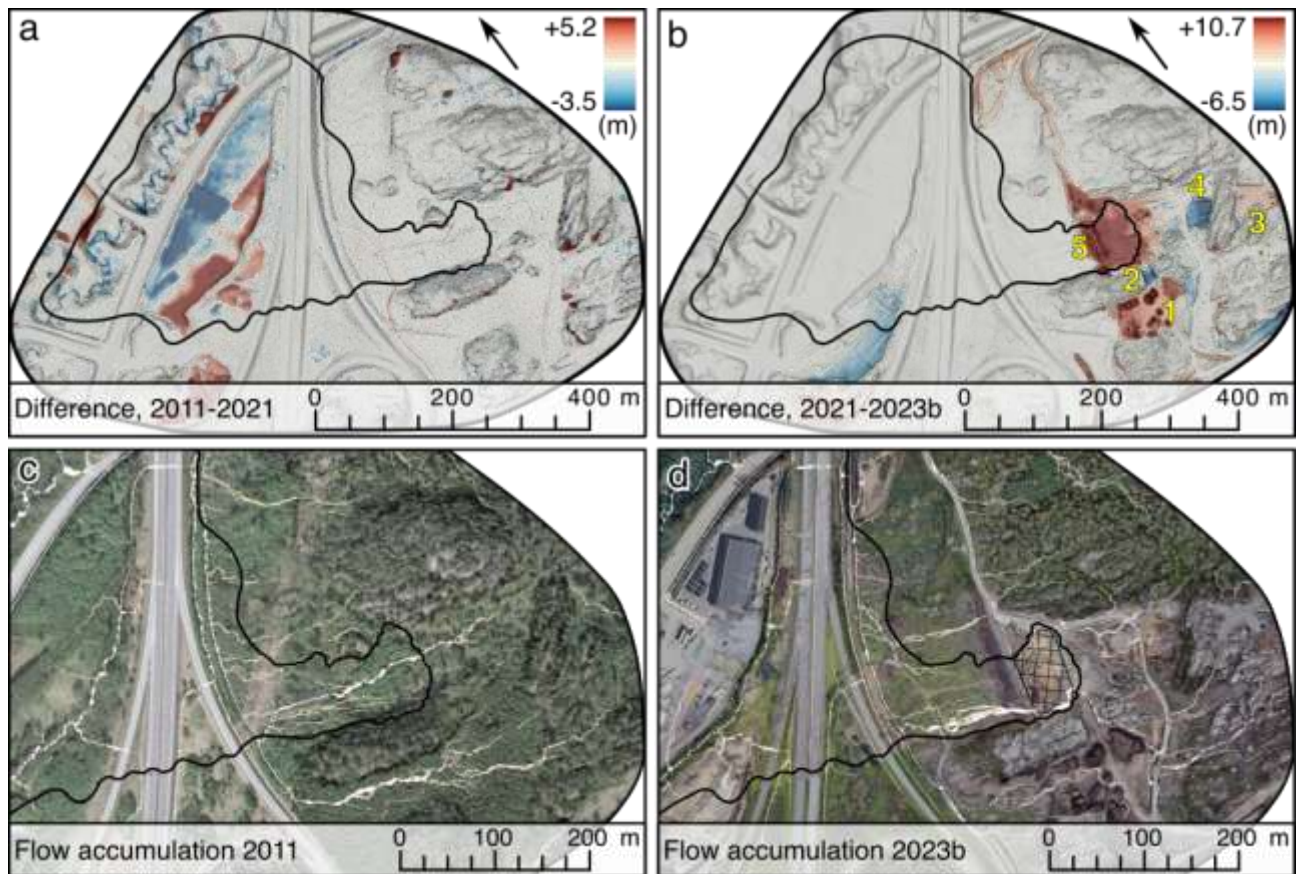
The ground modifications also altered precipitation-runoff patterns and groundwater conditions. Figure 3c displays the runoff pattern in 2011, based on flow-accumulation modeling, while Figure 3d shows the runoff modelled from the composite 09/20/2023 DTM. The flow-accumulation models indicate substantial changes in water pathways following the changes in the eastern area. The following refers to Figure 3d and the numbers in Figure 3b. First, the fill in the southern parallel valley (1), together with adjacent working roads and excavations south–southeast of the site, diverted runoff northward toward the future landslide. Similarly, blasting of bedrock to construct a working road directly south of the landslide pit (2) further increased runoff entering the depression. Farther east, at the hilltop, a small peatland was excavated and replaced with compacted fill to create a parking area (3). This change facilitated rapid surface runoff and likely increased the westward flow. In addition, gravel was excavated at the foot of the bedrock slope facing the future landslide (4), unintentionally creating an infiltration basin for groundwater. The final and most substantial modification was the large fill that later collapsed (5). This was built up between two bedrock shoulders, with retaining walls made of boulders and fillings of varying properties.

**Fig. 3** Elevation difference between DTMs from **a** 2011 and 2021, and between **b** 2021 and 2023 before the event. Flow-accumulation models based on **c** 2011 DTM and **d** 2023 before the event. In 2016, the triangular (iron-shaped) area west of E6 started to develop. In 2023, until the landslide, the area immediately west of the E6 and the area east of it were developed. The interventions in the eastern part significantly affected the runoff. A large part of the natural path through the southern fracture valley was rerouted towards the landslide valley. Excavations of outwash material created groundwater infiltration basins.

373 The anthropogenic development of the eastern part of the area significantly changed the runoff pattern (Fig. 3c &  
 374 d). When the fill material was placed in the southern fracture valley (#1 in Fig. 3b) together with excavations and roads,  
 375 a significant part of the runoff was forced north to the valley of the landslide. In addition, the blasting of the bedrock to  
 376 create a road (#2 in Fig. 3b) further increased the possibility of directing runoff to the north.

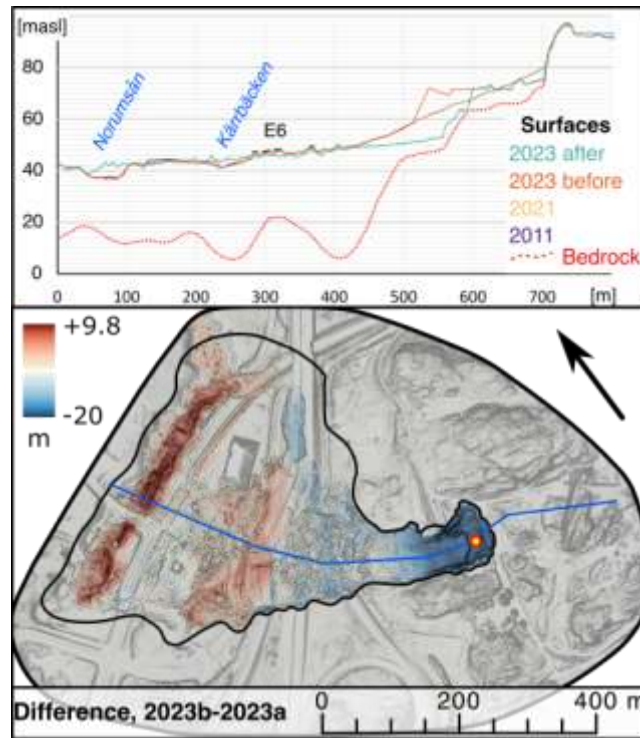
The vertical difference between the DTMs before (composite) and after the failure shows that displacement within the landslide pit reached approximately 20 m in depth, of which roughly half consisted of original deposits and half of fill material (Fig. 4). The profiles in the diagram represent elevation changes along the blue line in Figure 4. The bedrock surface is an approximation based on the available depth data.

**Fig. 4** Elevation profiles from generations of LiDAR images and a modeled bedrock surface. The blue line on the map represents the location of the profiles. The map shows the elevation difference between DTM\_230920 and DTM\_231106. A yellow-red star marks the shelf of clay that remained after the event.

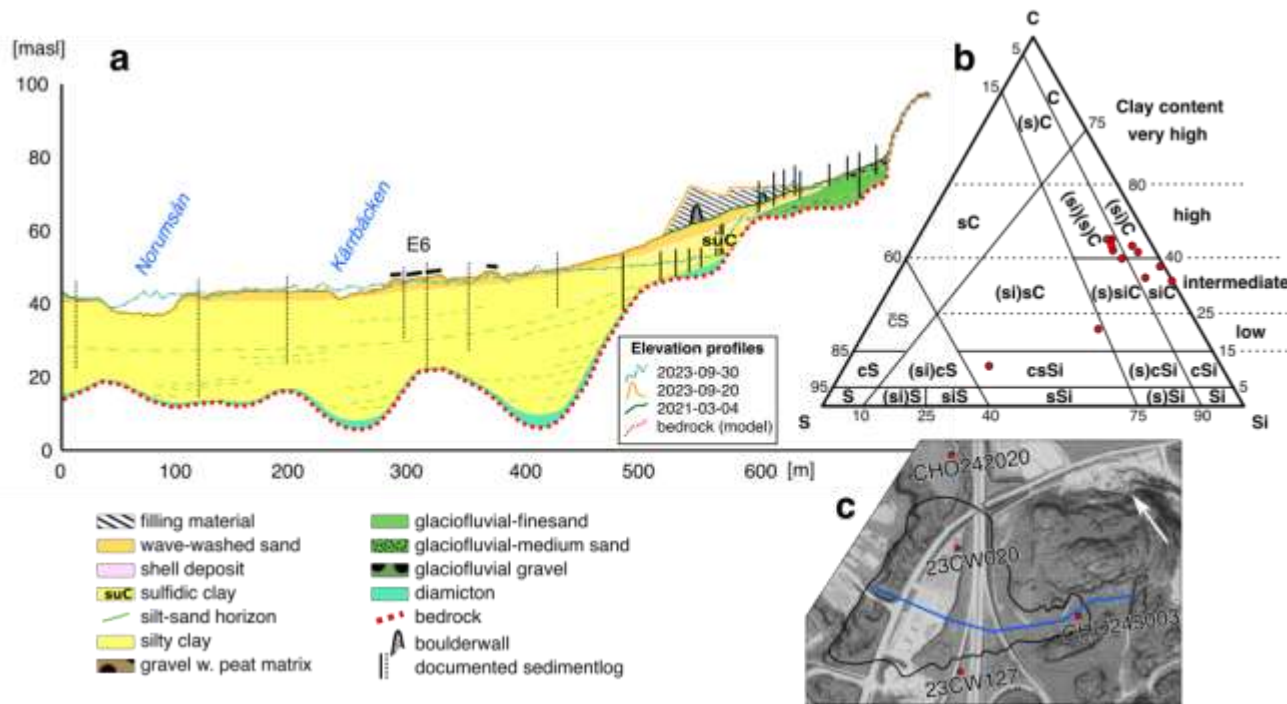
The failed mass is dominated by thick clay deposits overlying a thin frictional layer. Although stratigraphic data were initially lacking, later stabilization works in the eastern parts exposed clear sections east of the landslide scarp. These exposures, in addition to those revealed by the landslide, show the natural ground surface beneath 3–10 m of anthropogenic fill composed of gravel, marine clay with shell fragments, sand, and macadam.

Underlying sediments consist of glaciofluvial subaqueous fan deposits, with cyclic bedding of silt, sand, and gravel. These interbedded layers form hydraulically conductive horizons that influence groundwater flow. Intact clay inside the landslide scarp (see star in Fig. 4) is at least 5 m thick and contains multiple silt–sand and shell-rich layers. The clay exhibits vertical fracturing with sand-filled millimeter-scale fissures at depths where desiccation is unlikely, interpreted

**Fig. 5** (a) Mapped and interpreted stratigraphy along the blue line in c, where the location of the boreholes is marked with red circles. The landslide area is represented by the black polygon. **b** Grain-size plot (after Stevens 1983) with the mentioned samples from boreholes.

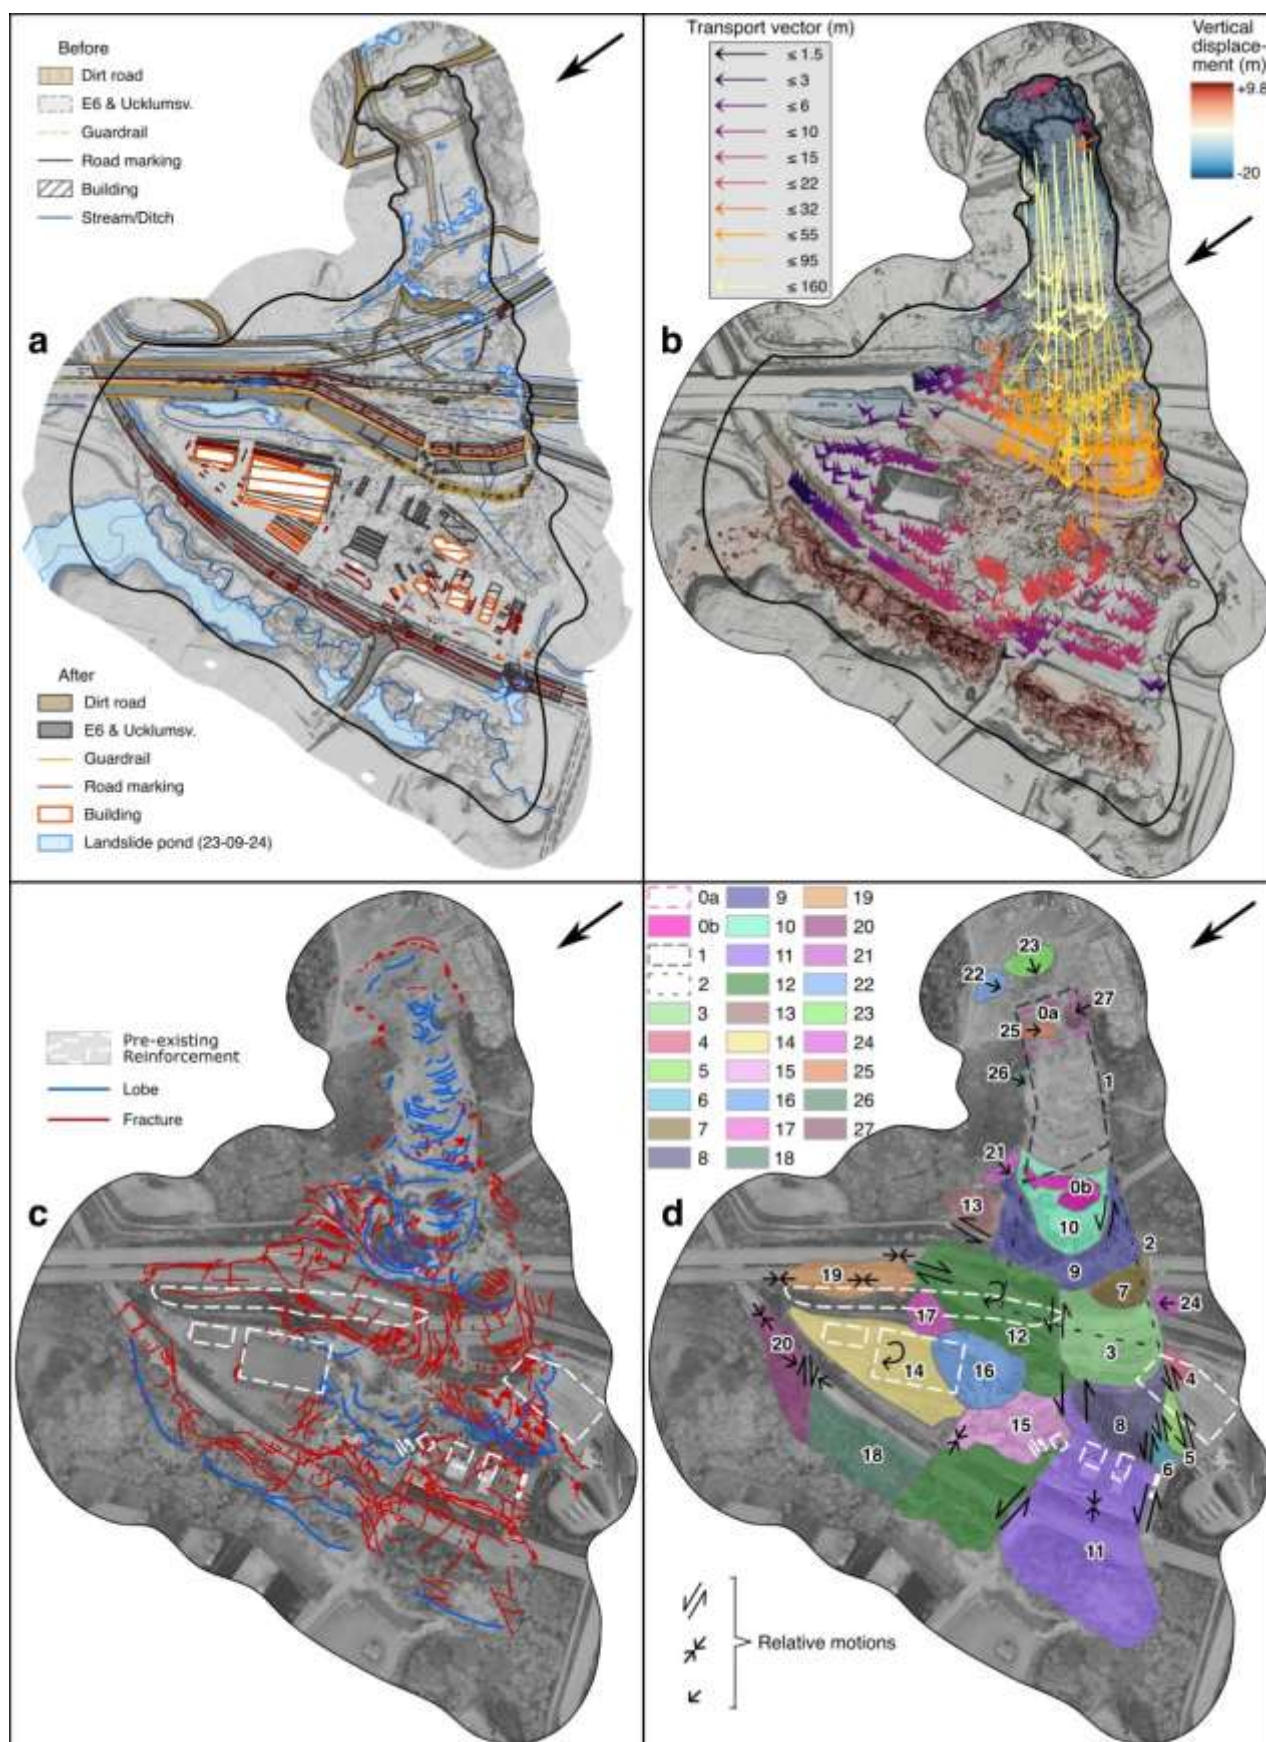
Mapping fissures and the morphology of displaced masses, on post imagery, provides further insight into deformation patterns. The mapped structures reflect the kinematics (Fig. 6c): lobes indicate motion perpendicular to their fronts, while fractures may form extensional, compressional, or sheared patterns depending on the directions of the forces. Therefore, these features can be used to reconstruct the movement pattern. Cross-cutting relationships are observable within these structures, and several major examples are highlighted with arrows representing relative

291 movements in Figure 6d. Both orthophotographs and field observations document tensional and compressional  
292 structures, as well as horizontal shear components (including several examples of echelon fractures). In addition,  
293 sliding fissures on exposed blocks of clay were mapped and used as indications of local movements, for example, along  
294 lobes (which were found to be orientated normal to those). The color codes in Figure 6d represent surfaces with  
295 internally consistent deformation or other common characteristics, and these are referenced in the following sections.

**Fig. 6** a) Ground displacements associated with the landslide were mapped using multiple identifiable physical objects, and the impoundments formed by the event were subsequently documented. b) Vectors were created from identified objects in pre- and post-failure images. Transportation of material was up to 160 m in the erosional eastern parts and then decreased towards Norums'an. c) Landslide-surface morphology shows lobes of material and fissures; these can be used to further interpret the progression. d) The landslide was subdivided into 27 morphological units for easier reference. Relative movements within the slide masses are marked by arrows. White-dashed lines mark where reinforcements were present before the event; embankment along E6 and piled surfaces below buildings and fuel tanks. Background: Hillshading and orthophoto derives from post-failure LiDAR acquired by Swescan on 11/06/2023.

InSAR data show that the E6 had significant ongoing subsidence. The highway area is principally flat, and the consolidation of clay is therefore not considered a weakening factor, but rather a stabilizing. Rerouting and filling of Kärrbäcken when the E6 was built, together with the ditches along the old Ucklumsvägen during the construction of the E6, may partly explain the unusual ground movements observed in the northern part of the landslide area. These movements occurred when the mass balance in other parts of the area changed; there is no evidence that the landslide was initiated there. Several well-founded structures in other parts of the landslide zone likely influenced how the ground moved during the event (see Fig. 6c & d).

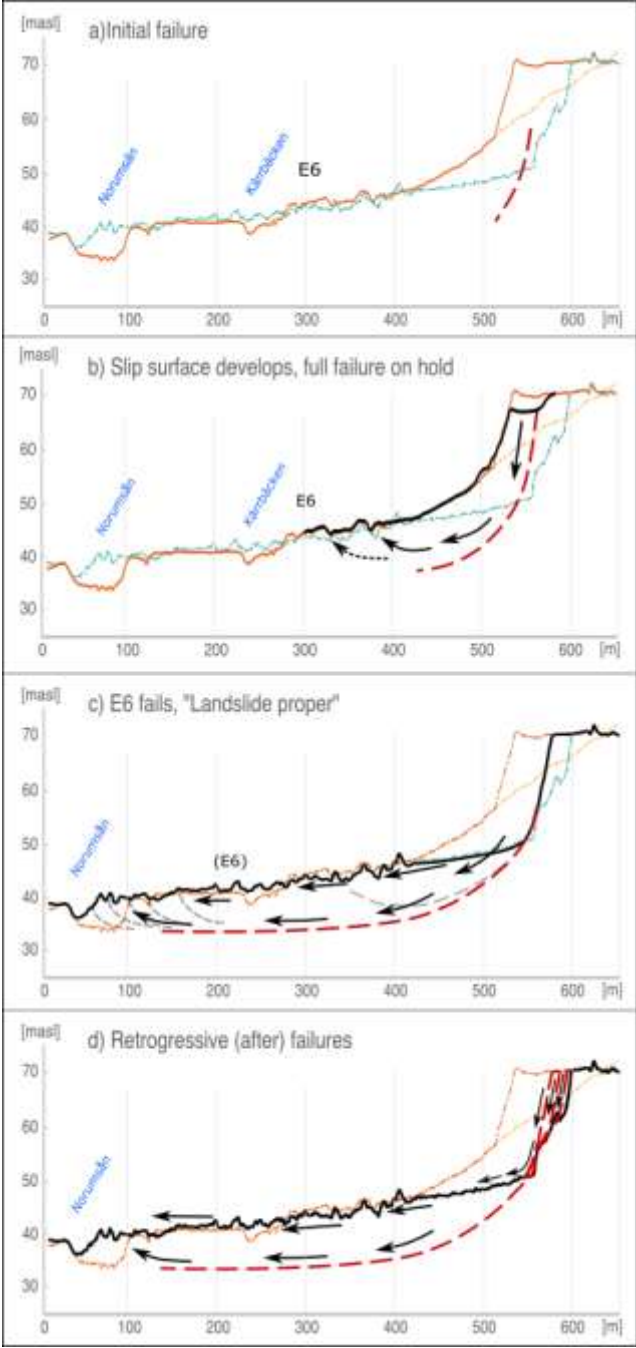
342 Panel **a** illustrates approximately where the initial failure in the underlying clay layers occurred. This may not  
343 correspond to the first perceptible surface movement; the failure could have propagated along the modelled slip  
344 surface, over ten meters below ground. Panel **b** shows this propagation reaching the near-surface zone, where the  
345 foundation and weight of E6 provide and/or the bedrock morphology resisting forces. Settlement occurs in the fill  
346 material while uplift develops farther downslope. This uplift may have caused the deformation experienced in the E6  
347 surface. Drainage in this area would also have been affected, potentially altering flow in Kärnbäcken. Panel **c** shows the  
348 structural failure of E6; once the resisting forces are lost (and the clay remoulds), the translational(-progressive)  
349 block—already weakened by overloading in the east—follows. A succession of mass movements then occurs, ultimately

350 reaching equilibrium as material is displaced into the floodplain of Norumsån. The mass movements that occurred  
351 during this landslide precursor phase likely created the recorded seismic signal. The seismic signal may have been  
352 amplified by structural failure of the comparatively rigid E6 roadway. Smaller retrogressive failures continued locally  
353 after the main event, with the larger ones occurring farthest east (Panel **d**). One of these may have caused the loud  
354 noise at 02:10 a.m. that prompted the emergency services to withdraw; this may, for example, have been the collapse of  
355 the construction road at the far eastern extent of the slide. Orthophotos show that units **25**, **26**, and **27** failed two to  
356 three days later (Fig. 6d).

377  
 378 **Fig. 7** Suggested sequence of events for the landslide. Based on failure modeling (Fornes 2024) and morphology and kinematic mapping.  
 379 **a.** The loading causes the soil layers under the 'bank' (anthropogenic fill) to begin developing failures. **b.** The failure continues according to the theory  
 380 in a translational progressive landslide. **c.** When E6 fails, and its resisting force disappears, the failure surface of the slab landslide is probably well-  
 381 developed. **d.** The landslide develops progressively, with a spread to Norumsån and northwards. Up to 10 m heave in Norumsån. The furthest parts  
 382 east, at the rear edge of the landslide, fail regressively.

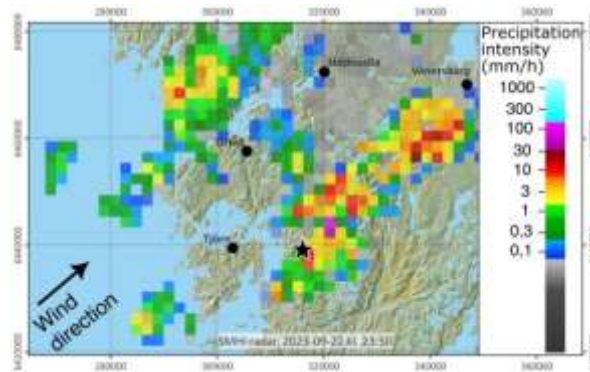
**Fig. 8** Meteorological radar image presenting precipitation at 11:50 pm, less than two hours before the event. The black star marks the location of the Stenungsund landslide. Note the wind direction and the purple cells that represent up to more than 100 mm/h. Downloaded (and modified) from <https://www.smhi.se/data/nederbord-och-fuktighet/nederbord/radarbilder-aktuella-och-historiska>.

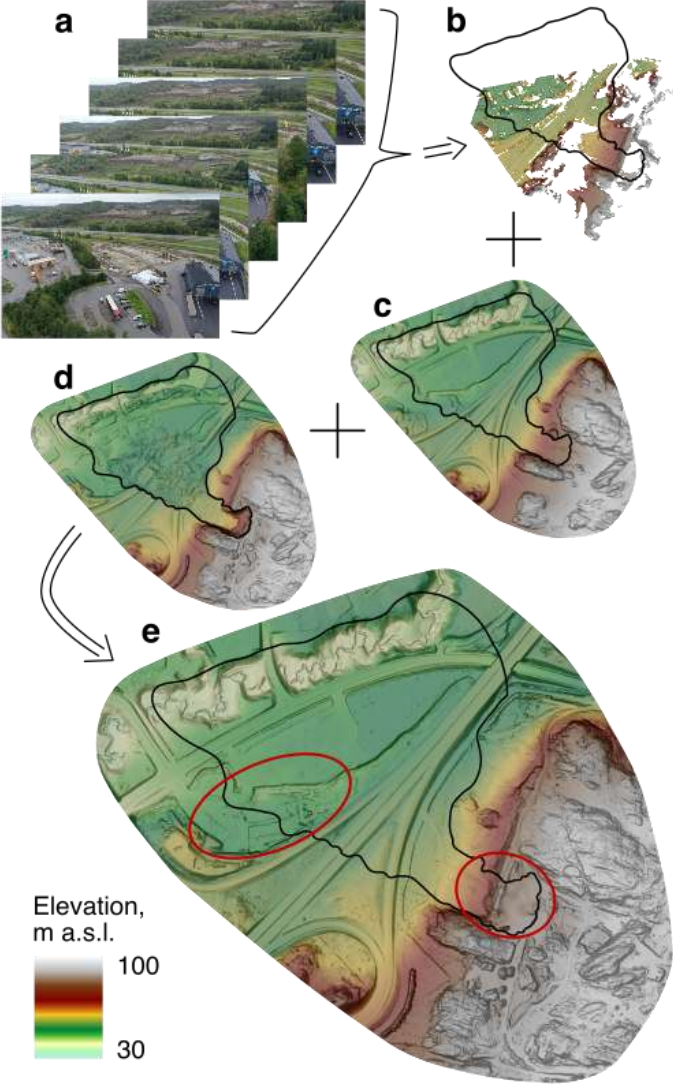
586  
587 **Fig. OR2** **a** From six photographs taken by Mikael Berglund on 20 September 2023, it was possible to recreate an orthophoto and **b** DTM of the area 2  
588 days before the landslide. This was done by merging the significant parts of that DTM with **d** the LiDAR from after the landslide, along with the **c**  
589 latest LiDAR from before (2021). **e** Red circles mark the two areas with ongoing construction, which were critical for the reconstruction of the area.  
590 The drone multi-photo DTM had high spatial resolution but needed to be adjusted by 2-4 meters in height to align with the post-slide DTM.

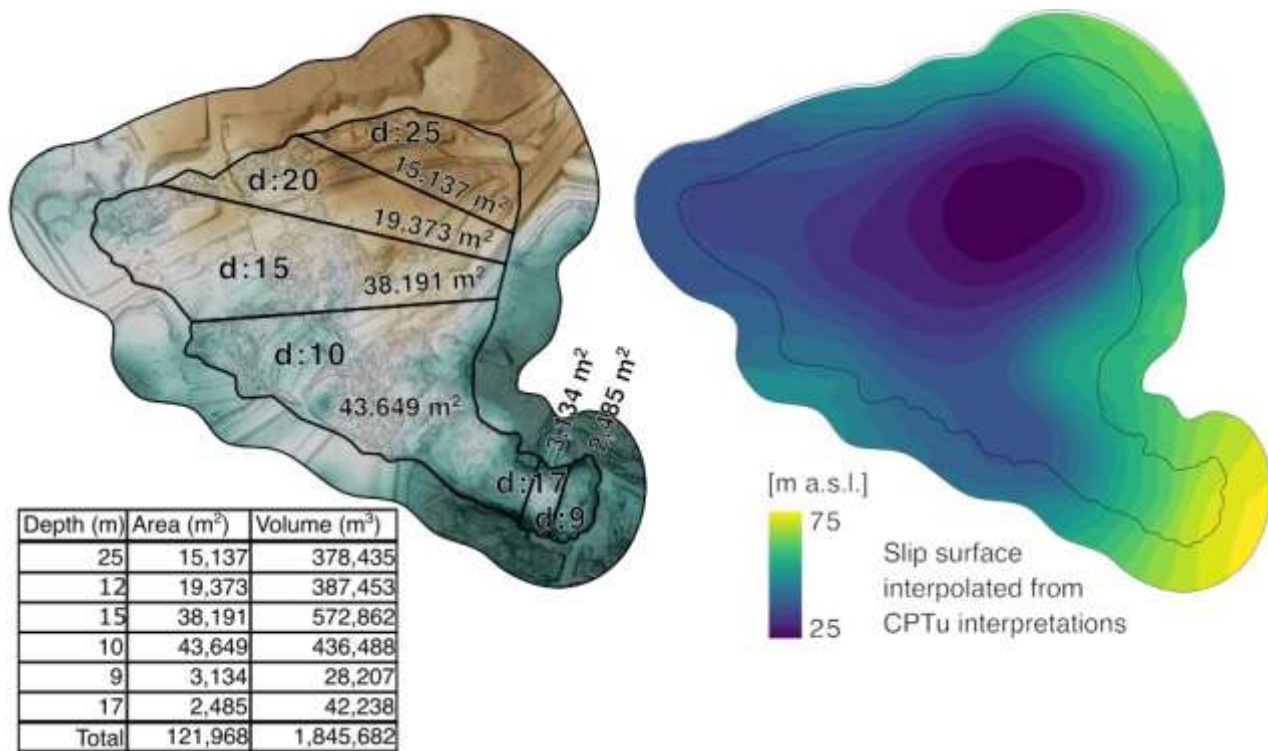
593 **Fig. OR3** The total displaced mass is estimated at 1.2–1.85 million cubic meters. The landslide area is divided into six sub-areas, each with different  
594 depth estimates from CPTu diagrams. When the volume between DTM 20230920 and the modeled 'slip surface', also in Online Resource 2, is  
595 calculated, the result is just over 1.2 million cubic meters. We interpret this to mean the total volume should be within the range of 1.2–1.85 million  
596 cubic meters. There is uncertainty in the depth estimates from CPTu interpretations used for modeling the slip surface. This model also exhibits  
597 significant edge effects, resulting in an underestimation of the volume. Other sources of uncertainty are the various resolutions in the pre-event  
598 DEM:s and re-laid material, obscuring the original surface. Another parameter to consider is the depth of the pilings in the northern area and its

599 implications for the interpreted movements. Background: Colored bedrock model; hillshade, DTM 06/11/2023.

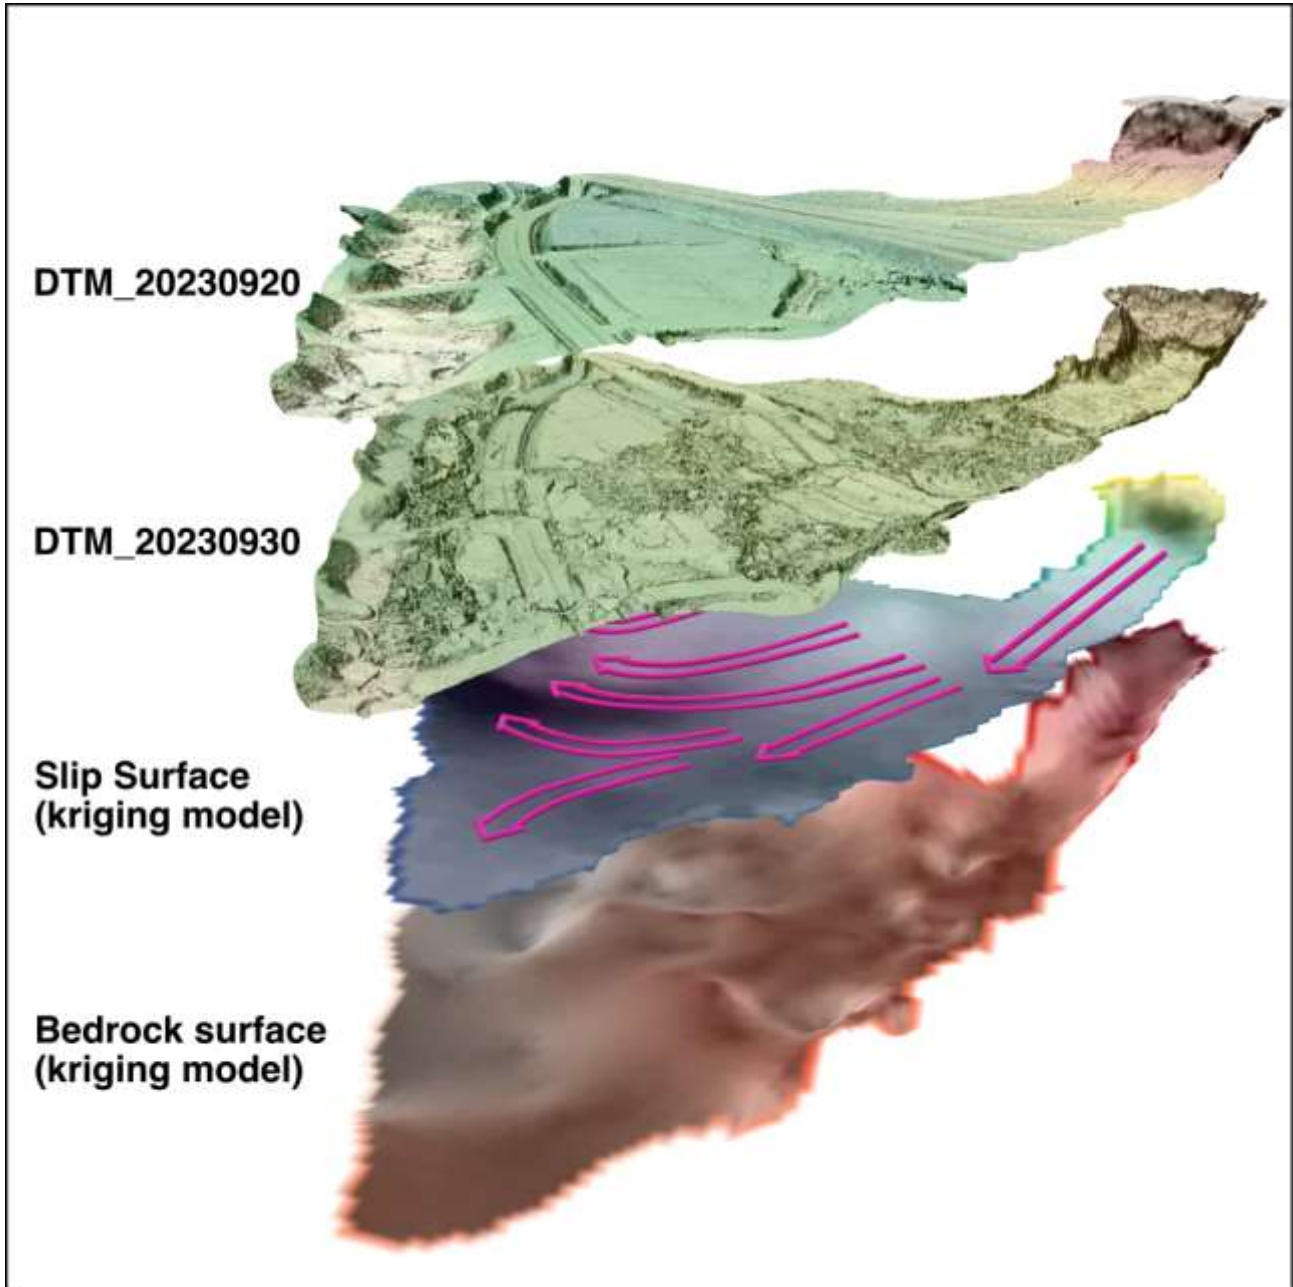
601  
602 **Fig. OR4** 3D perspective of the surfaces in the landslide area, vertically exaggerated by 2. The ground surfaces are based on LiDAR scans from before  
603 and after the event. The two lower surfaces are modeled based on interpretations of geotechnical borehole data and field observations. CPTu  
604 diagrams are the main input for the slip surface. However, these come with significant uncertainties. In addition, the slip-surface model has  
605 significant edge effects.
