London, 18<sup>th</sup> April 2015

## **Analysis SEM-EDS of the pendant MV13 from Mirasiviene, Seville.**

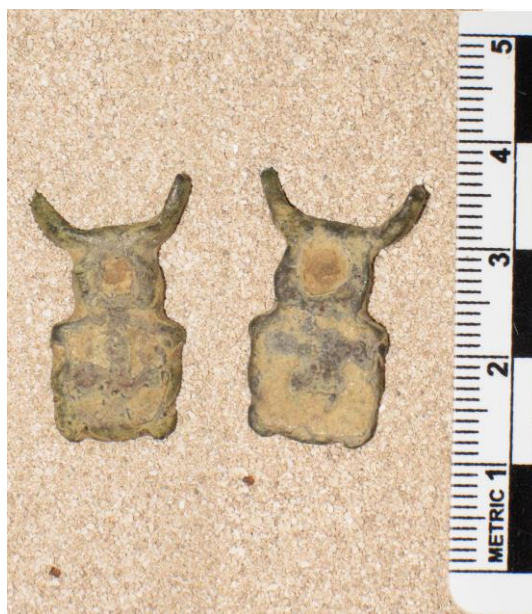
Copper alloy fitting that may be part of a broken pendant. The fitting has two protruding (broken) ends and a hole passing through the flattened section. The hole becomes wider at the back (Fig. 1). There are slight indentations on the front that form a pattern of a circle divided into four quarters. According to the conservation report, remains on the surface suggest that the object may have had a thin coating of silver.

Fig. 1. Front and back of the MV13 pendant.

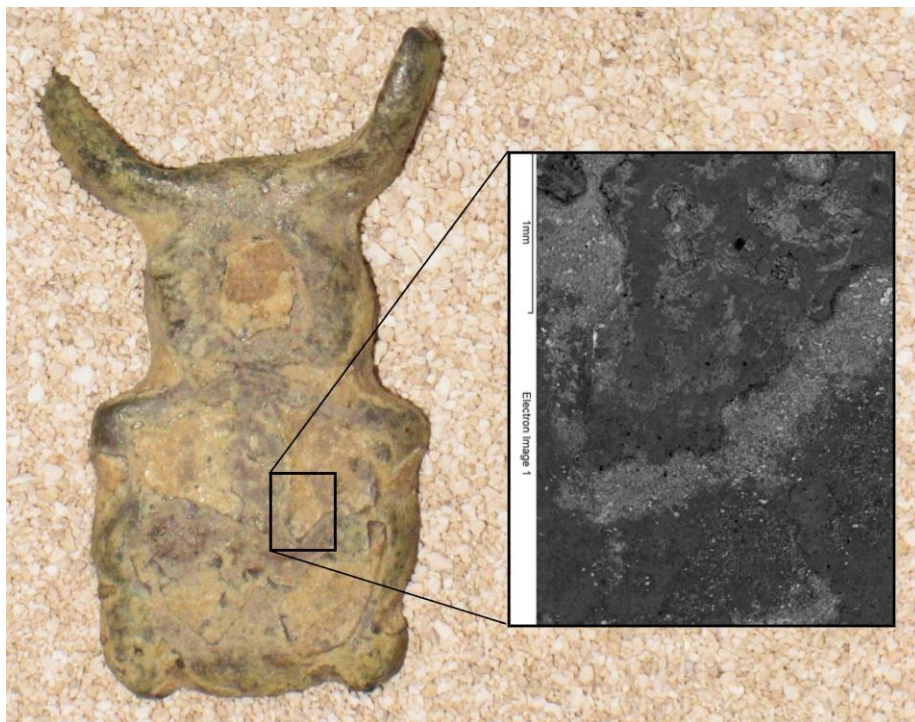
Fig. 2 Area selected for superficial analysis.

Results showed a copper composition (oxygen and impurities due to surface oxidation and corrosion) without any other alloying element such as arsenic, tin or zinc (see spectra 4 and 5). Analyses of the areas inside the quarters evidenced copper corrosion and soil (spectra 1 and 2).

Bright features in the metallic area evidenced the presence of silver amalgam in which elements of the superficial corrosion (Mg, Al, Si, Cl, Ca, Fe) were also detected (spectrum 3).

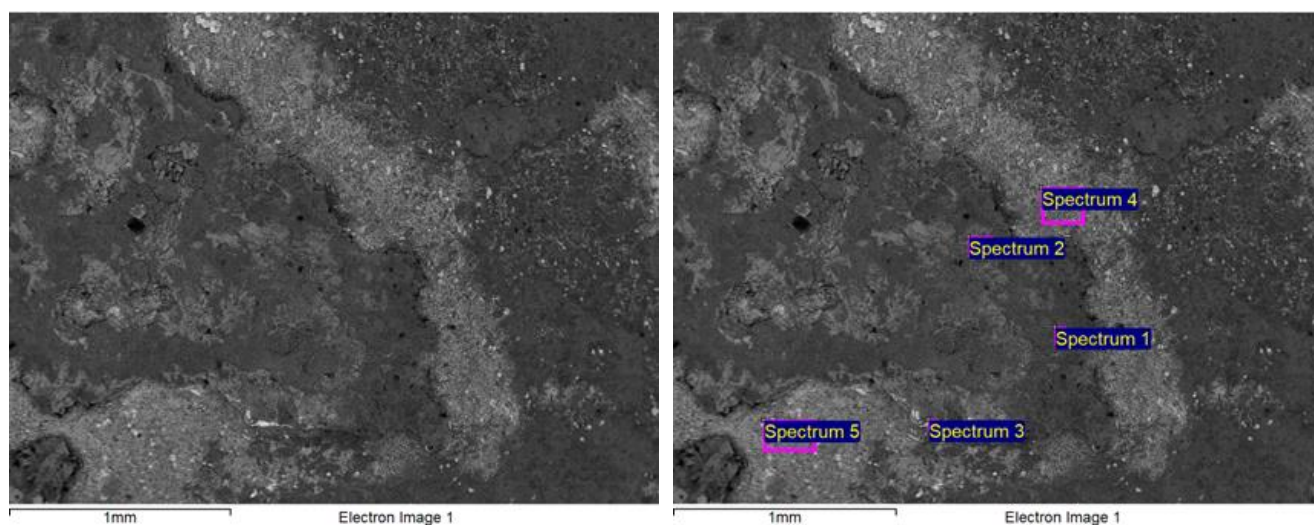
Results presented normalised in wt%. Spectra 3-5 presented in elements as these correspond to metallic areas although high levels of oxygen evidence they are oxidised. Remains of superficial corrosion are also detected.

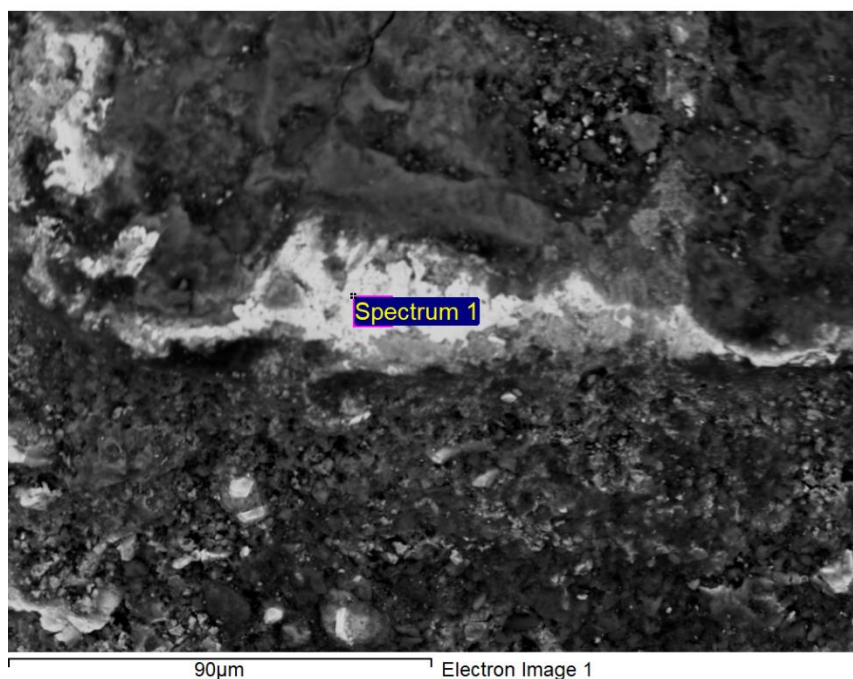
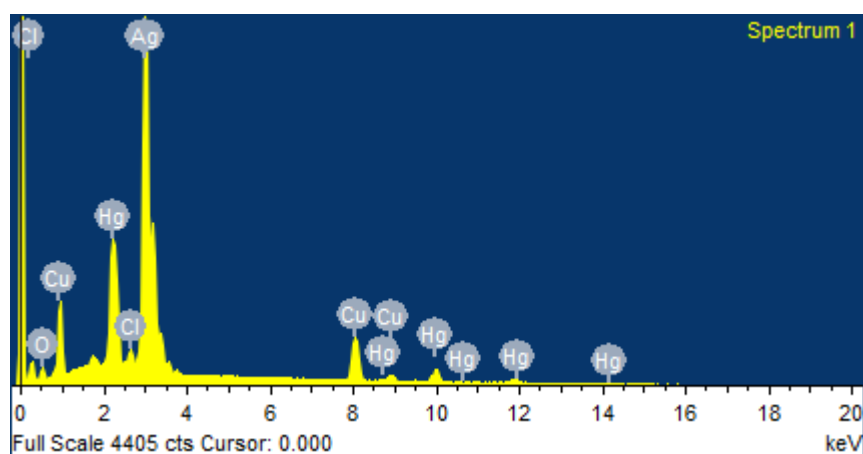
Analyses of the bright features were also conducted at high magnifications, where remains of silver amalgam were better detected.

Superficial qualitative SEM-EDS analyses of the pendant confirmed it was a copper fitting possibly exhibiting some silver decoration, as remains of silver amalgam have been detected on its surface.

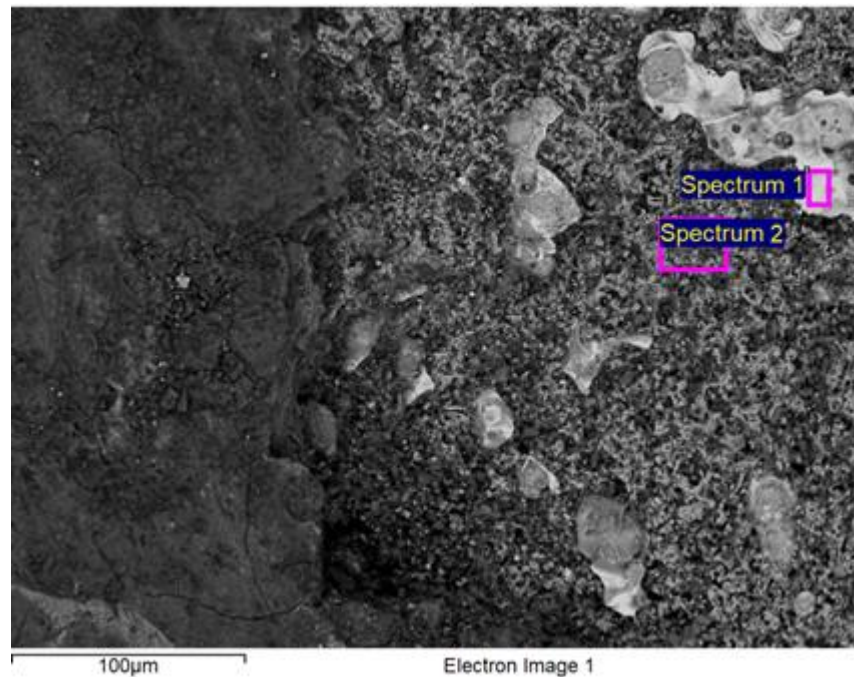
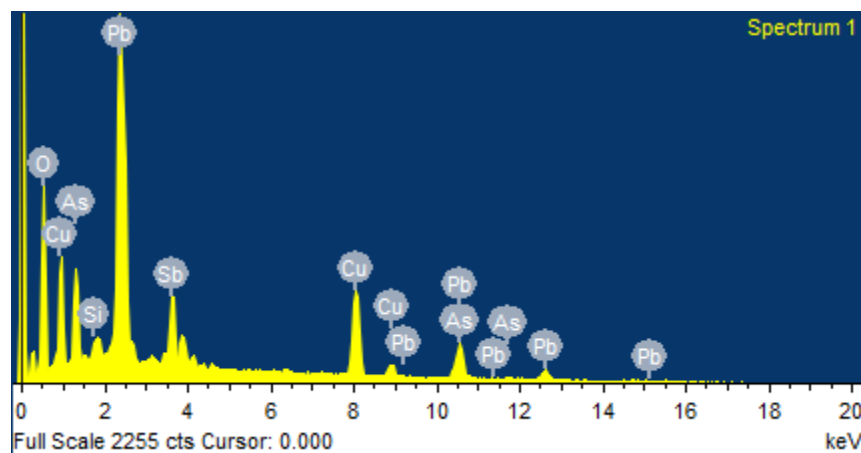
Other analyses on the metallic areas evidenced impurities of lead, arsenic and antimony which were not detected on general analyses.

Results presented normalised in wt%. Spectra presented in elements as these correspond to metallic areas although high levels of oxygen evidence they are oxidised. Remains of superficial corrosion are also detected in spectrum 2.
