**Online Resource 1** A collection of photos from field trips.

**Journal:** Wetlands Ecology and Management

**Title:** Advancing Salt Marsh Restoration for Coastal Resilience: A learning exchange

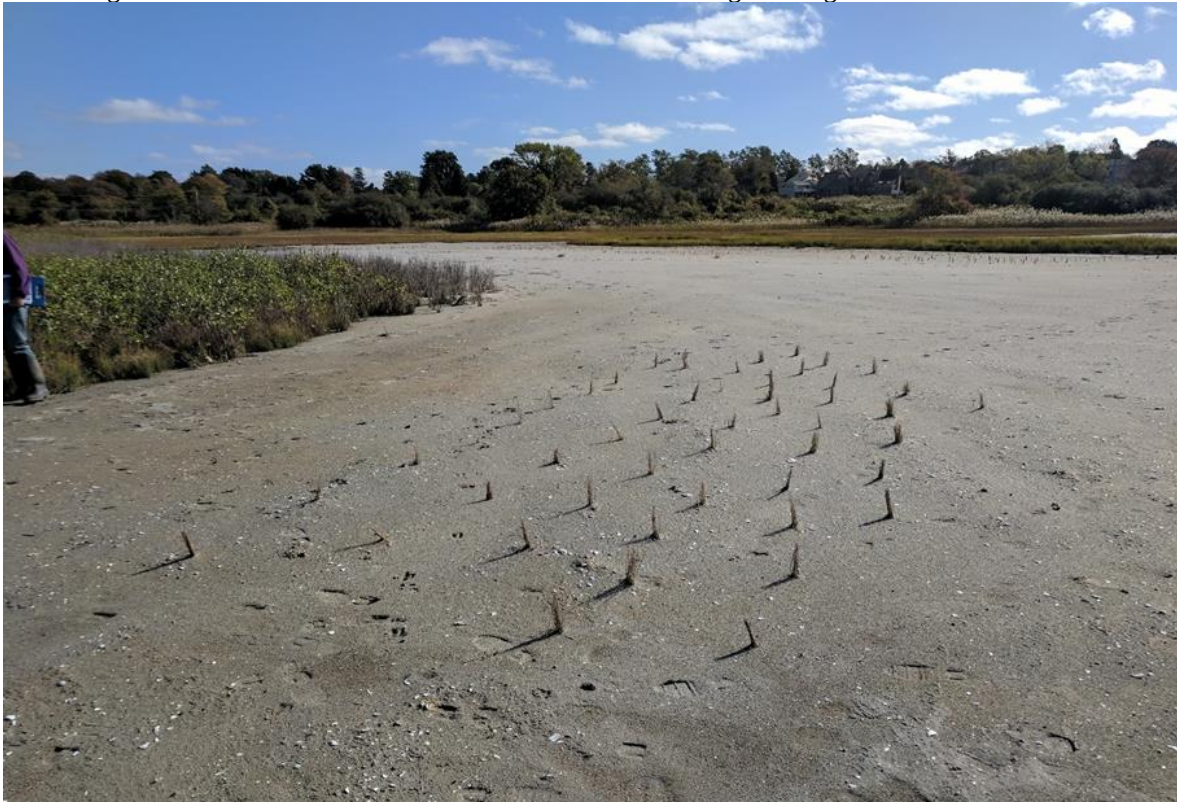
**RI Photo 2.** Middlebridge site, John H. Chafee National Wildlife Refuge in Narragansett, RI. Nursery planted *Distichlis spicata* plugs struggled initially. Perhaps they were planted before sediment chemistry had settled. Photo Alexa Fournier.

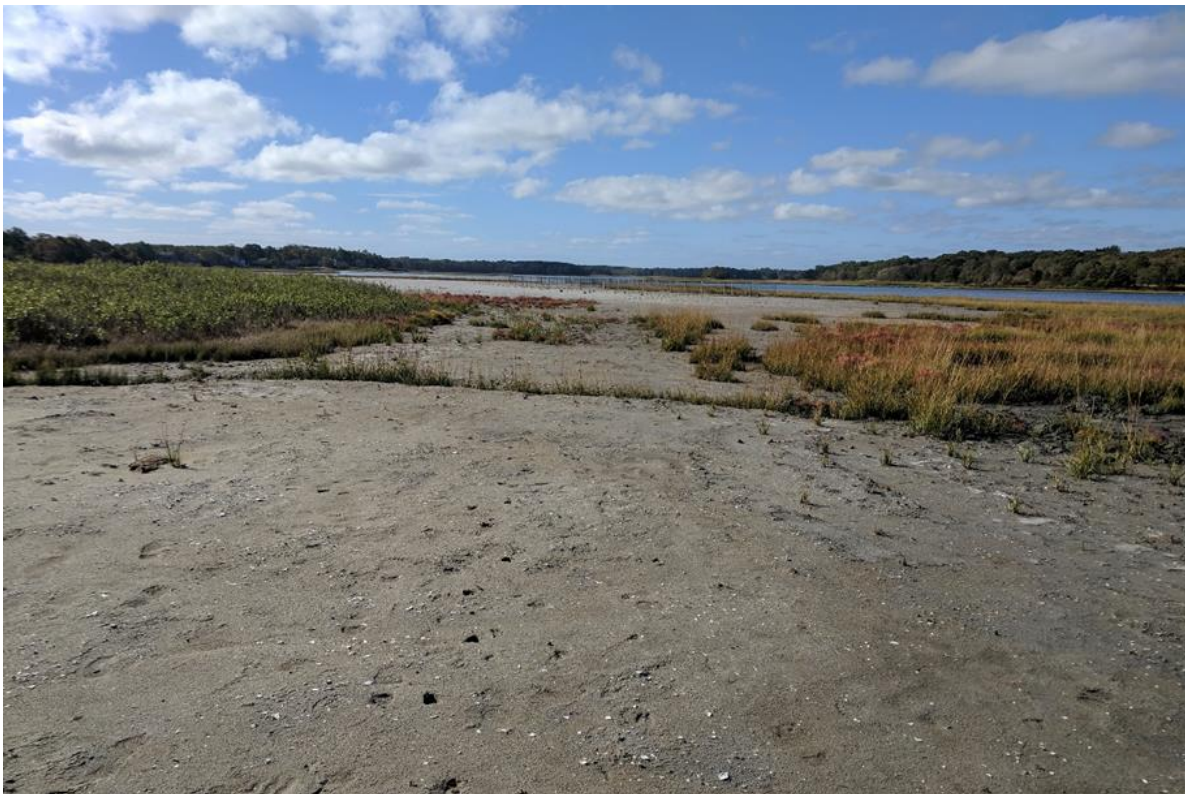
**RI Photo 3.** Middlebridge site, John H. Chafee National Wildlife Refuge in Narragansett, RI. Although nursery planted vegetation plugs struggled initially, naturally recruiting *S. alterniflora*, *Salicornia* colonized this small runnel. Photo Alexa Fournier.

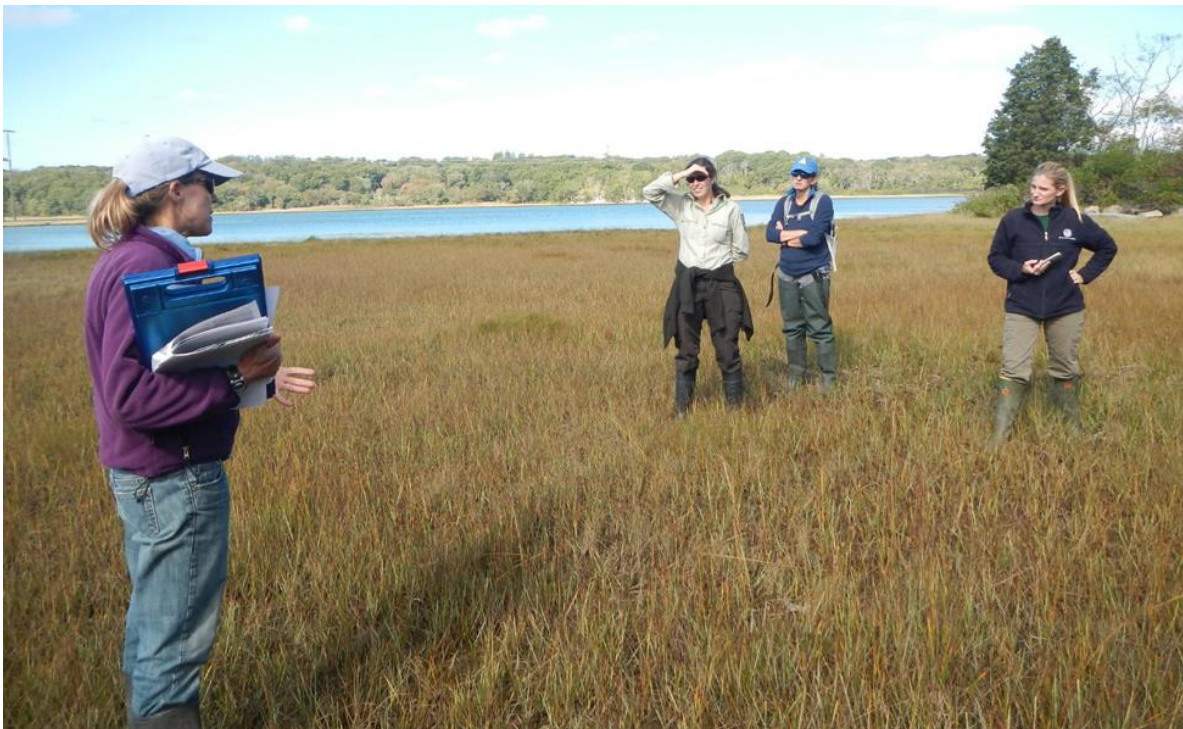
**RI Photo 5.** Canonchet treatment site part of the John H. Chafee National Wildlife Refuge in Narragansett, RI. has revegetated well after runnel treatments. Photo Nicole Maher @TNC

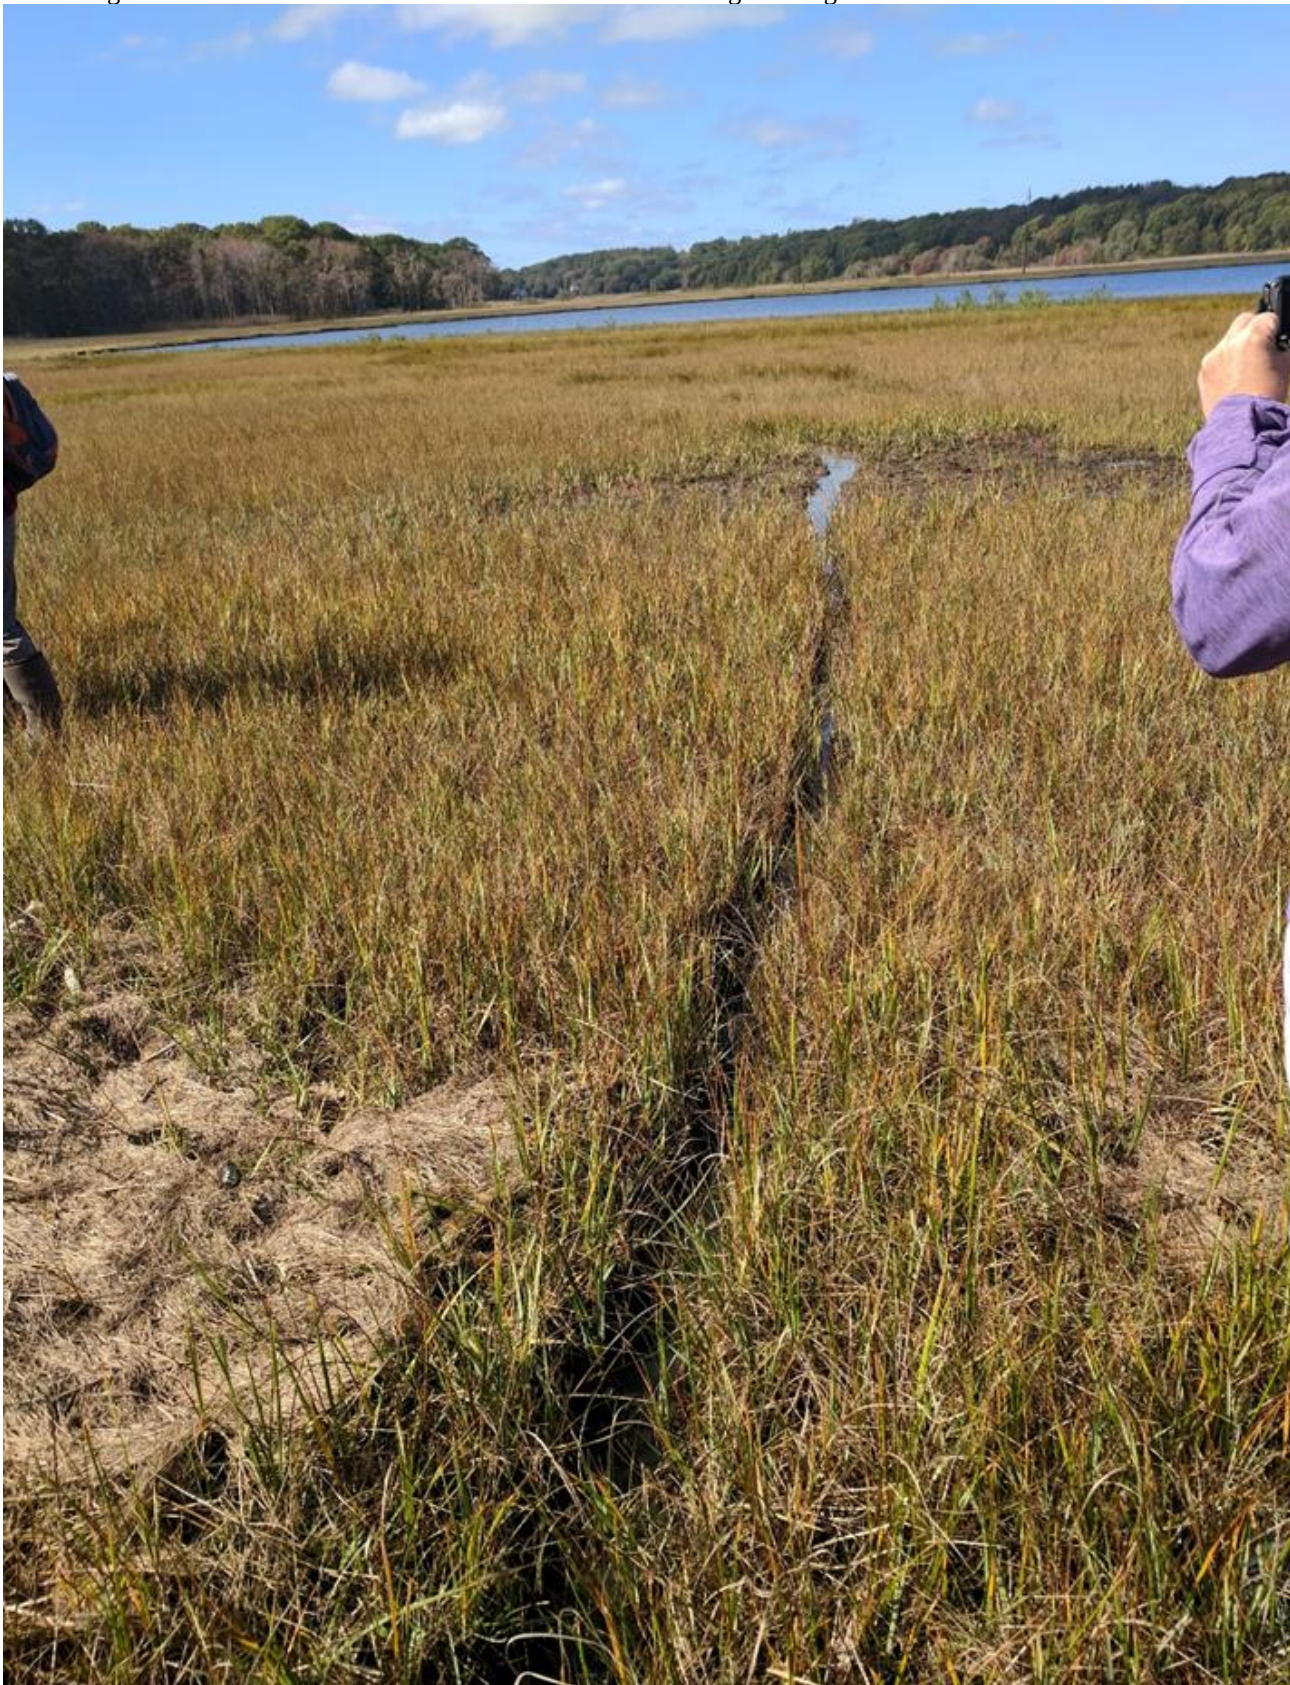
**RI Photo 6.** Example runnel in the restored (treatment) section of Canonchet part of the John H. Chafee National Wildlife Refuge in Narragansett, RI. Runnel is quite small in width and depth (15 cm wide x 25 cm deep). It connects low section in the upper photo with the back channel that was dug for drainage. Photo Alexa Fournier.

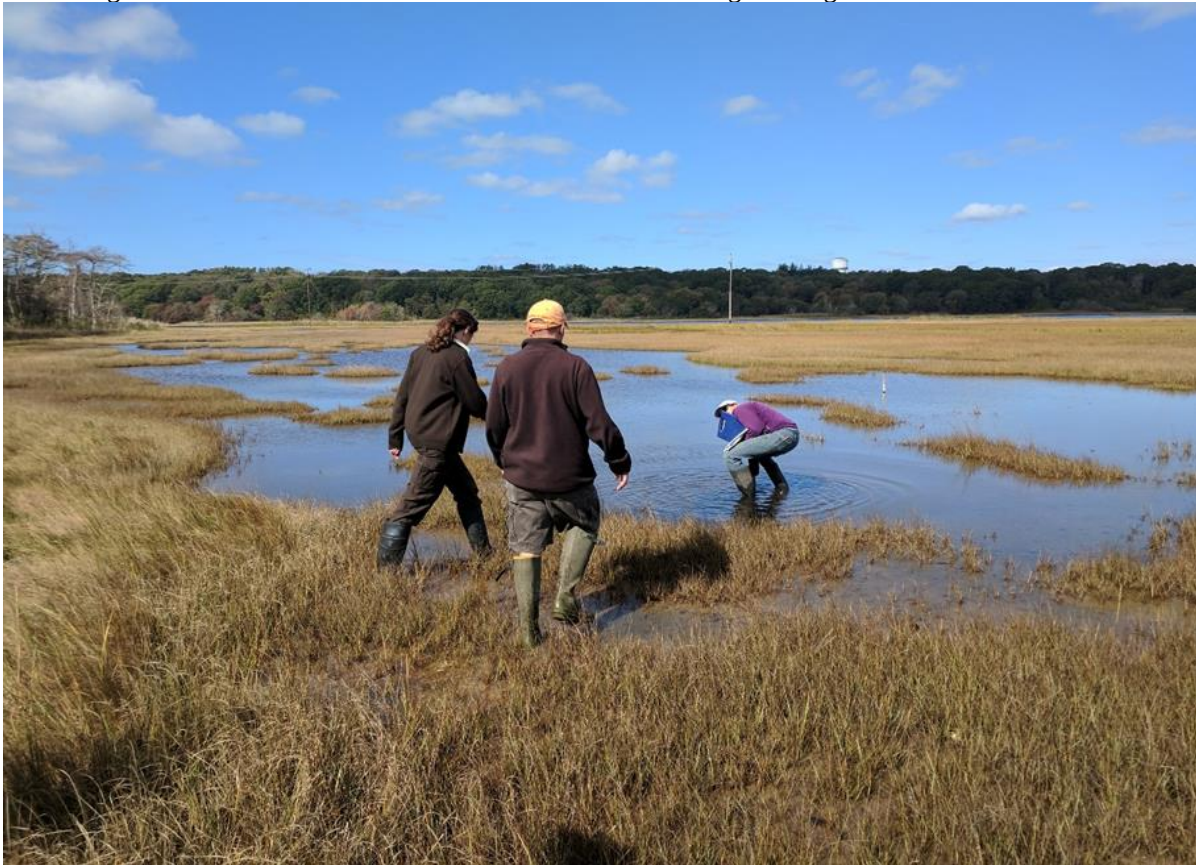
**RI Photo 7.** Canonchet control site part of the John H. Chafee National Wildlife Refuge in Narragansett, RI is still very waterlogged and has unvegetated areas of open water that are extensive and expanding. Photo Alexa Fournier.

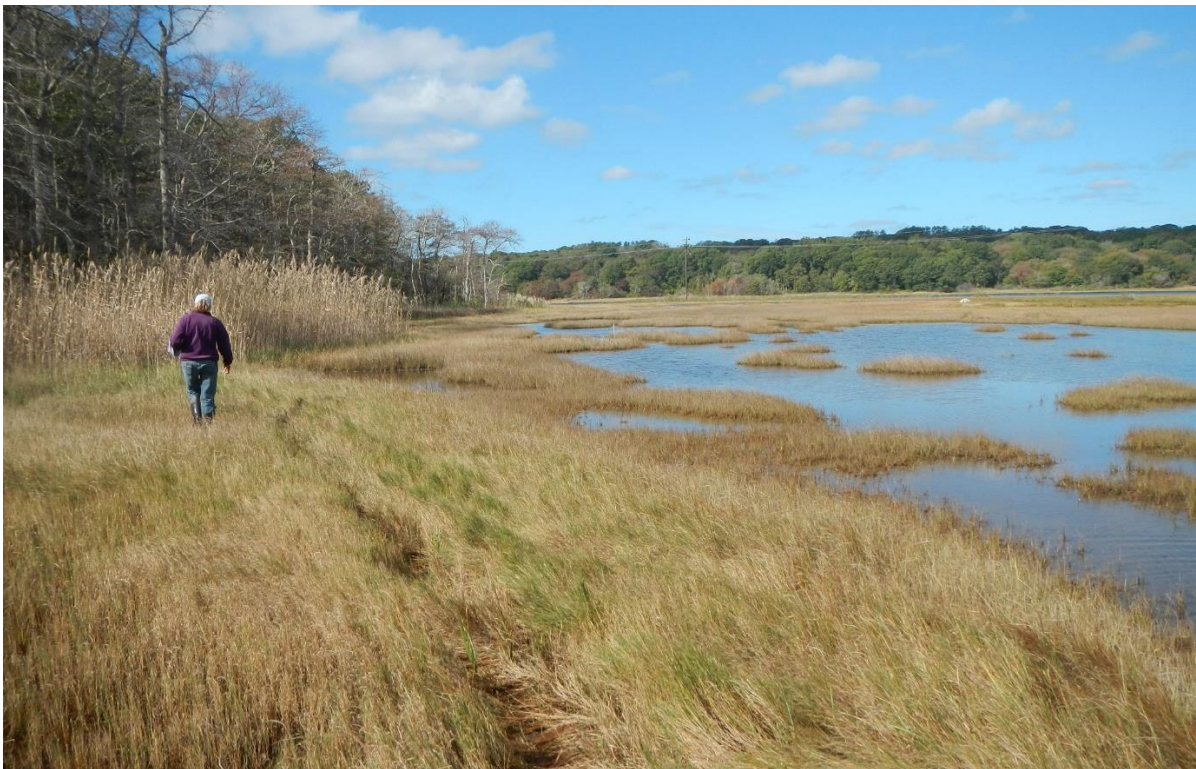
**RI Photo 8.** Canonchet control site part of the John H. Chafee National Wildlife Refuge in Narragansett, RI is still very waterlogged and has unvegetated areas of open water that are extensive and expanding. Photo Nicole Maher @TNC

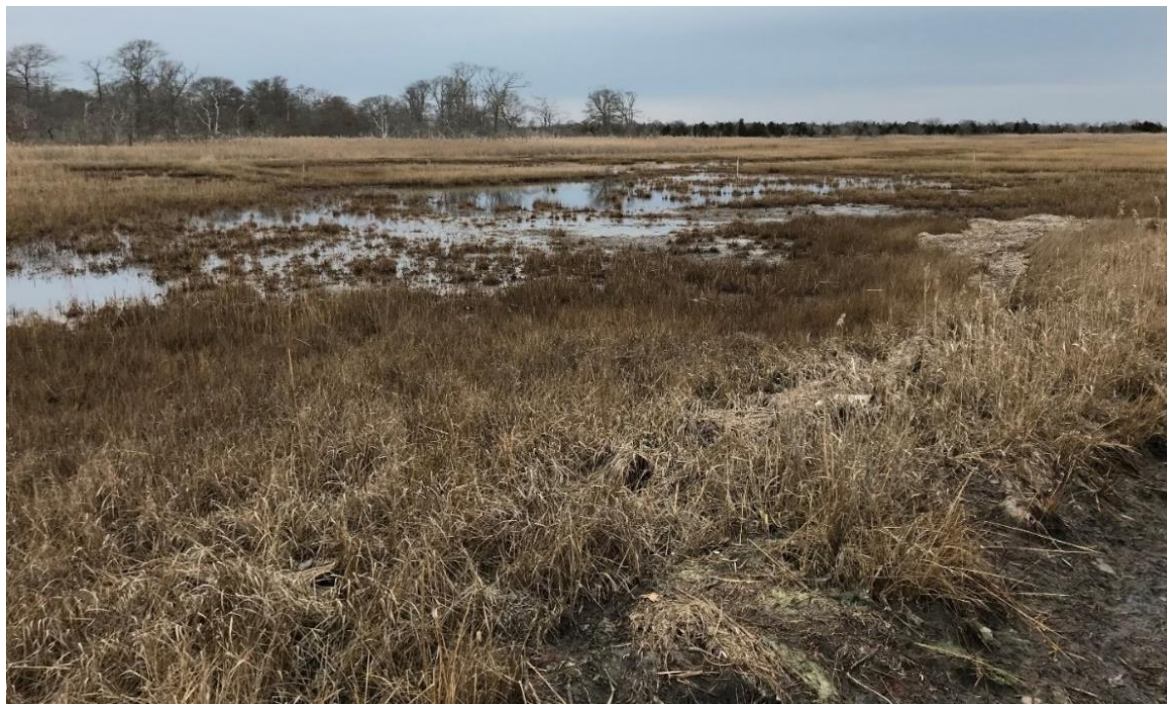
**Suffolk County Photo 2.** Gardiner Park East November 2018 Extensive waterlogging in southern stretch of marsh pre-restoration. This location is in the background of Figures 1 and 2 in the main text. Photo Nicole Maher @TNC

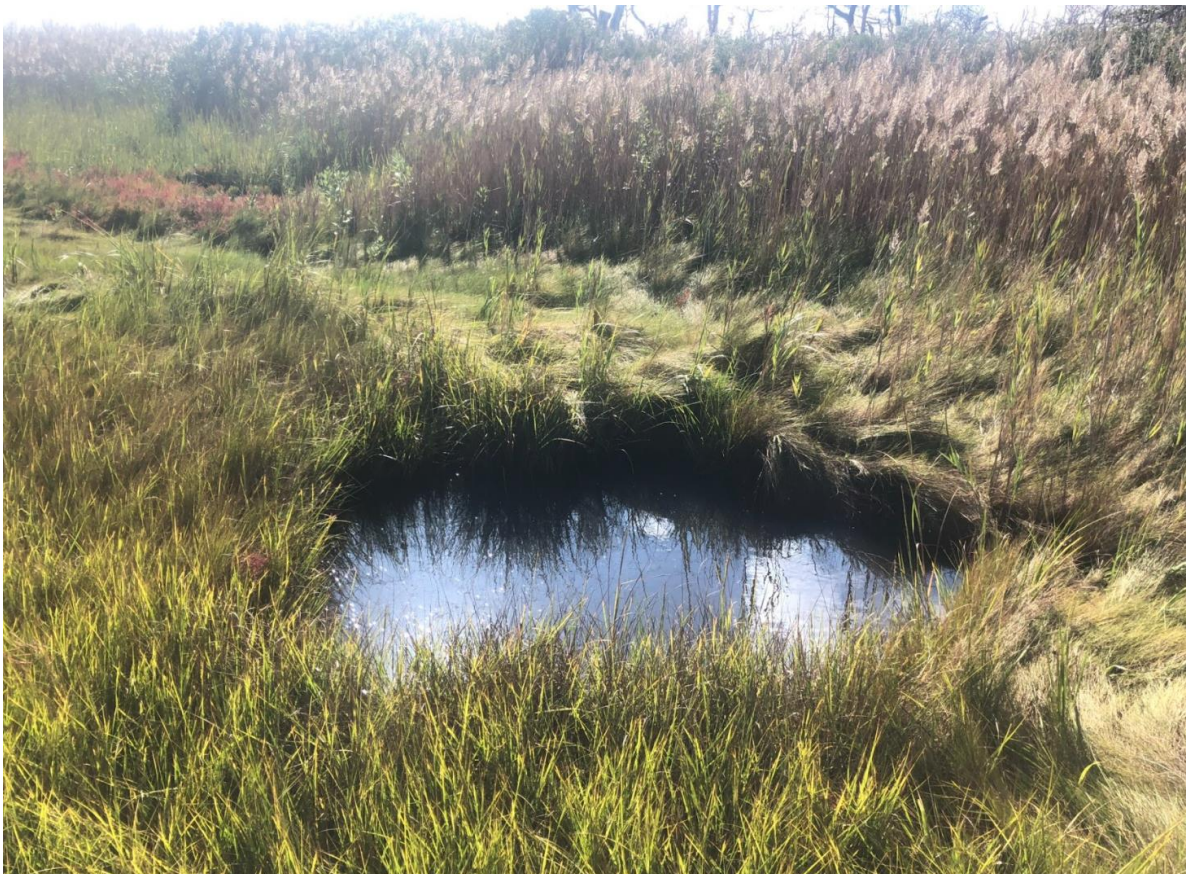
**Suffolk County Photo 4.** Micro-pool for fish habitat in Gardiner Park East two years post-restoration (10/08/20). Micro-pool is placed near the upper edge of the high marsh and connected to drainage through a runnel. Notice *Spartina alterniflora* on the lower and left-hand side of the pool; *Spartina patens* on the upper and right-hand sides; and stunted *Phragmites* beyond the *S. patens*. Photo Camilo Salazar.

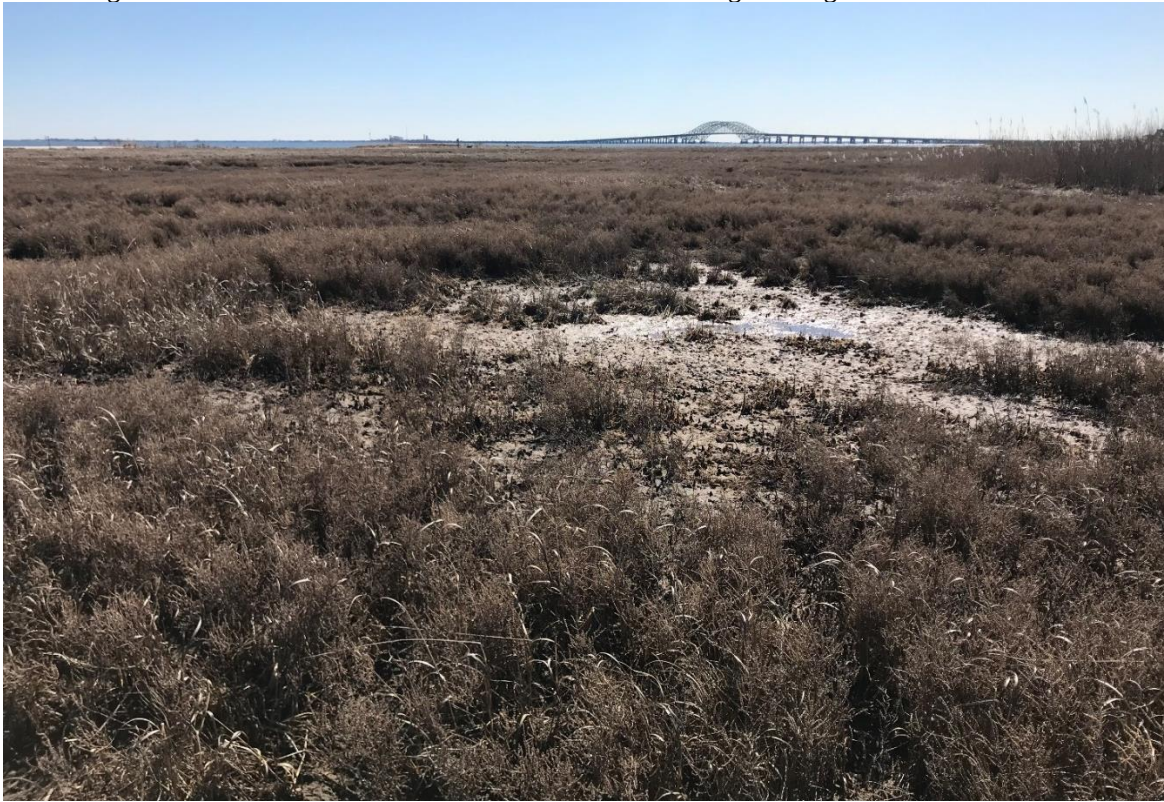
**Suffolk County Photo 5.** Gardiner Park East two years post-restoration (03/08/21). This is the same spot featured in Figures 1 and 3 in the main body of the text. Robert Moses Causeway bridge in background for marker. There are still some bare spots in this location, but it is largely covered by 20 cm tall *Salicornia* spp. Photo Nicole Maher @TNC

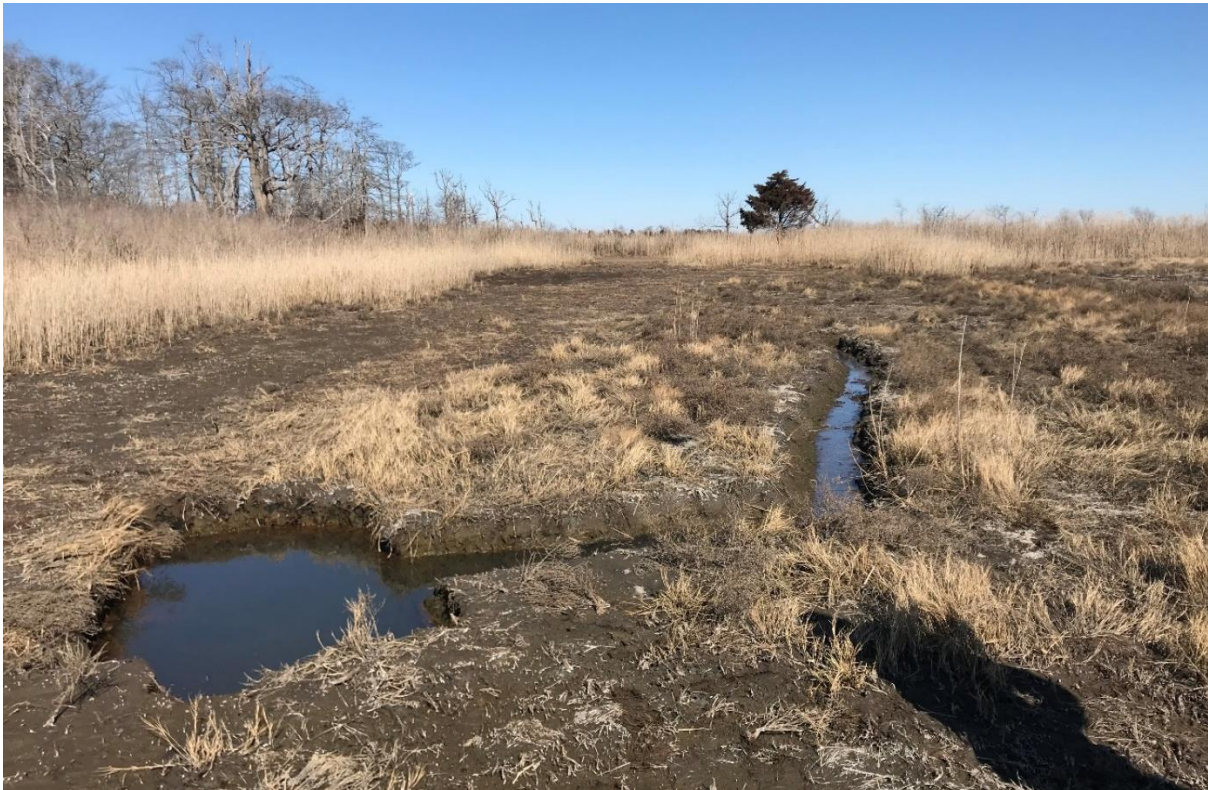
**Suffolk County Photo 6.** Micro-pool and runnel in Gardiner Park West less than one-year post-restoration (03/08/21). Micro-pool is in upper part of high marsh habitat near the invasive *Phragmites* line. Photo Nicole Maher @TNC

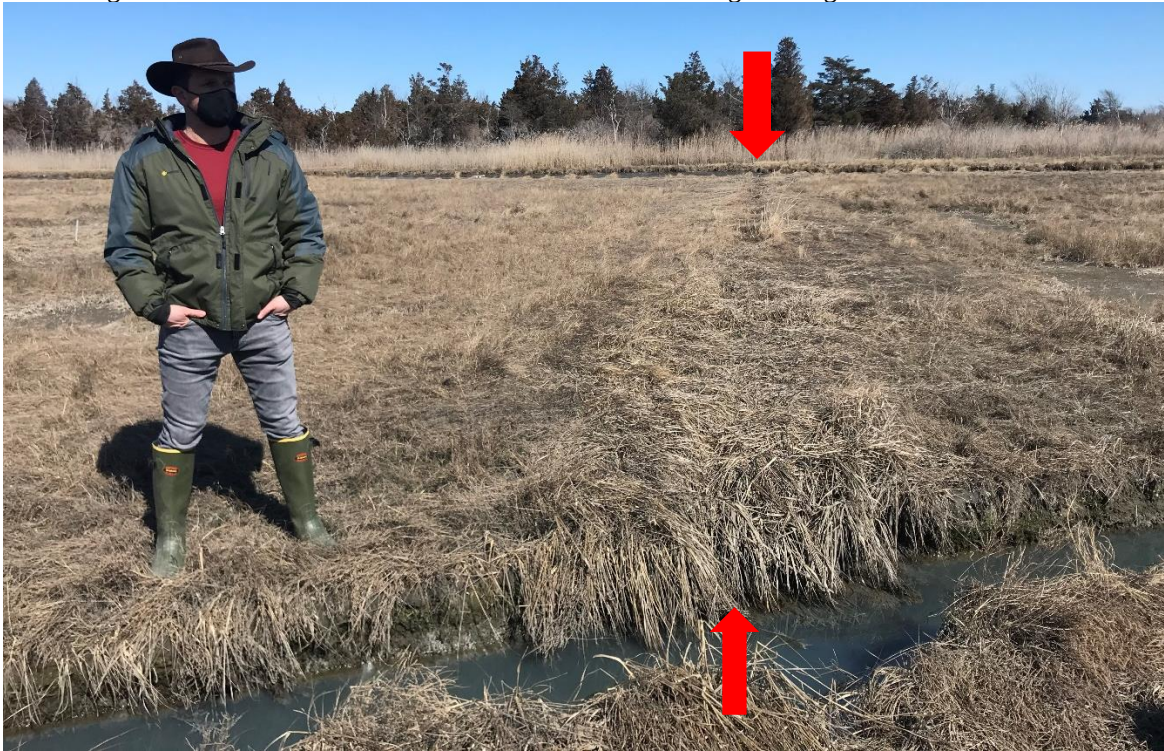
**Suffolk County Photo 7.** Gardiner Park East two years post-restoration (03/08/21). Filled in linear mosquito ditch between the two red arrows. Aged coir log staked down and buried with peat collected from nearby micro-pool and runnel construction. Peat placed vegetation side up. Ditch fully vegetated after two growing seasons. Photo Nicole Maher @TNC

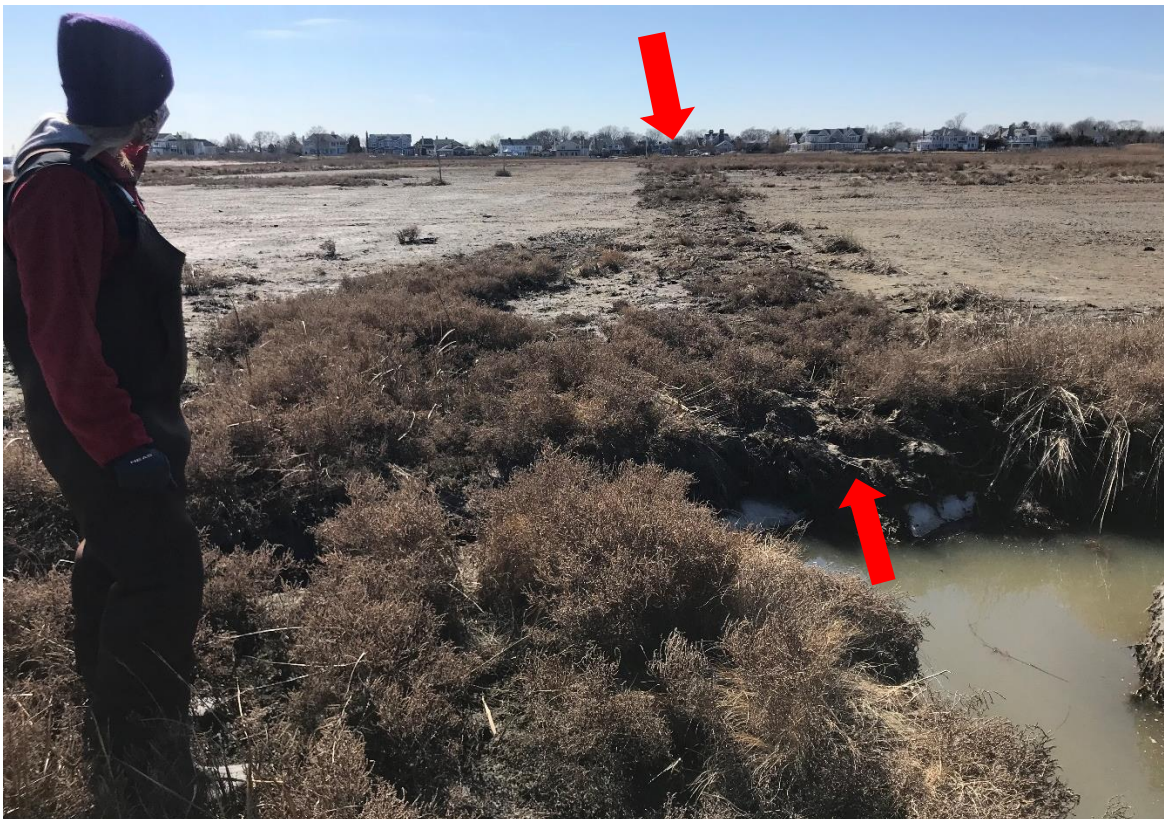
**Suffolk County Photo 8.** Gardiner Park West less than one-year post-restoration (03/08/21). Filled in linear mosquito ditch between the two red arrows. Aged coir log staked down and buried with peat collected from nearby micro-pool and runnel construction. Peat placed vegetation side up. Photo Nicole Maher @TNC
