**Novel ultrasound classification of tubal ectopic pregnancy:  
exploring underlying connections among sonographic and serum  
markers**

**ELECTRONIC SUPPLEMENTARY MATERIAL**

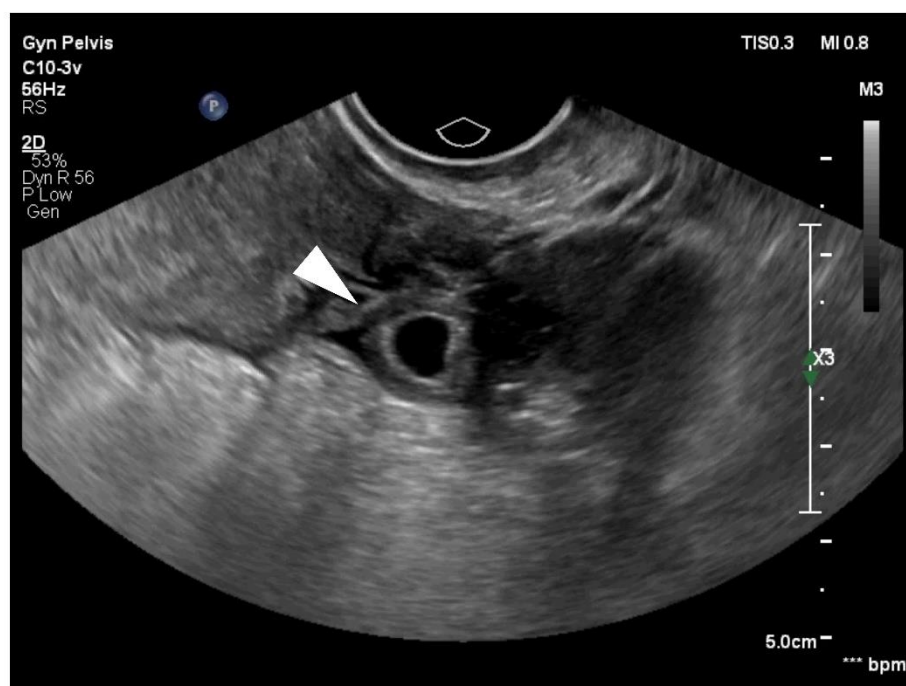
**Figure S1. Static frame of Video S1.** This image shows a simple GS-like TEP mass. The trophoblastic ring (arrowhead) is clear and no hematosalpinx is present.

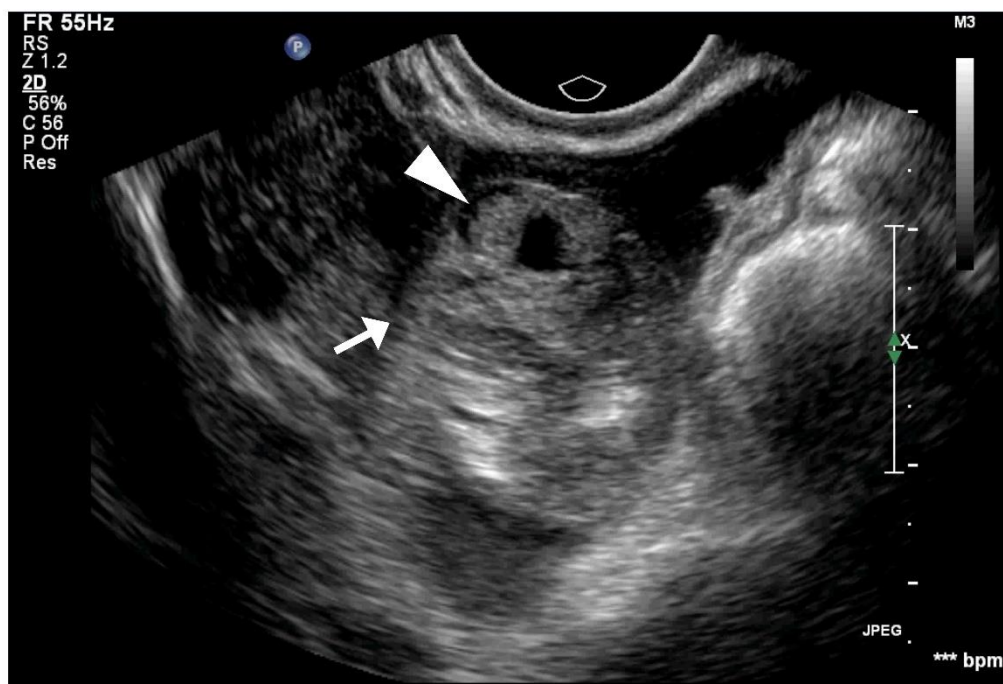
**Figure S2. Static frame of Video S2.** This image shows a complicated mass with both hematosalpinx (arrow) and a clear trophoblastic ring (arrowhead).

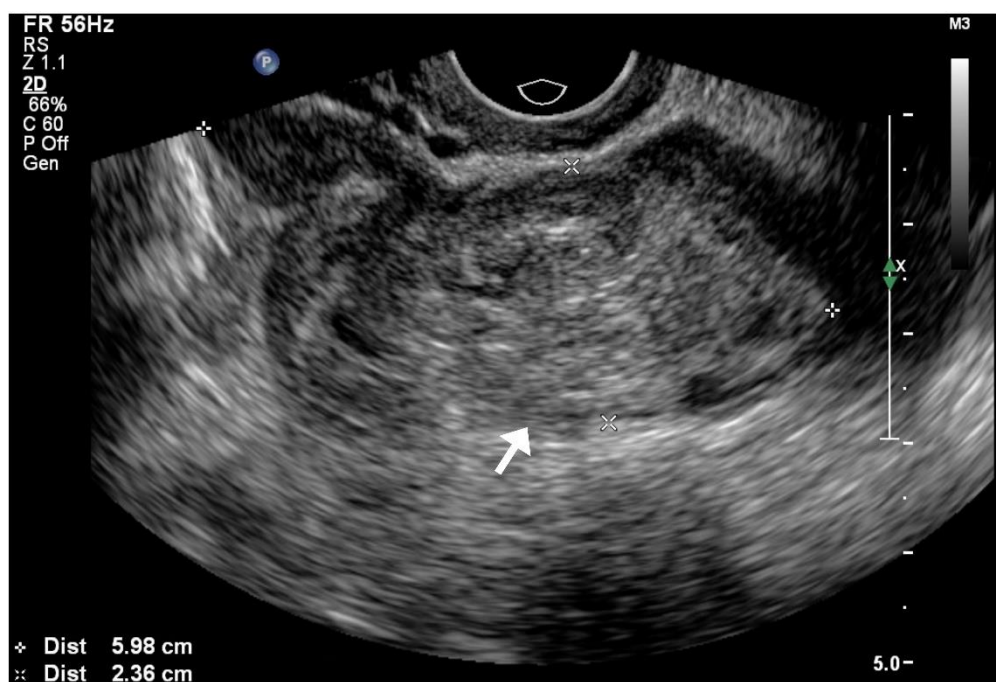
**Figure S3. Static frame of Video S3.** This image illustrates hematosalpinx without an obvious trophoblastic ring. The distended Fallopian tube (arrow) lacks a recognizable trophoblastic ring.

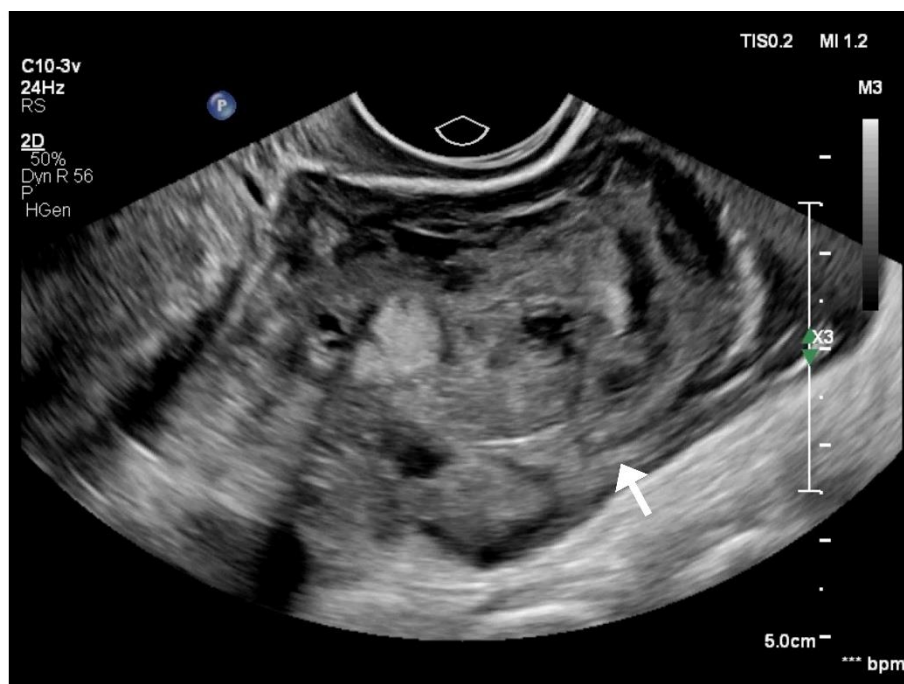
**Figure S4. Static frame of Video S4.** This subtype is characterized by an irregular mixed-echoic mass (arrow) and loss of recognizable tubal structure.

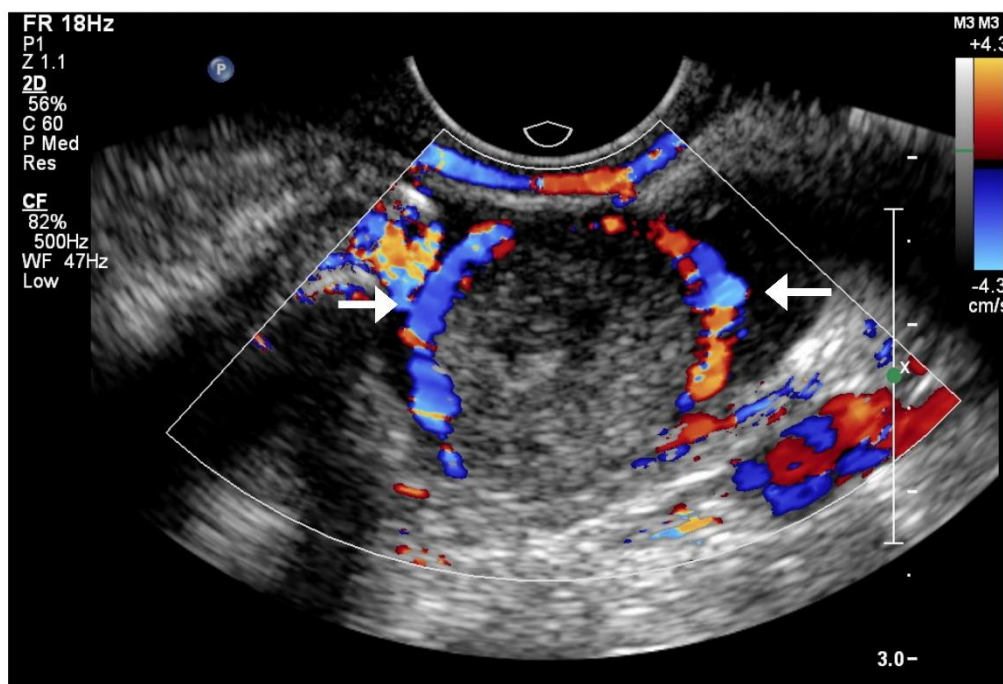
**Figure S5 Color Doppler ultrasound of a complicated mass.** Annular blood flow signals (arrowheads) are visible around the mass and represent blood flow of salpinx wall, whereas no intralesional flow is detected within the gestational tissue inside the mass.
