Stormwater Pollution Prevention Plan  
for  
Vermont Railway, Inc.  
Shelburne Transload Facility  
Shelburne, Vermont

Permit Number 7514-9003

Last Revised: November 3, 2017

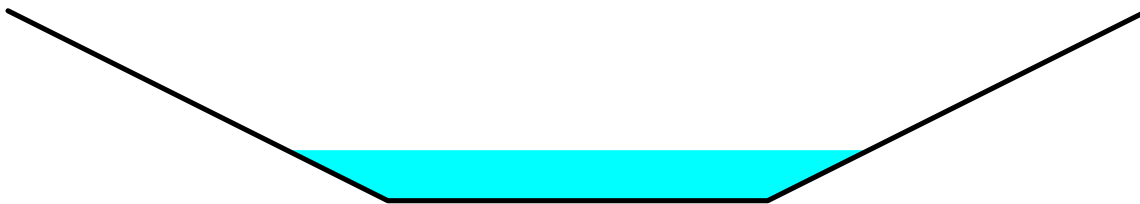
**Reach 8R: Treatment Swale****Hydrograph**

Length= 1,125.0' Slope= 0.0124 '/'

Inlet Invert= 121.00', Outlet Invert= 107.00'

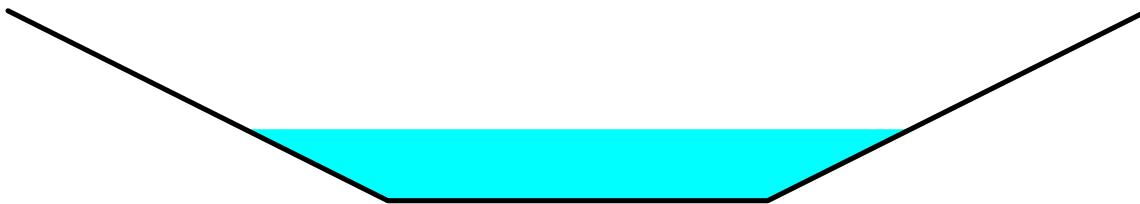
**Reach 8R: Treatment Swale****Hydrograph**

Length= 1,125.0' Slope= 0.0124 '/'

Inlet Invert= 121.00', Outlet Invert= 107.00'

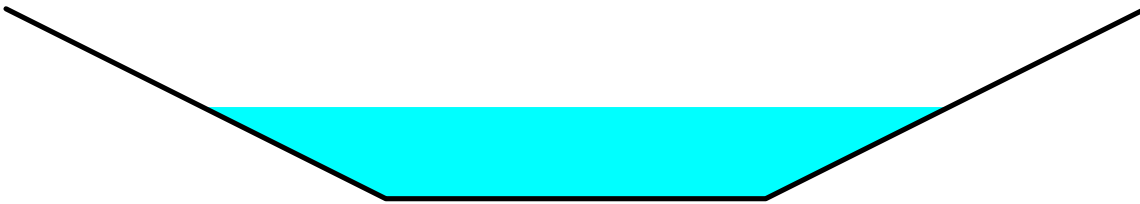
**Reach 8R: Treatment Swale****Hydrograph**

Peak Storage= 3,620 cf @ 11.99 hrs  
 Average Depth at Peak Storage= 0.72'  
 Bank-Full Depth= 1.50' Flow Area= 9.0 sf, Capacity= 19.17 cfs

3.00' x 1.50' deep channel, n= 0.074  
 Side Slope Z-value= 2.0 '/' Top Width= 9.00'  
 Length= 1,125.0' Slope= 0.0124 '/'  
 Inlet Invert= 121.00', Outlet Invert= 107.00'

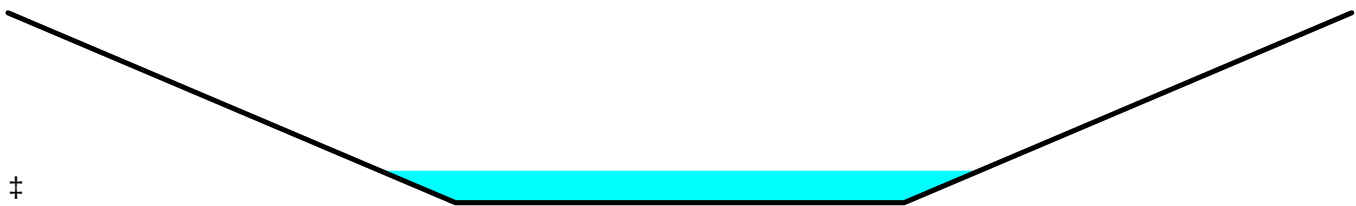
**Reach 9R: Treatment Swale****Hydrograph**

Length= 121.0' Slope= 0.0207 '/'

Inlet Invert= 123.50', Outlet Invert= 121.00'

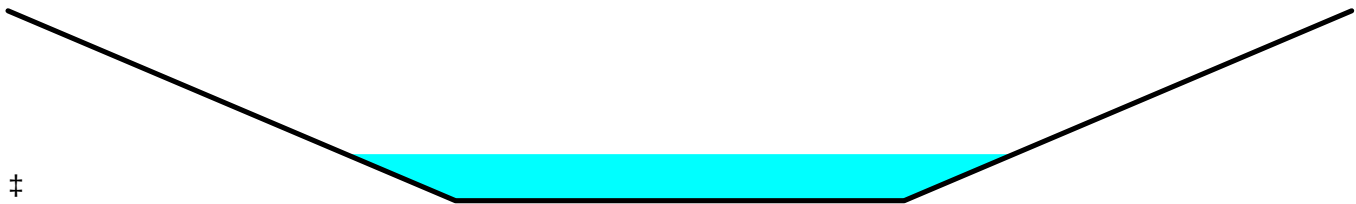
**Reach 9R: Treatment Swale****Hydrograph**

Peak Storage= 196 cf @ 11.97 hrs  
 Average Depth at Peak Storage= 0.33'  
 Bank-Full Depth= 1.33' Flow Area= 10.6 sf, Capacity= 14.83 cfs

4.00' x 1.33' deep channel, n= 0.138  
 Side Slope Z-value= 3.0 '/' Top Width= 11.98'  
 Length= 121.0' Slope= 0.0207 '/'  
 Inlet Invert= 123.50', Outlet Invert= 121.00'

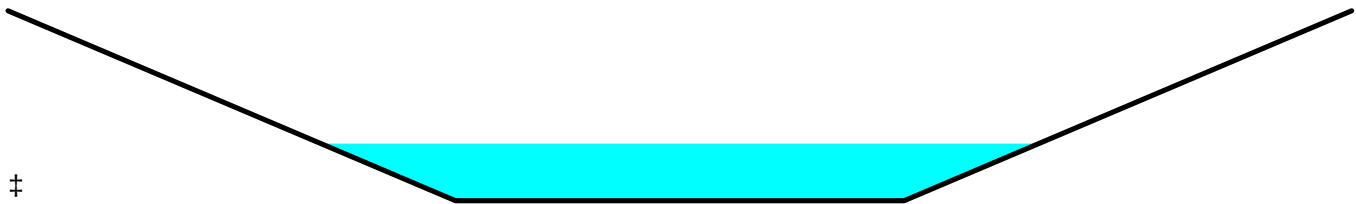
**Reach 9R: Treatment Swale****Hydrograph**

Length= 121.0' Slope= 0.0207 '/'

Inlet Invert= 123.50', Outlet Invert= 121.00'

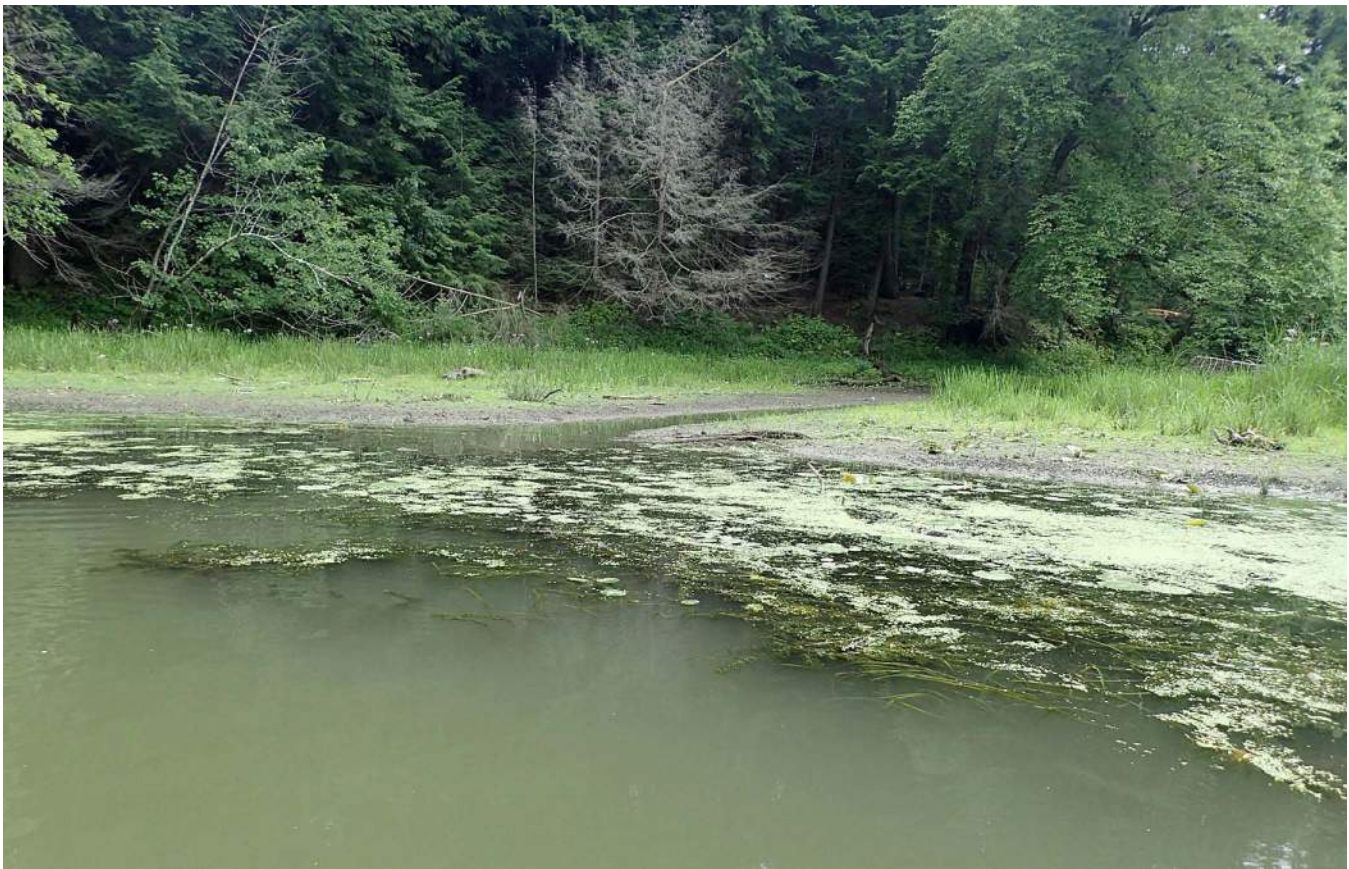
The proposed stormwater discharge is through the small channel shown here.

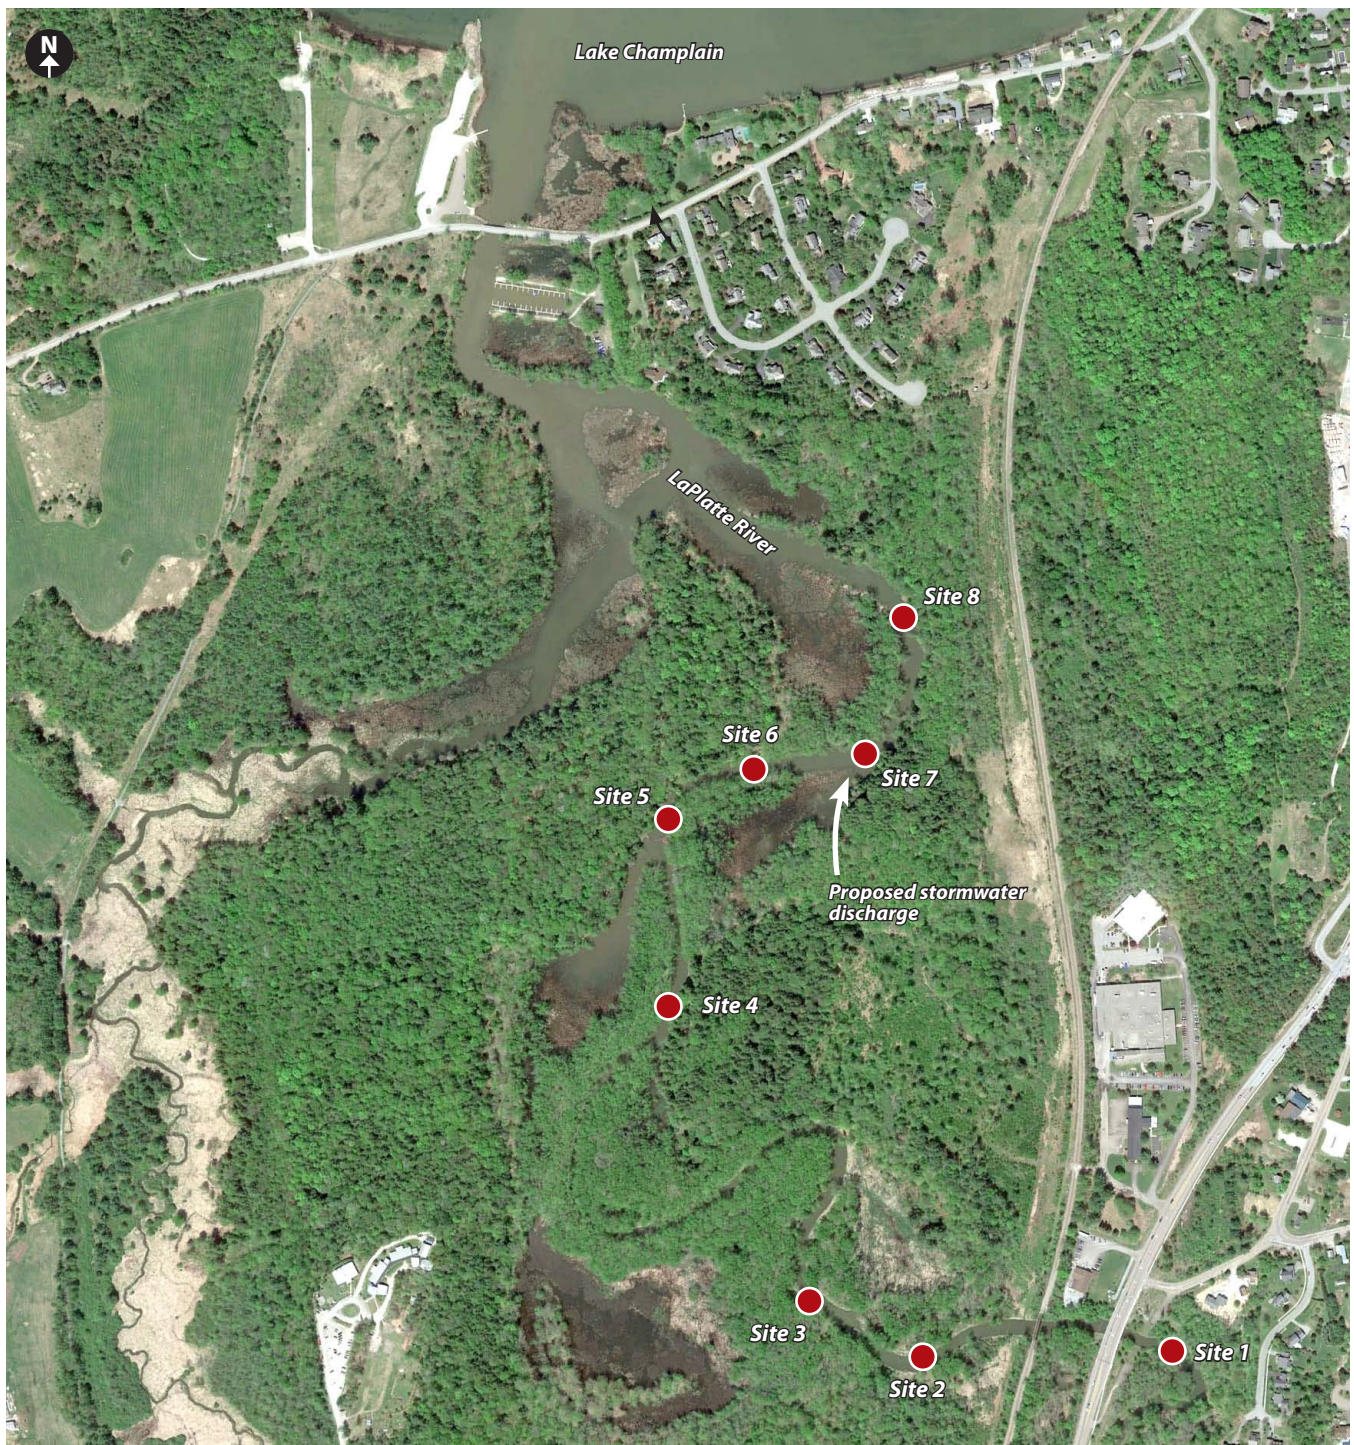
**Figure 1.** Fish survey sites in the LaPlatte River upstream and downstream from the proposed stormwater discharge of the Shelburne Transload Facility (Shelburne, Vermont).

**Study Area:** Eight sites were surveyed; these spanned a distance of approximately 2,000 meters of the river from 80 meters upstream from Route 7 to 180 meters downstream from the proposed stormwater discharge (Figure 1). Areas of the LaPlatte River farther downstream to Lake Champlain were assessed, but not sampled, due to a combination of poor habitat, deep water, and limitations of the sampling gear. The entire reach from Route 7 to Lake Champlain is a very low-gradient, meandering reach at lake level, and has extensive riparian wetlands that flood or dry with lake level fluctuations.

**Table 1.** Sampling dates and habitat at each of the survey sites. See Figure 1 for locations.

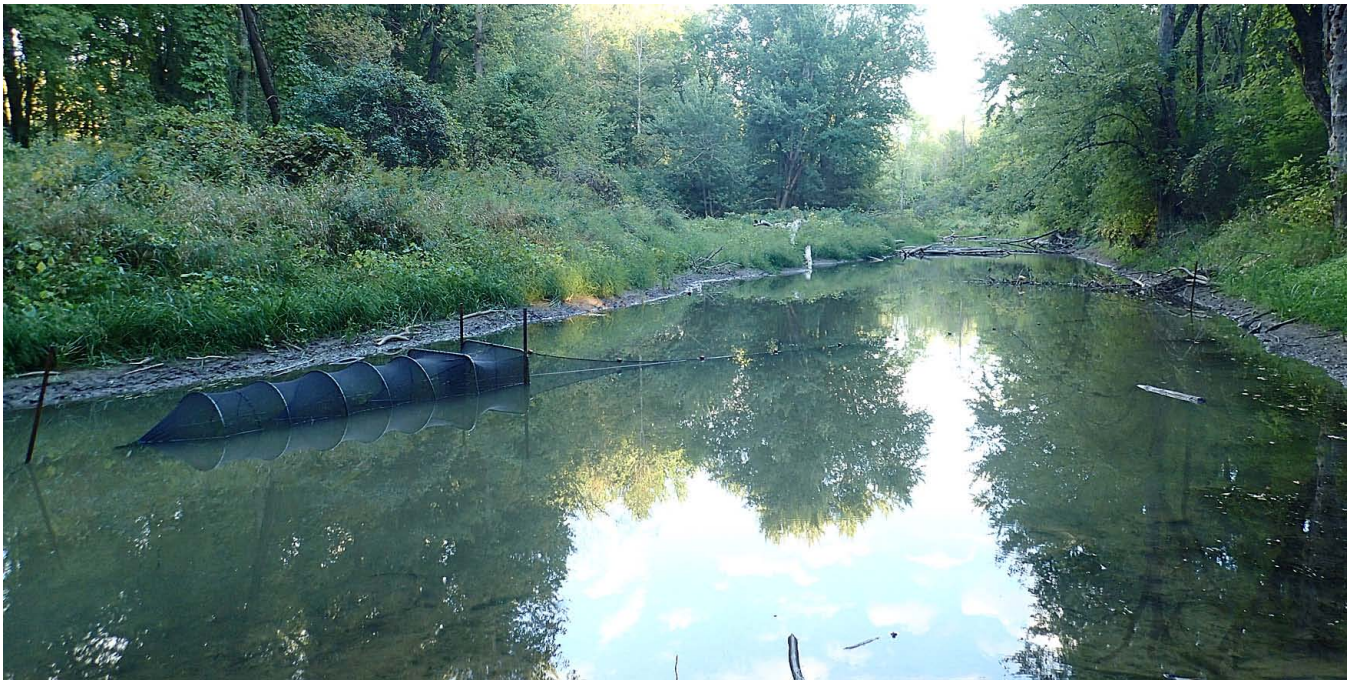
**Methods:** One site was surveyed each night. At each site, one fyke net was placed parallel to the current at a depth of 0.5-1.0 meters. The fyke net had a 3x4' frame size and 0.25" mesh size; it was ordered from Christiansen Nets (see photos in this report). It was installed in the evening, around 5:00-6:00, and biologists returned in the morning (8:00-9:00) to check

Survey method photos: fyke net (top and bottom left), minnow trap (middle right), and Vermont DEC fish expert Rich Langdon assisting with species identification.

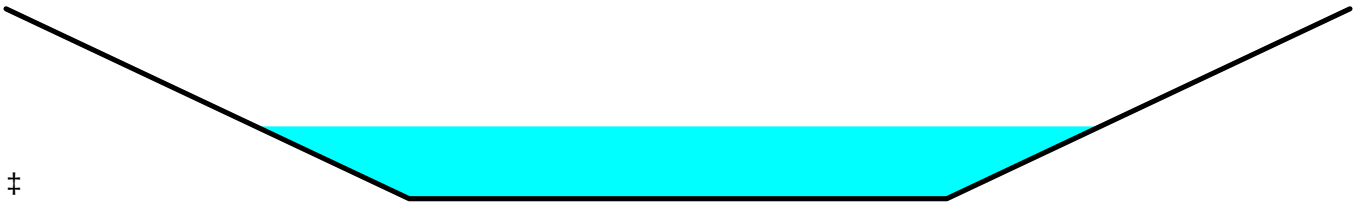
**Reach 1R: Pretreatment Channel**

Peak Storage= 1,908 cf @ 12.08 hrs  
 Average Depth at Peak Storage= 0.57'  
 Bank-Full Depth= 1.50' Flow Area= 15.8 sf, Capacity= 18.53 cfs

6.00' x 1.50' deep channel, n= 0.099  
 Side Slope Z-value= 3.0 '/' Top Width= 15.00'  
 Length= 433.0' Slope= 0.0060 '/'  
 Inlet Invert= 112.35', Outlet Invert= 109.75'

Hydrograph
