### **The spatiotemporal evolution of compound impacts from lava flow and tephra fallout on buildings: lessons from the 2021 Tajogaite eruption (La Palma, Spain)**

This supplementary information provides a compilation of field observations of i) house typology, ii) hazards metrics and sequence and iii) impact mechanisms for the buildings described in the main manuscript. Building nomenclature follows the definition provided in Figure 2a of the manuscript. For each house, we provide the damage state inferred from the scheme of Meredith et al. (2022) summarised in Table 2 of the manuscript. Each house also comprises a collection of pictures taken during the Oct 2021 (during the eruption, pre lava-flow inundation) and Nov 2022 (after the eruption).

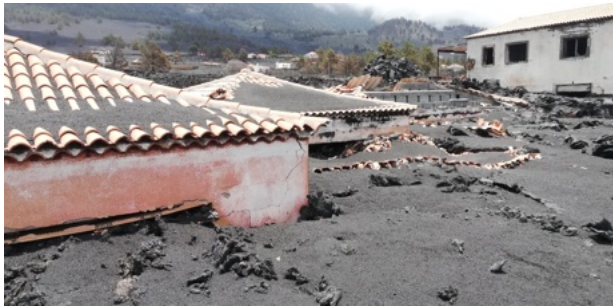
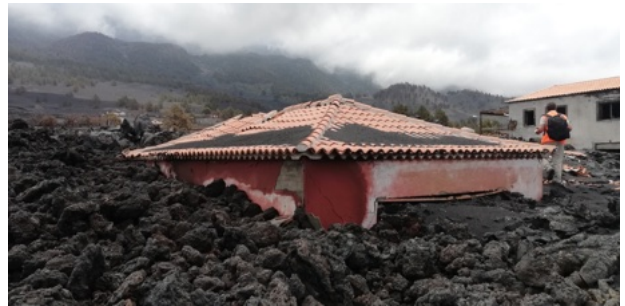
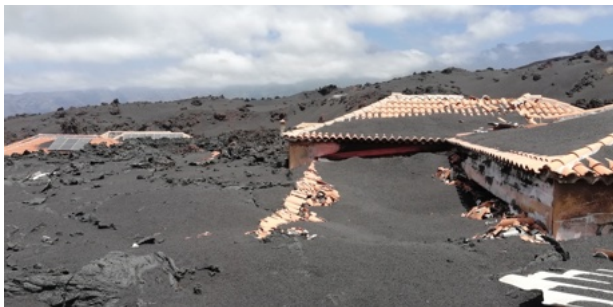
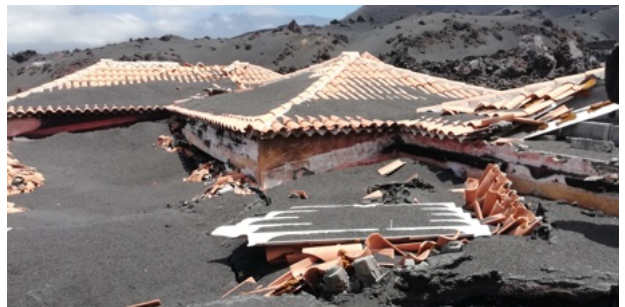
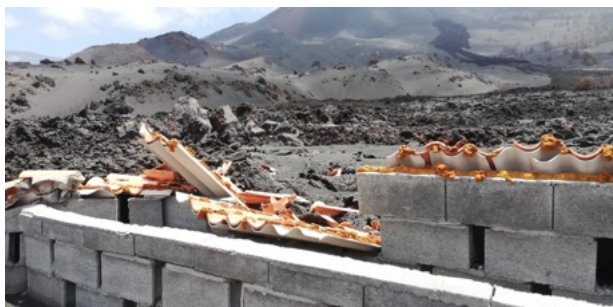
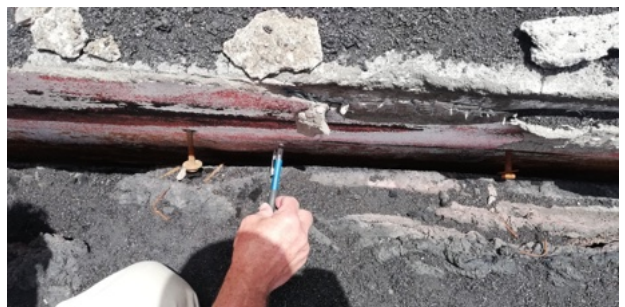
**17/05/2022:**

**Damage:** Flow impacting from the E to the front of the main house (up to 75 cm on the roof). First floor 50-70% flooded by lava, only the ceiling can be seen. A'a lava from the E, NE and pahoeohoe from S-SE of the house. Lava comes out through openings of the W side of the house. No major structural damage but there are fractures in the corners of the walls and the chimney. Fire damage in the interior and heat removes exterior paint from the house leaving the wall white. Burnt wooden beams and composite material and tiles of the accessory roofs collapsed (a,b,c). Garage (II), storage room (III) and Pool (IV) completely covered by lava.

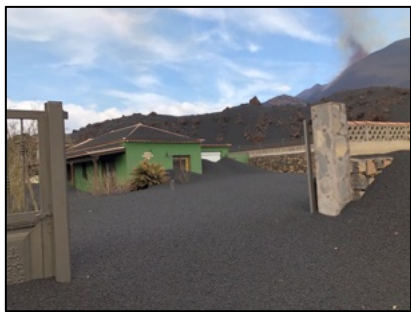
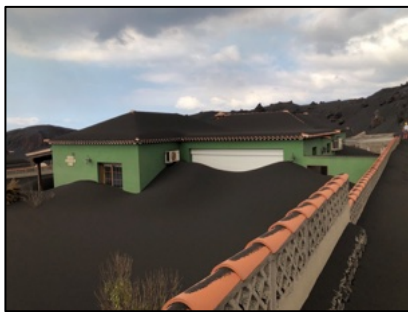
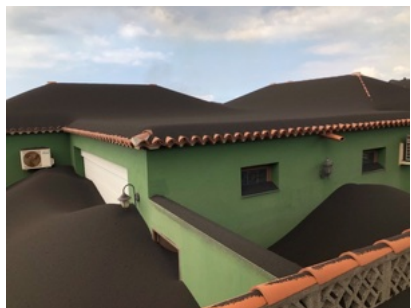
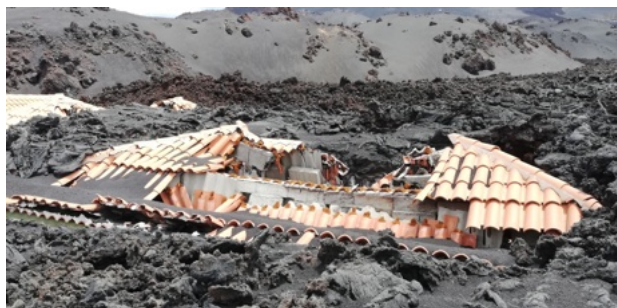
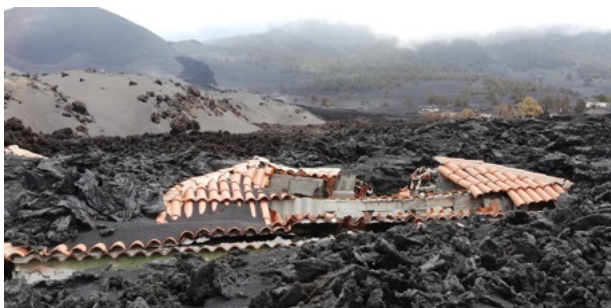
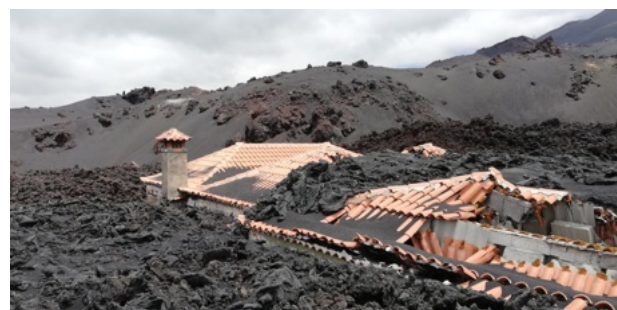
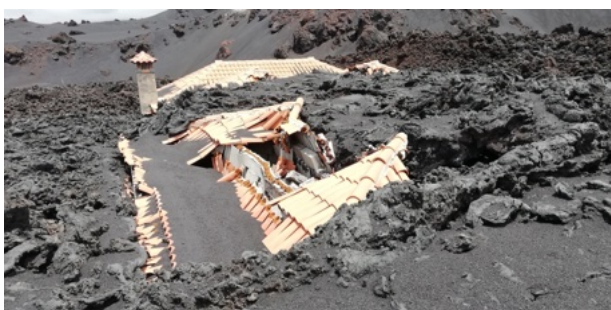
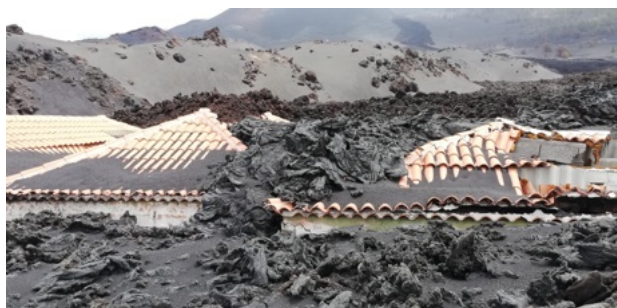
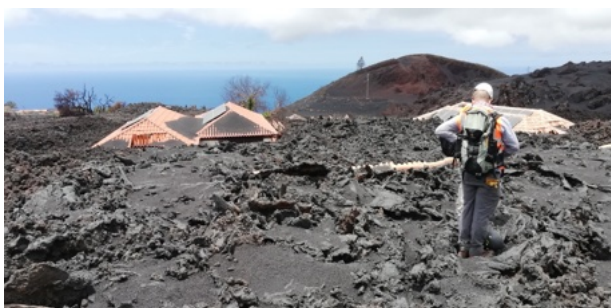
\* The double load where the pitches of the two northern roofs meet could have caused it to collapse since its shape allows for greater accumulation.

**Damage:** A'a flow impacting from the N and NE and Pahoehoe from the E, S and W to the main house. First floor completely flooded by A'a lava and pahoehoe on top of it. Structural damage of the chimney and fractures in the walls. Fire damage in the interior and heat removes exterior paint from the house leaving the wall white. Accessory roof "a" completely covered by pahoehoe lava and "b" collapsed. Secondary structures (II, III) and pool (IV) completely covered by lava.

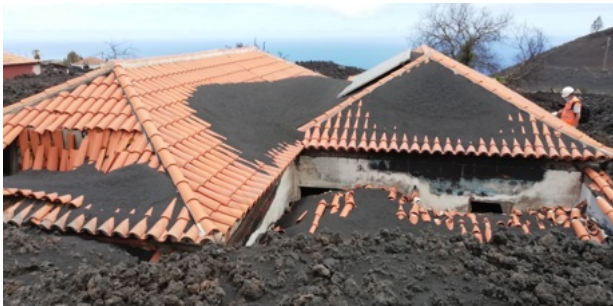
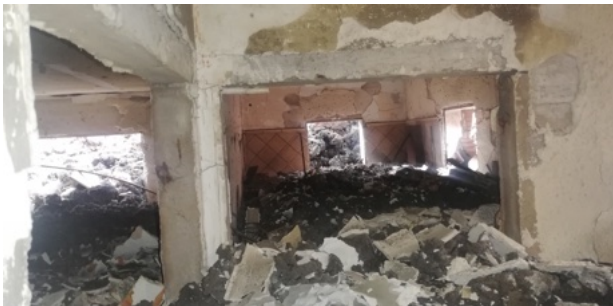
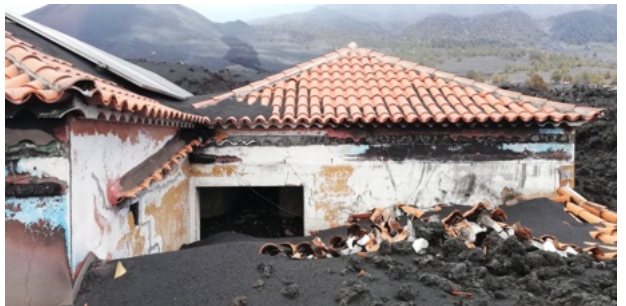
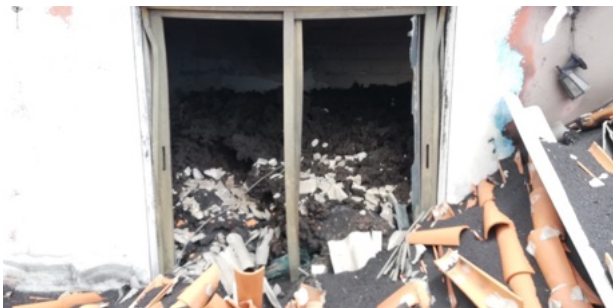
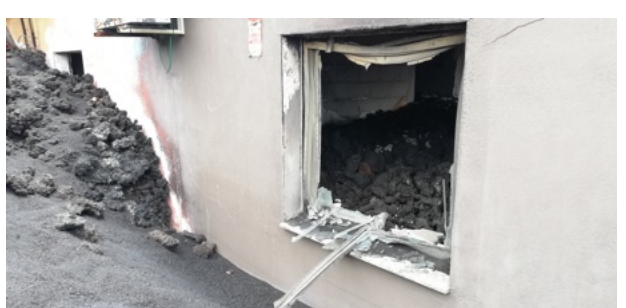
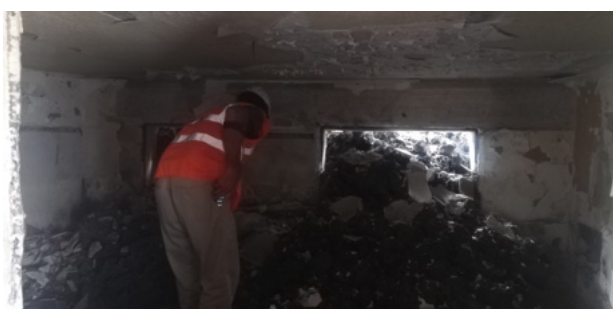
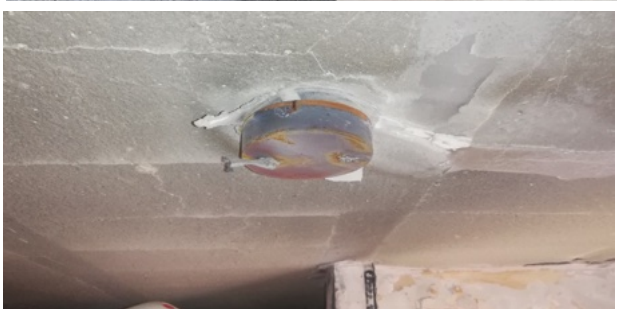
**17/05/2022:**

**Damage:** Flow impacting from the E to the main house. First floor completely flooded by lava entering openings E, and SE. Lava comes out through openings of the W, of the house. No major structural damage but fractures in the NW corner of the house, fire damage in the interior heat removes exterior paint from the house leaving some parts of the wall white. Metal frame of sliding door (opening 2) deformed by heat. Burnt wood beams and collapsed fiberglass and tile roof of the accessory roofs (b and c). Accessory roof "d" collapsed by A'a lava pressure. Secondary structure (II) and accessory roof "a" completely covered by A'a lava (at least 60 cm on top of the roof).

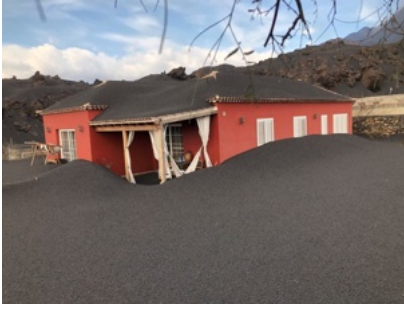
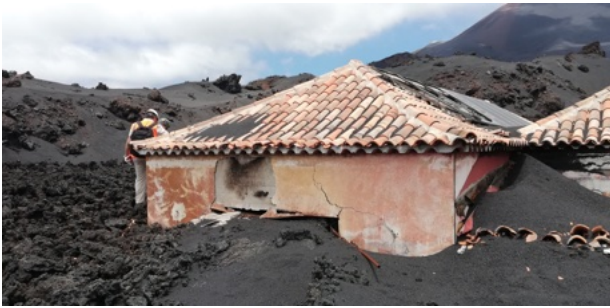
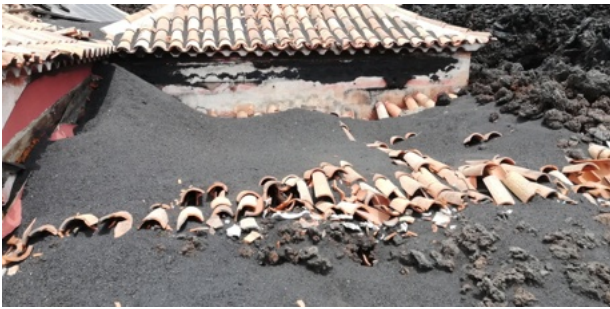
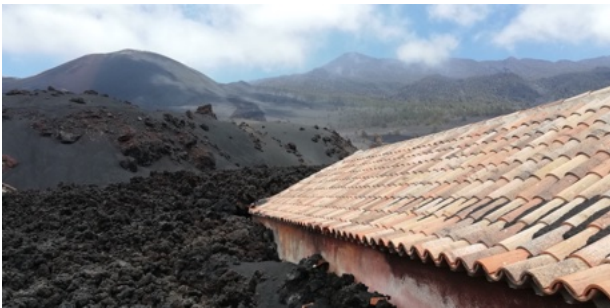
\*The double load where the pitches (pitch angle of 19-27°) of the two northern roofs meet could have caused it to collapse since its shape allows for greater accumulation. Just under this area there are no cement blocks to hold the fiberglass sheets and tiled roof.

\*broken solar panels probably caused by the internal heat of the house (3 out of 8 and 4 out of 8 in both southern pitches of the main house).

**Damage:** Flow impacting from the E to the main house. First floor completely flooded by lava, pahoehoe probably entering S-SE openings. Lava Pahoehoe comes out through W opening (I). Structural damage, fractures and openings in the W walls and fractures in the N side of the house, fire damage in the interior, heat removes exterior paint from the house leaving some parts of the wall white. Burnt wood beams and collapsed fiberglass and tiled roof of the accessory roof (a). Secondary structure (II) completely covered by A'a lava.

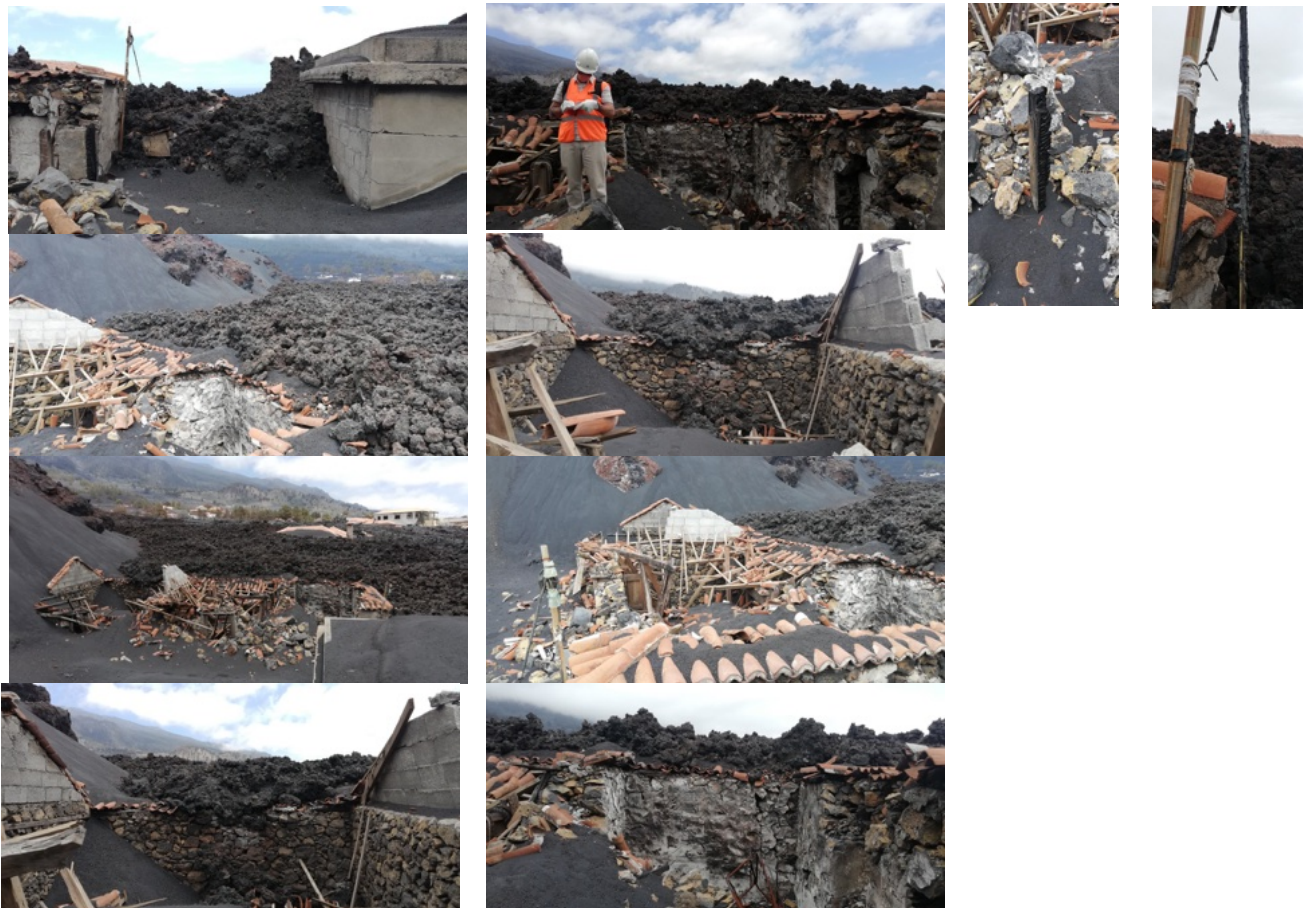
**17/05/2022:**

\*Broken stone walls ~60 cm wide in contrast to 12 cm concrete block walls

**Damage:** Flow impacting from the S to the secondary structure 1. The A'a lava pushes the wall of broken stones and tilts it to the N. Lava does not enter the structure 1 but surrounds it from the S-SW until it reaches the secondary structure 2 and enters it through opening 3. Structural damage, in the northern wall of structure "I", and SE corner of structure "II". Melted cables and opening 1 (wooden door) burned. The pressure of the lava finished collapsing the roof that had previously begun to fall due to the accumulation of tephra and then helped the north wall to collapse.

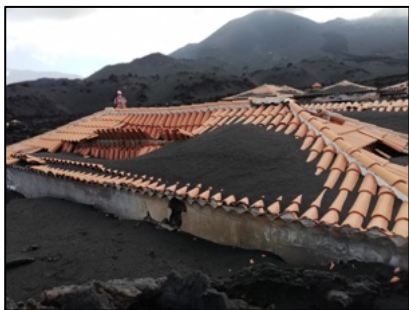
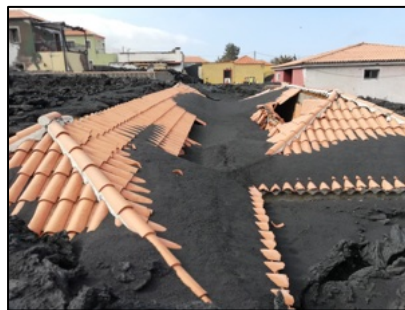
**Damage:** Totally surrounded by pahoe-hoe lava. Tephra accumulated in the middle of the 2 roof pitches generates collapse. There are cracks in the walls (facade). There is structural damage but not major, it is possible, but we are not 100% sure (it cannot be seen due to the lava flood).

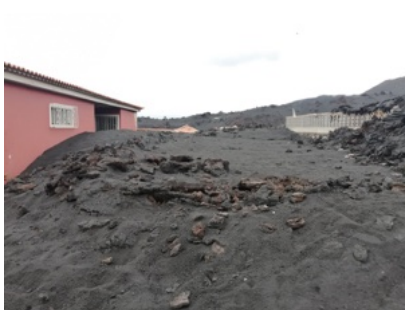
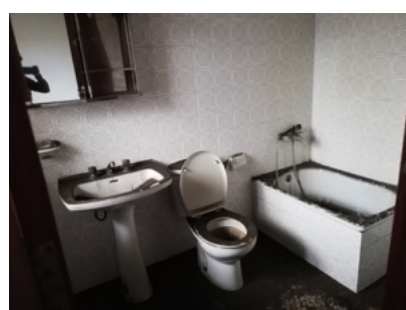
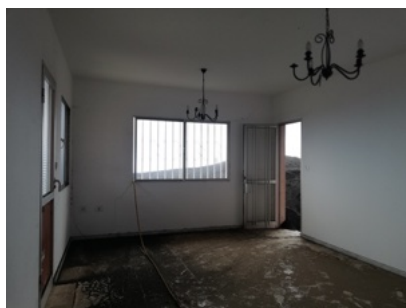
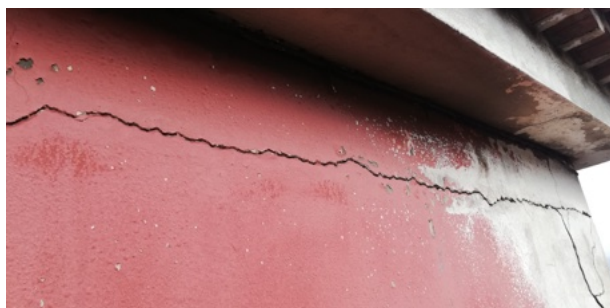
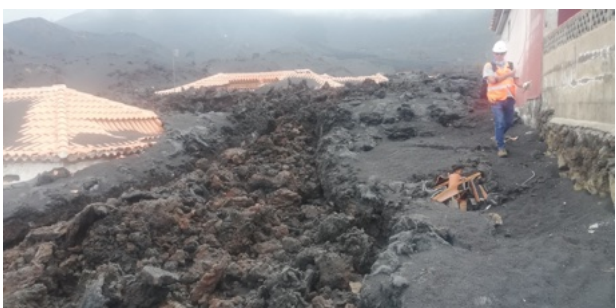
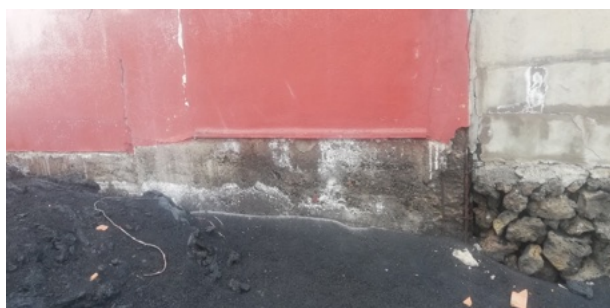
**Damage:** House surrounded by pahoehoe lava coming from the E and touching the NE corner. The heat removes red paint leaving the wall white and what is left of the paint appears bubbly. From the bottom of the roof to the top of the pahoehoe lava there are 130 cm. Structural damage (cracks in the walls) is observed. There are deflation cracks on the edges of the pahoehoe lava. We entered the house and took photos, there are fractures in every room of the house. On the N wall of the house an iron rod sticks out of it. This could be very bad for the house as in this coastal environment, it can be corroded very quickly.

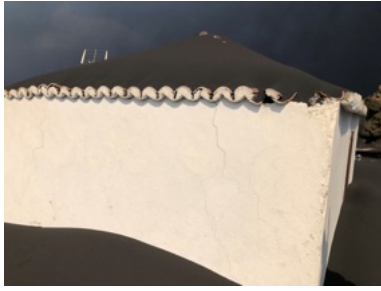
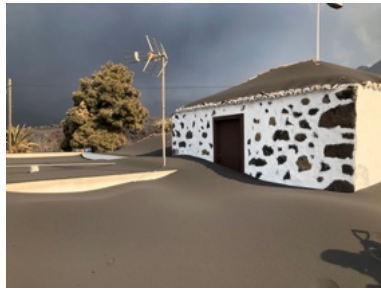
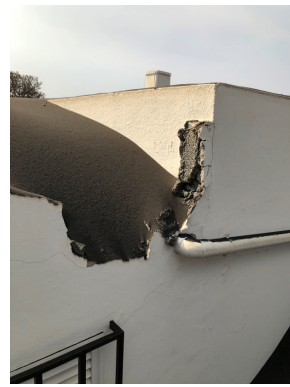
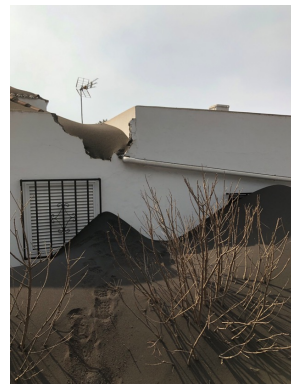
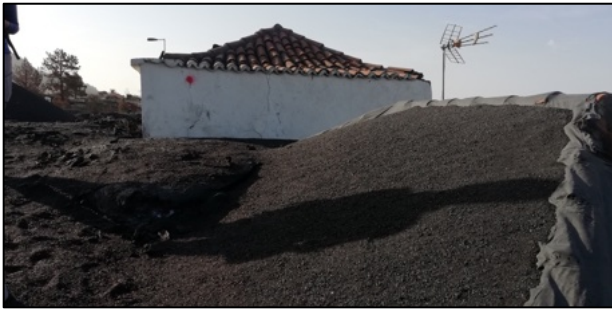
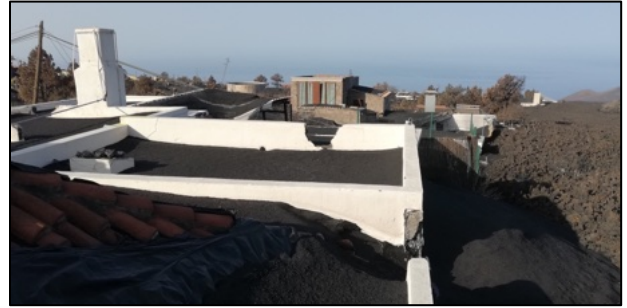
**Damage:** Pahoe-hoe lava enters opening 4 but just a little and then surrounds the house to the N. Tephra accumulated to the north of the house protects openings 2 and 3 and blocks the advance of lava A'a into the house. There are fractures in the block and broken stone walls, but it is not possible to see if the roof broke under the pahoe-hoe lava.

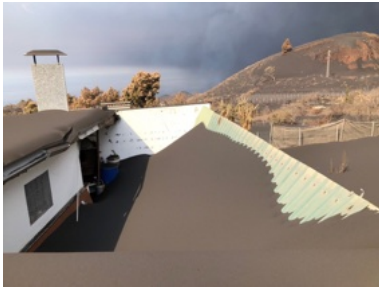
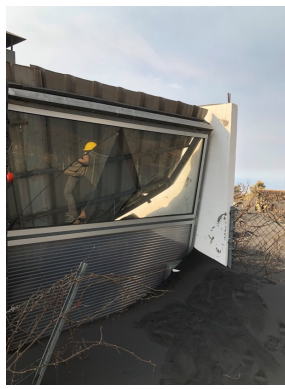
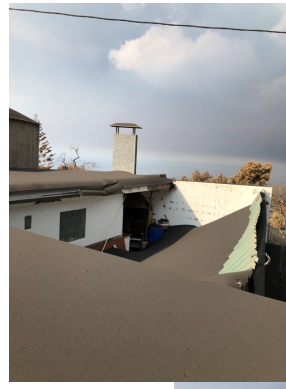
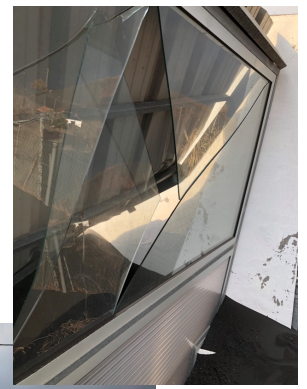
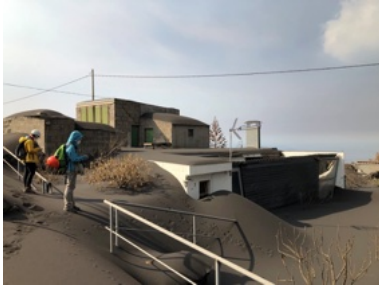
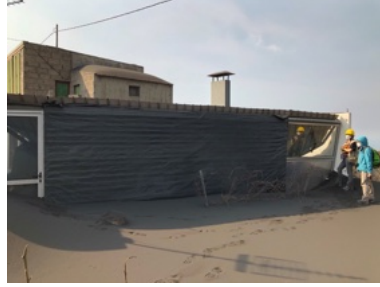
**Damage:** Lava A'a enters through opening 2 (N) towards what looks like a bathroom and through the side door (opening 1). Corrugated metal accessory roof collapsed by tephra prior to lava arrival.

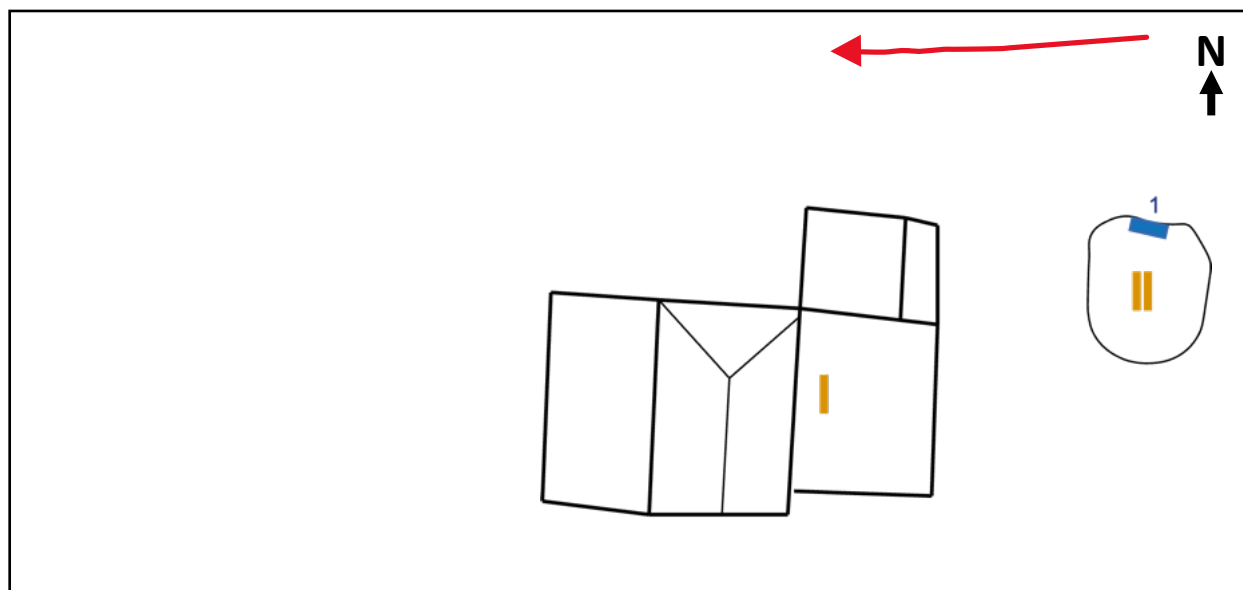
**Footprint of the property:**

**Damage:** 460 cm of distance between the A'a lava and the structures of the house. The glass of the door facing the lava (opening 1, to the N) was probably broken by the heat but the lava did not touch the house and there are no other visible damages.

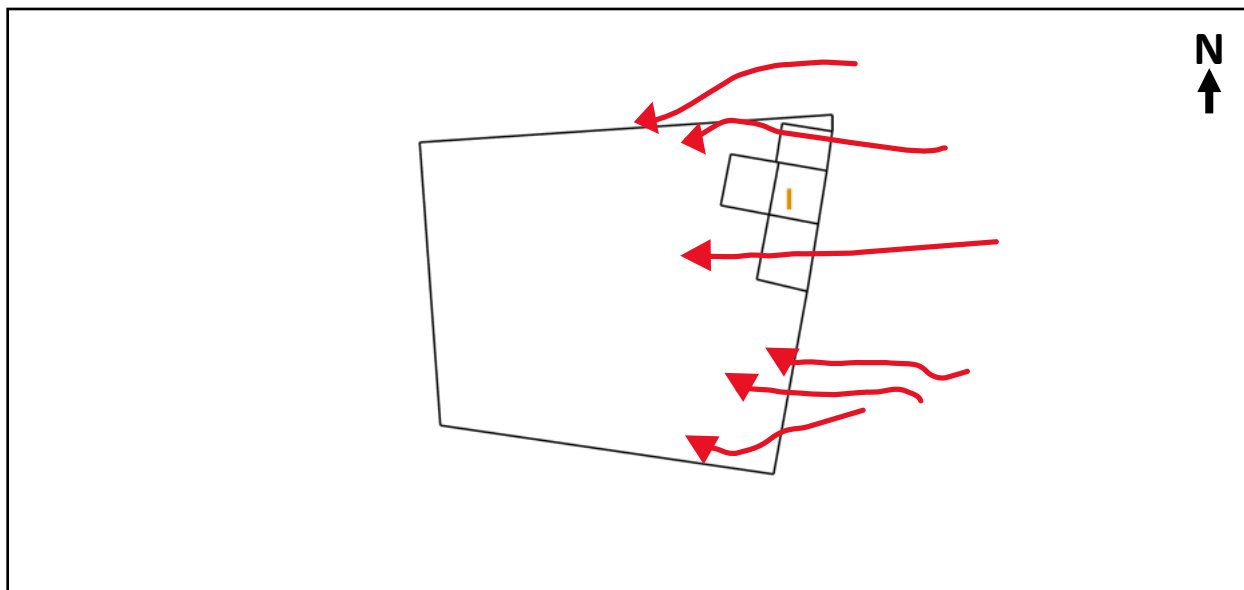
**Footprint of the property:**

**Damage:** There are signs of 3 buried structures, one with broken stone and tiles, another with blocks and fiberglass and tiles roof, and another with blocks and a corrugated metal roof. The northern structure has A'a lava on top of pahoe-hoe. The other 2 structures are destroyed by pahoe-hoe lava and then lava A'a collapses the roofs.

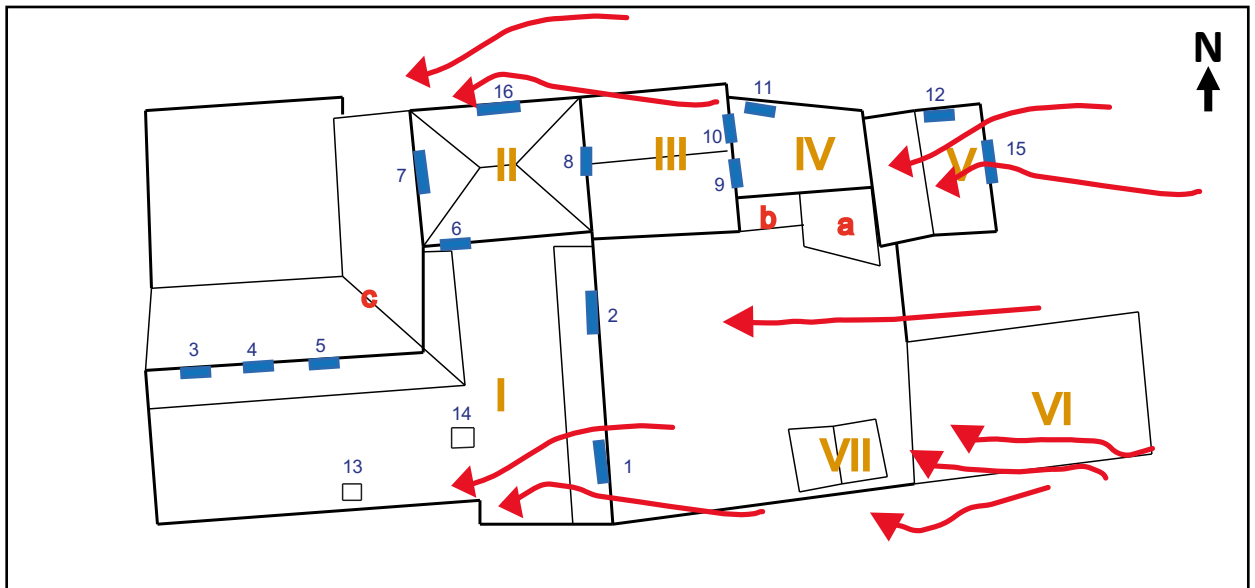
### Footprint of the property:

**Damage:** All roofs collapsed except for Primary 1 (I). Lava A'a does not enter through openings 1 and 2, it only passes over the flat roof of (I). The bars protected the structure (II) from the lava entering through opening 16. Total failure of the S wall of (III) due to the external A'a flow. In (III) deflation is observed. A'a probably entered the house through opening E (15), filled the room up to the ceiling, and then breached wall W, draining the lava. There is evidence of lava on the walls (at least 2 m). A'a flow also entered the house through the opening 12. Composite material and tiles roofs supported by wooden beams (burned) are collapsed. Metal framing melted (windows). Wooden beams that supported the accessory roofs are burned.

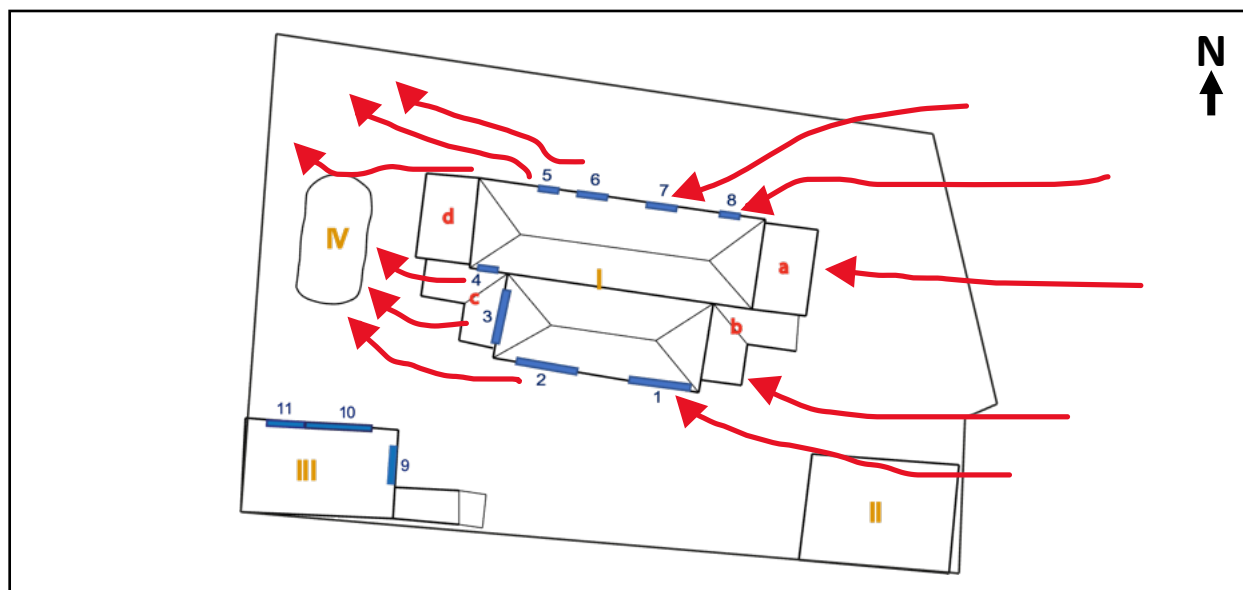
### Footprint of the property:

**Damage:** Flow impacting from the E to the front of the main house. First floor completely flooded by lava entering openings E, NE and SE. Lava comes out through openings of the W, NW and SW of the house. No major structural damage but fire damage in the interior of the house. Thermal sagging in the steel rafters of the accessory roofs (Tube support 8x8 cm and 4x6 cm) and roof of composite material and tiles collapsed. Thermal sagging in the big steel rafter, burnt wood beams and collapsed fiberglass and tile roof of the Barbecue structure. Pool (IV) completely covered by lava.

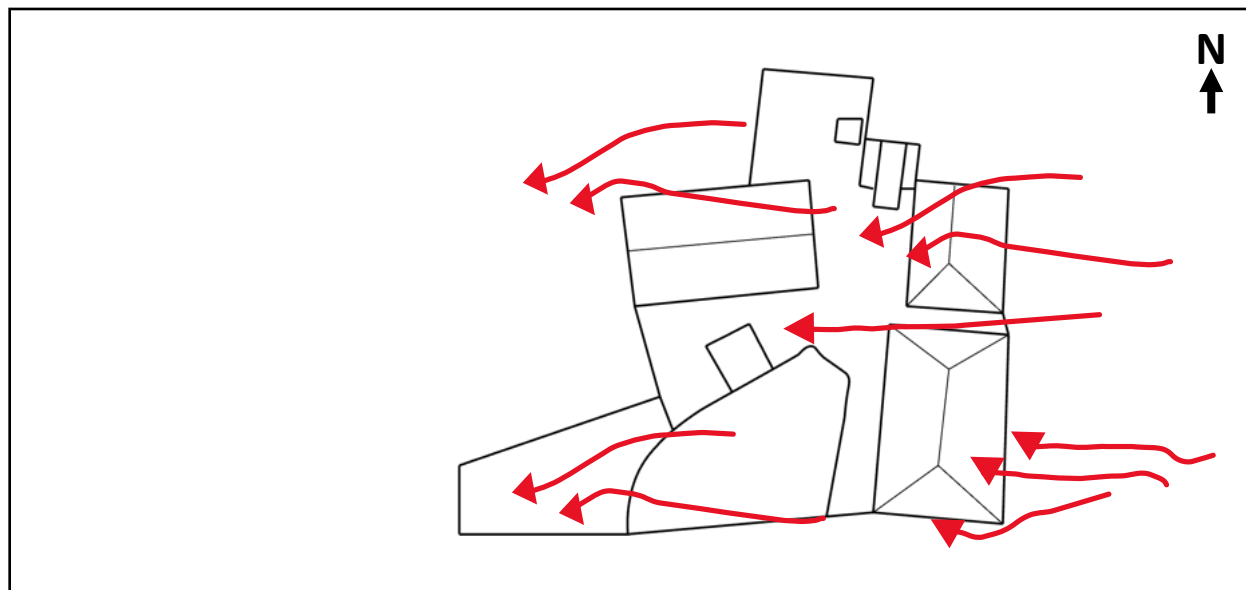
**Footprint of the property:**

**Damage:** Completely buried or washed away by A'a lava flow. Pahoehoe lava also appears in contact with one of the walls that is possible to see through the rubble with a new texture that we had not seen before. 10 m downstream there is another piece of the wall and tiles running SW and NW.

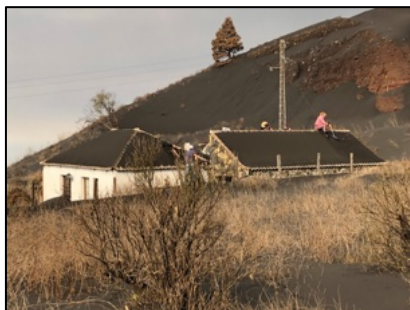
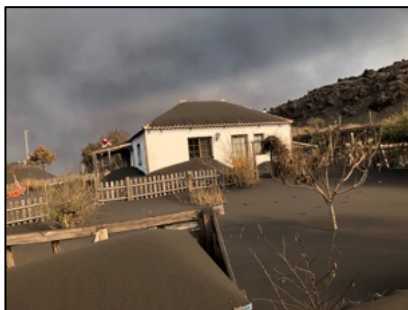
**30/10/2021:**

**Damage:** Fractures are observed in the walls, the top plate on the wall. The beams that support the ceiling and the tiles were made of wood and they are burned now. A'a lava entered the house through opening 8 and 10 filling the room but stopped in the frame of opening 9.

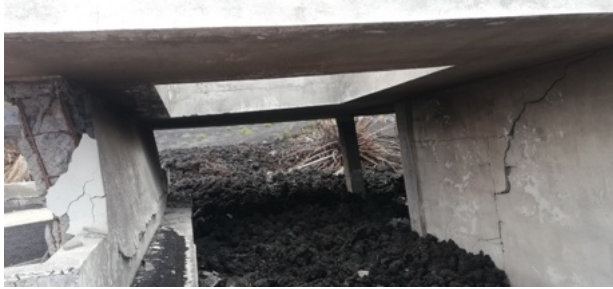
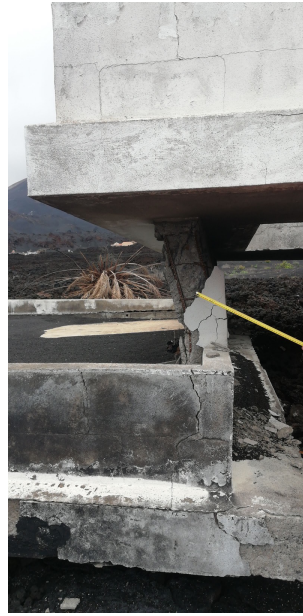
**20/05/2022:**

**Damage:** Structure made of blocks and reinforced concrete pillars. Fractures are observed throughout the building and the walls are inclined (9-10°). One of the pillars moved 16 cm to the left. Southern wall is displaced 2.5 cm from the pillar. The building looks burned inside.
