# Anthropogenic fill and geological–hydrological controls on progressive failure in the 2023 Stenungsund quick-clay landslide (SW Sweden)

Christian Öhrling<sup>1,2\*</sup> and Ola Fredin<sup>1</sup>

## Abstract

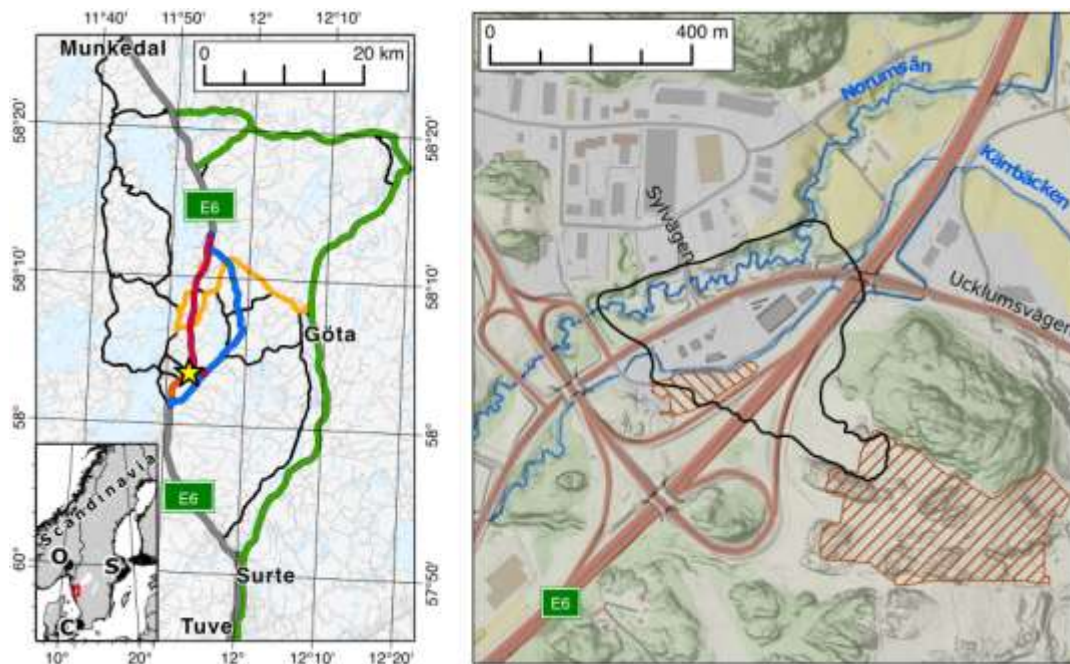
**Fig. 1 a** The Swedish west coast contains widespread marine clays prone to quick-clay formation. The 23 September 2023 landslide occurred at the Stenungsund interchange on the E6 in southwestern Sweden (yellow star). Road closures rerouted traffic: the designated Gothenburg–Oslo diversion is shown in green, while the largest increases occurred on local roads (blue) and other routes with elevated heavy traffic (orange/black), several of which required repaving and reinforcement. Many major landslides have occurred in the region; four examples are: Surte (1950), Göta (1957), Tuve (1977), and Munkedal (2006). **b** The landslide area is outlined by the black polygon; red hatching shows active construction. Norumsån and the spring-fed Kärrbäcken traverse the area. Background: Topographic and elevation data © Lantmäteriet.

At around 01:40 a.m. on 23 September 2023, a large landslide occurred at the Stenungsund interchange on the E6 in southwestern Sweden ( $58^{\circ}3'33''\text{N}$   $11^{\circ}52'55''\text{E}$ ) (Fig. 1). The event displaced 15 hectares of soil and construction materials, tore apart both the E6 and a municipal road, dammed a small river, and destroyed several commercial buildings. Within the landslide area, nine cars and one bus were trapped while driving, and eleven professional drivers were in their parked trucks. Fortunately, no fatalities occurred – largely due to the timing of the event at night, when traffic and commercial activity were minimal. Nevertheless, the event caused severe economic disruption, blocking the main transport artery between Oslo and continental Europe, highlighting the vulnerability of infrastructure in sensitive clay terrain.

The landslide area is 15 ha, with a distance of 620 m from the back scarp to the slide masses in the river *Norumsån* ('Norumsån' from here on) and a width along the local road *Ucklumsvägen* of 450 m, while being 400 m parallel to E6 (Fig. 1). The elevation difference in the affected area is 37 m, between the top of the filling in the east at 72 m a.s.l. and the bottom of *Norumsån* in the west at 35 m a.s.l.

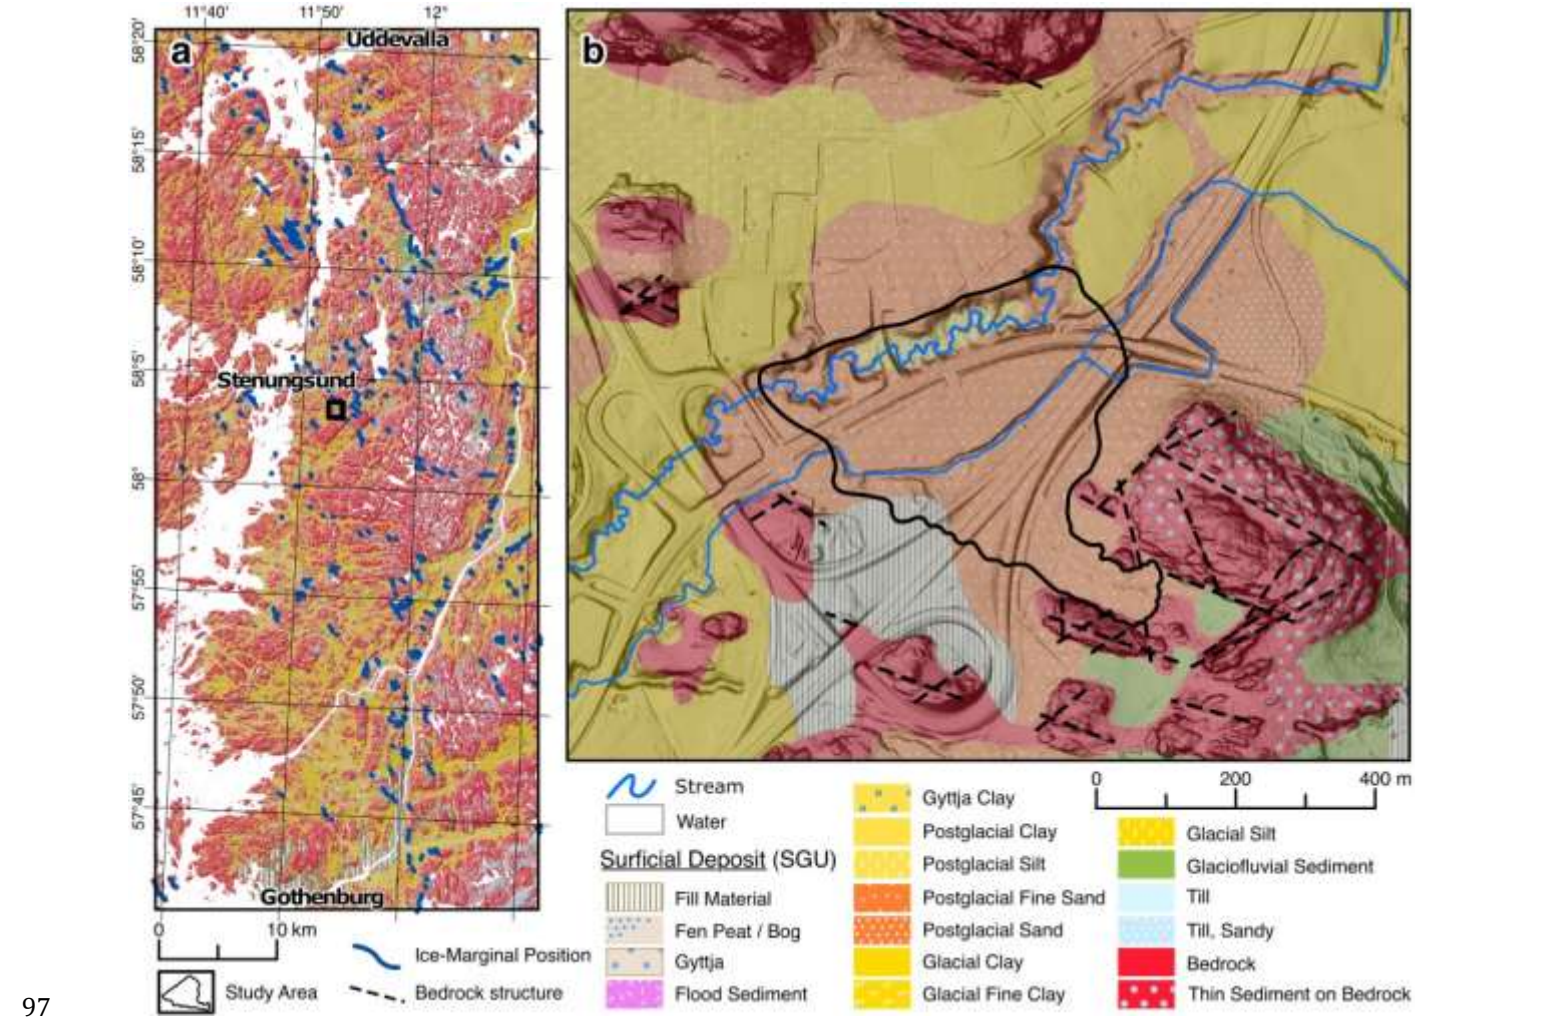
83 The bedrock in the Stenungsund area consists of a granitoid intrusion within the Idefjord terrain, dated to  $1,522 \pm$   
84 10 Ma ([Åhäll 1990](#); [Åhäll and Connelly 2008](#)). Gneiss and granite show variable deformation (folding, fracturing, and  
85 mylonites). Deformation intensity depends on lithology and proximity to tectonic zones, which are linked to the  
86 Sveconorwegian orogeny (1,150—900 Ma). Extensive fracture and fault zones strongly influence groundwater flow and  
87 slope stability (Fig. 2).

98 **Fig. 2 a** Regional geological setting where the Quaternary Deposit Map (SGU 2024) displays red for bare bedrock and yellow for clay. Blue lines  
 99 represent ice-marginal positions (end moraines), and the black rectangle marks the extent of b. **b** The affected landslide area is zoomed in on the  
 100 same surficial deposit map. Linear structures are marked on the bare bedrock. Postglacial silt and sand, wave-washed sediment during regression,  
 101 superpose the previously deposited clay that is found on the surface where no wave-washed material was deposited or preserved.

102 During the deglaciation at the site, the ice margin readvanced and left a large glaciofluvial deposit just on and  
 103 behind the hill, east of the landslide (Fig. 2). Regression later exposed these sediments to wave washing, reworking, and  
 104 subsequent redeposition. As a result, the valley infill comprises interlayered glaciomarine clay, glaciofluvial outwash,  
 105 and postglacial clay, silt, and sand with varying permeability.
