## Online Resource 1

Supplementary material to the article published in Environmental Science and Pollution Research  
*Coastal erosion as a source of mercury into the marine environment along the Polish Baltic shore*  
by M. Beldowska, A. Jędruch (✉), L. Łęczyński, D. Saniewska and U. Kwasigroch  
University of Gdansk, Institute of Oceanography, Pilsudskiego 46, 81-378 Gdynia, Poland  
✉ Corresponding author e-mail: [agnieszka.jedruch@ug.edu.pl](mailto:agnieszka.jedruch@ug.edu.pl)

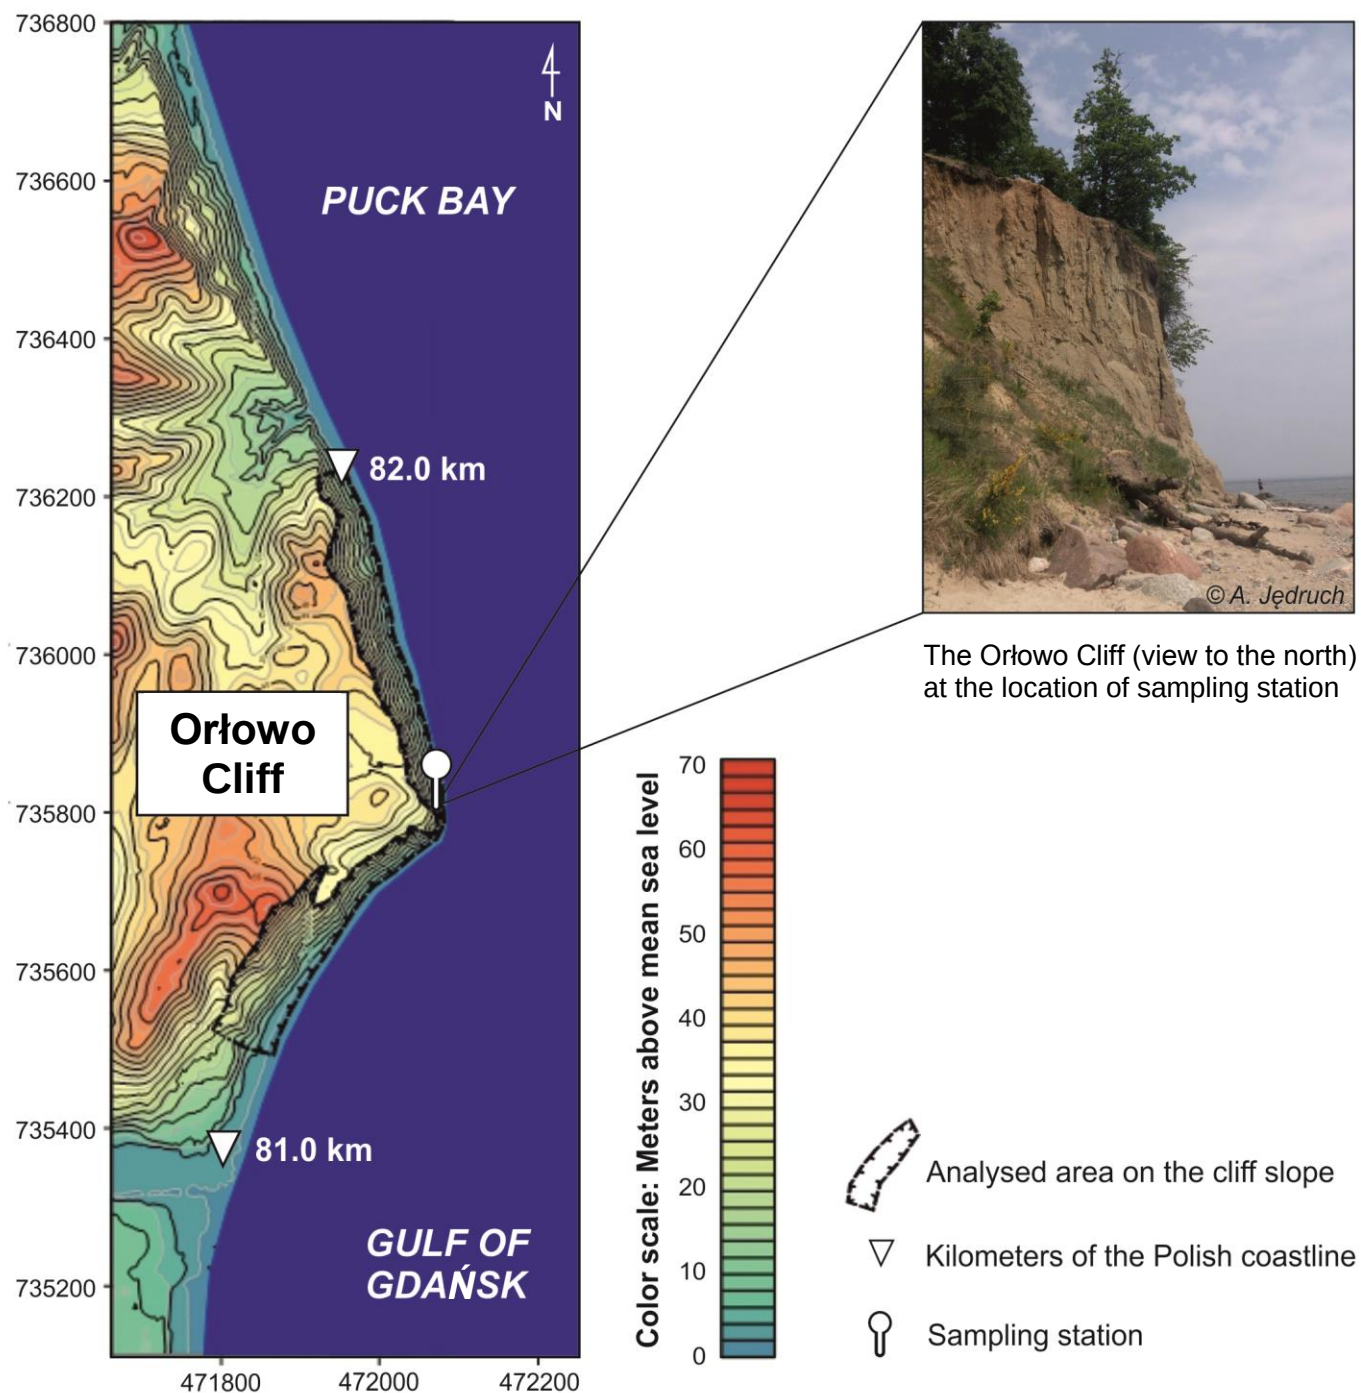
**Map of the cliff area showing the investigated sector (Polish coastline section: 81.30 km – 81.95 km) based on the Airborne Laser Scanning (ALS) results (Orłowo Cliff example):**
