## **Supplementary information**

### **High-throughput screening of zwitterion-based coatings towards improved mechanical stability and drug-loading capacity**

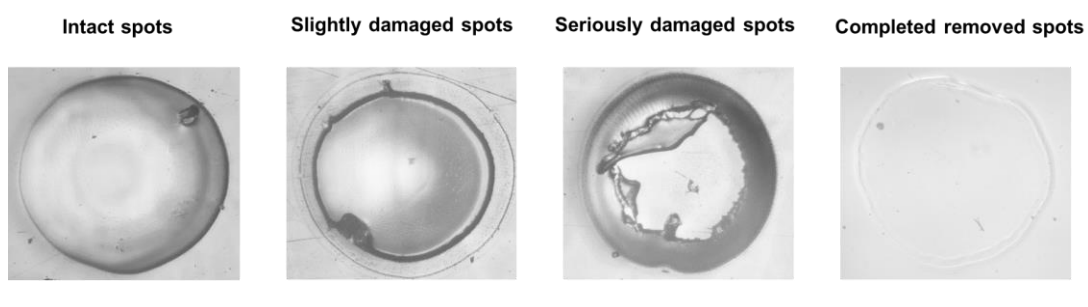
**Supplementary Figure 1.** The representative optical images of intact spots, slightly damaged spots, seriously damaged spots, and completed removed spots. The colors of the lines below images correspond to the colors exhibited in heat maps.

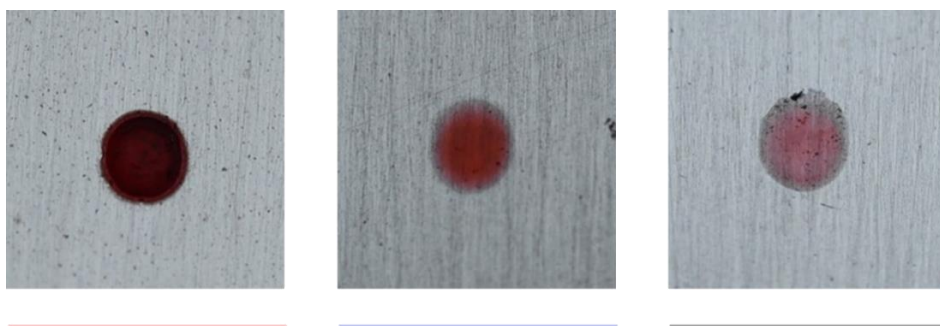
**Supplementary Figure 2.** The representative macroscopic images of the hydrogel coating spots after the immersion in Congo red solution for 24 h. The colors of the lines below images correspond to the colors exhibited in the three-dimensional histogram.
